RESERVE STUDY

Kingston Plantation Master Association, Inc.

Myrtle Beach, South Carolina
April 27, 2022

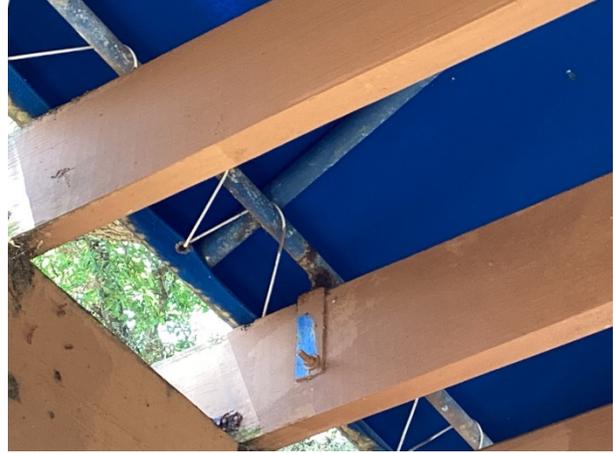
Rust evident

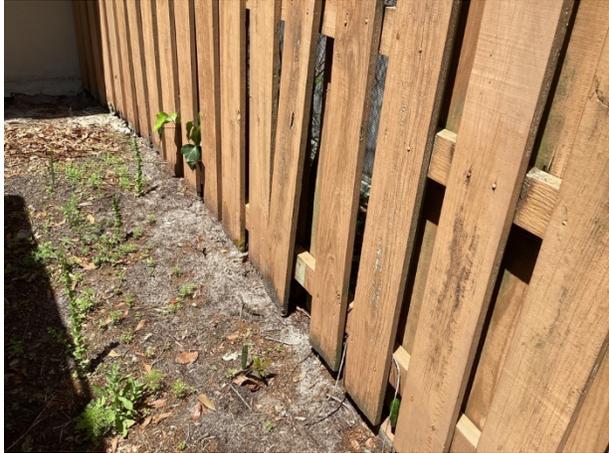
Condition: Fair overall with loose boards evident. The Association informs us of plans to conduct minor repairs funded through the operating budget in the near future.

Loose board

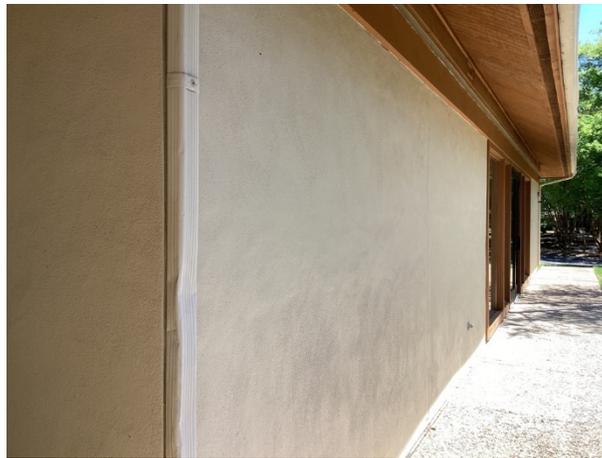
Condition: Good overall with the exception of the adjacent stand-alone walls, which are in poor overall condition. We note multiple areas of cracks and poor finishes.

Stucco overview

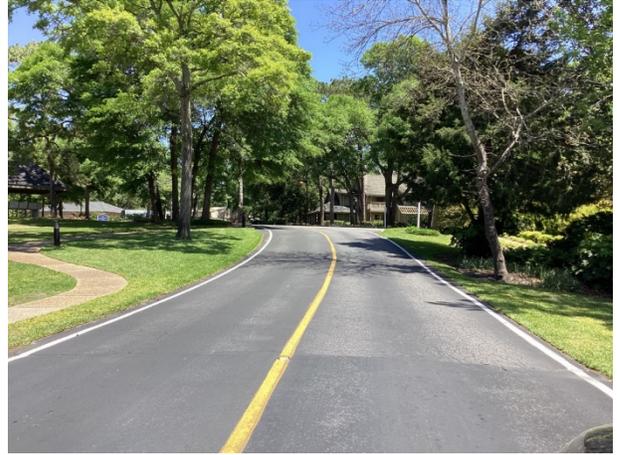
Alligator cracks and settlement at Plantation Lakes Drive

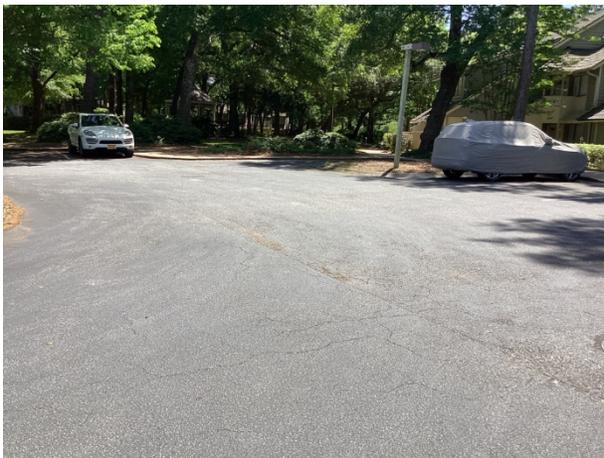
Pavement cracks at Baslow Court

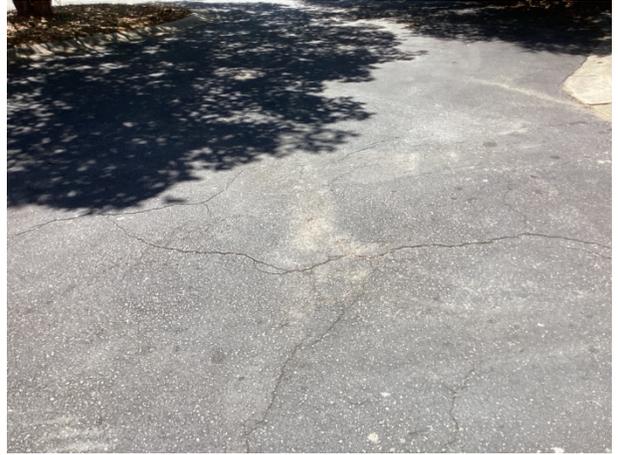
Pavement cracks at Richmond Park

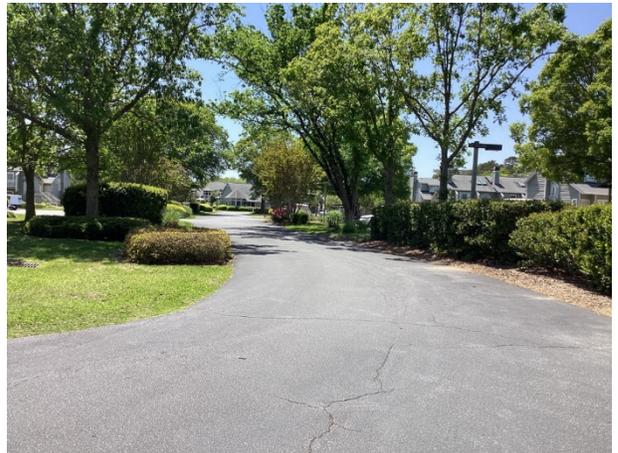
Cumberland Terrace – pavement cracks evident

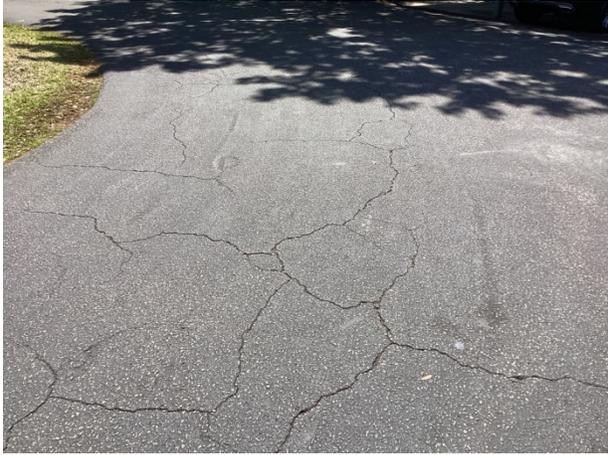
Pavement cracks at Abergale circle

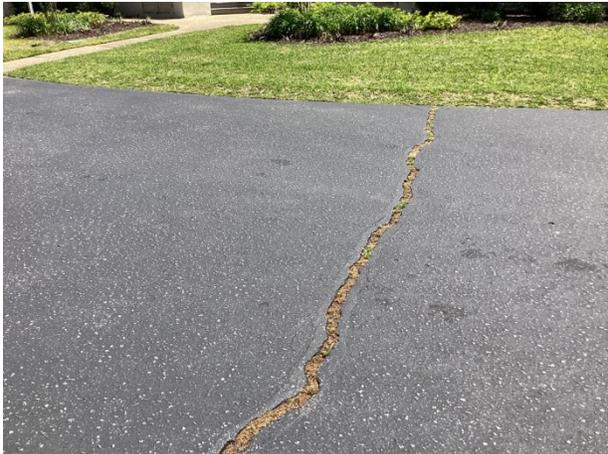
Severe cracks at Westleton drive

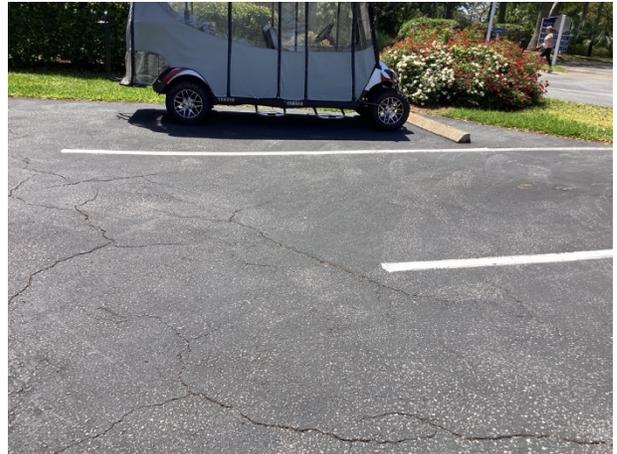
Pavement cracks at Saint Clears Way

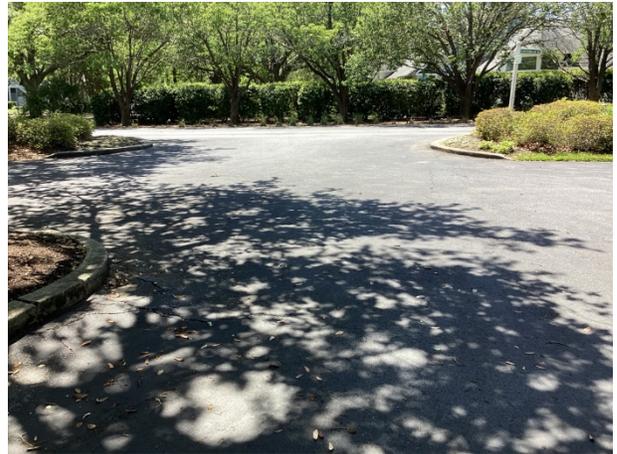
Pavement cracks and root intrusion at Gloucester on the Point

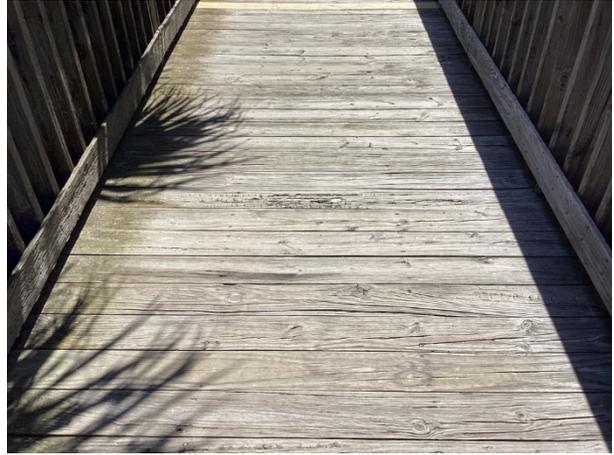
Deck deterioration

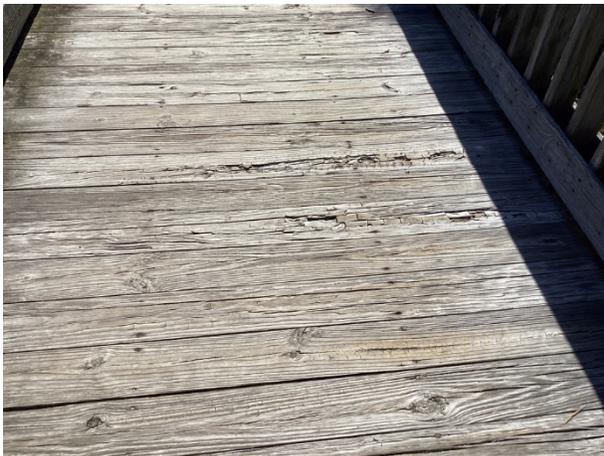
Deck weathering

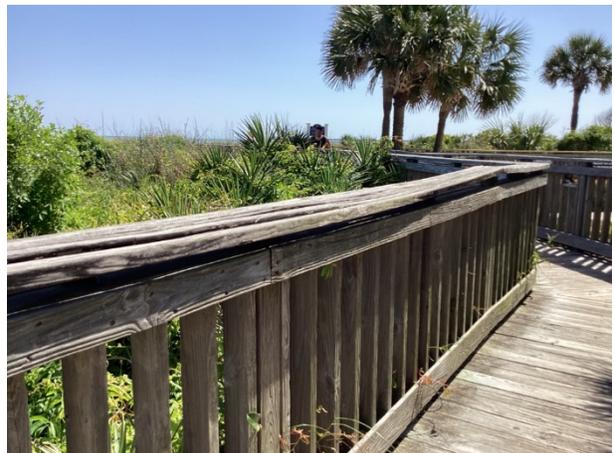
Railings deterioration and warps

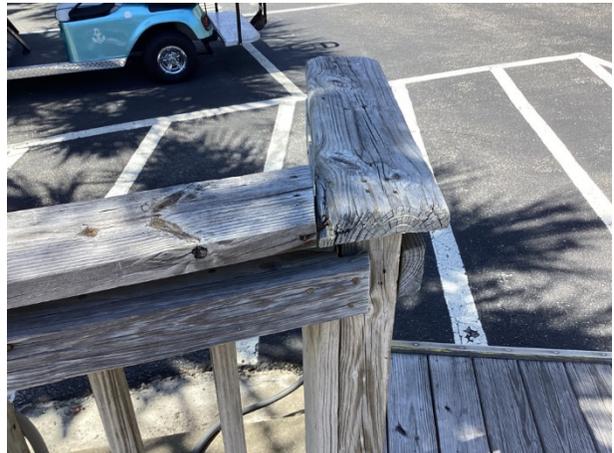
Deteriorated wood at pool deck

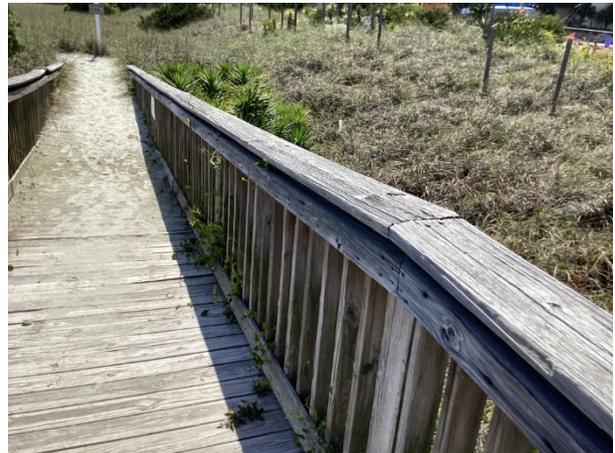
Railings deterioration at the Embassy Suites beach access

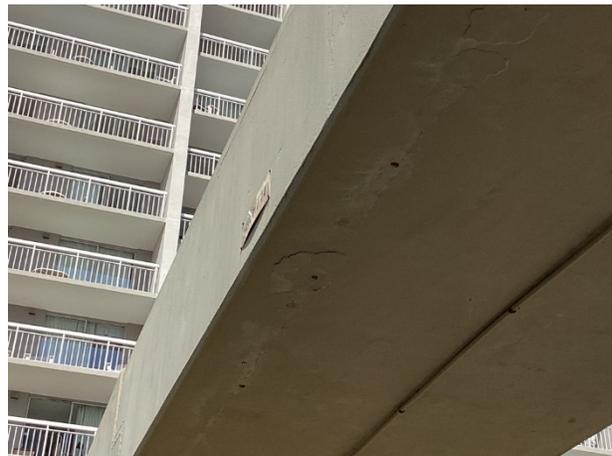
Finish deterioration

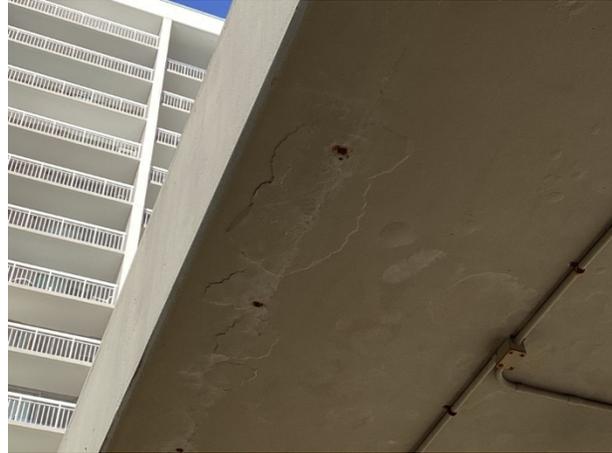
Rust spots evident

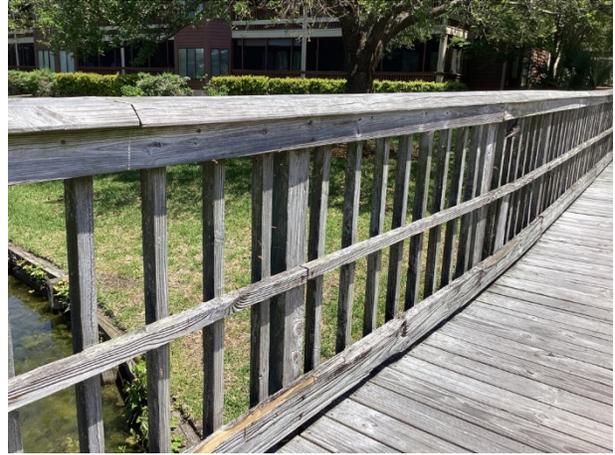
Laurel Court bridge railings – wood deterioration evident

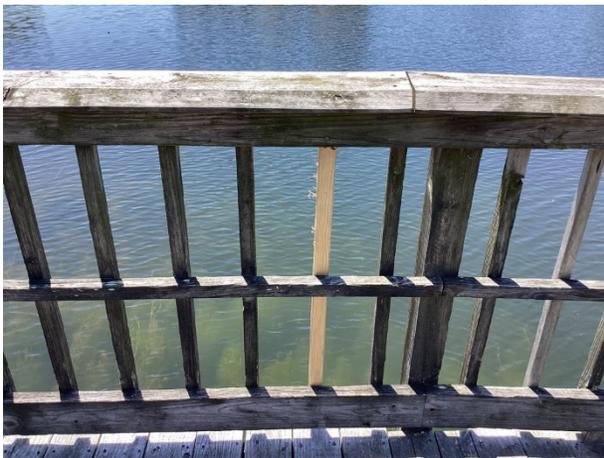
Repairs evident

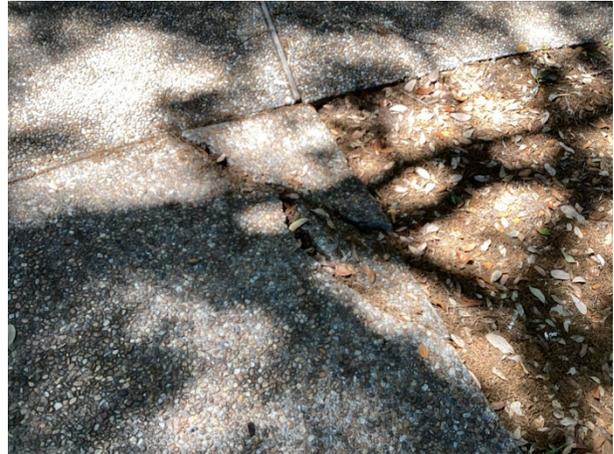
Sidewalk cracks and settlement

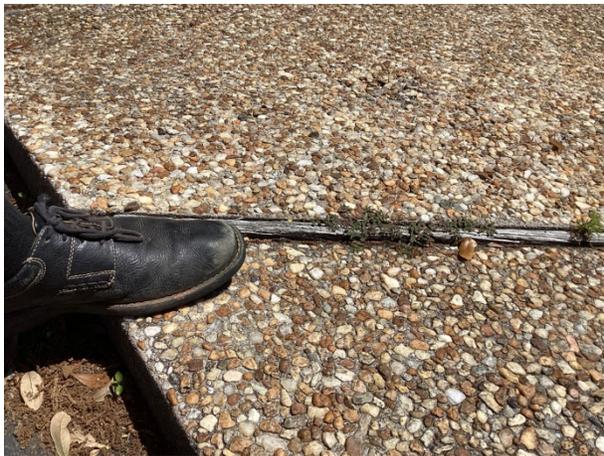
Sidewalk trip hazard – The Americans with Disabilities Act (ADA) of 1990 defines a ‘trip hazard’ as any vertical change of over 1/4 inch or more at any joint or crack.

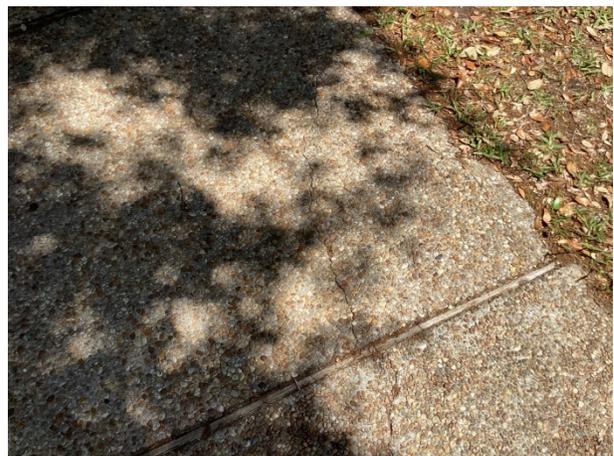
Sidewalk cracks

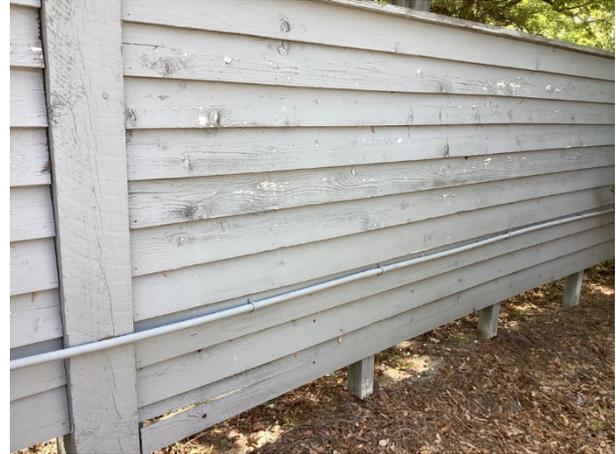
Finish and wood deterioration

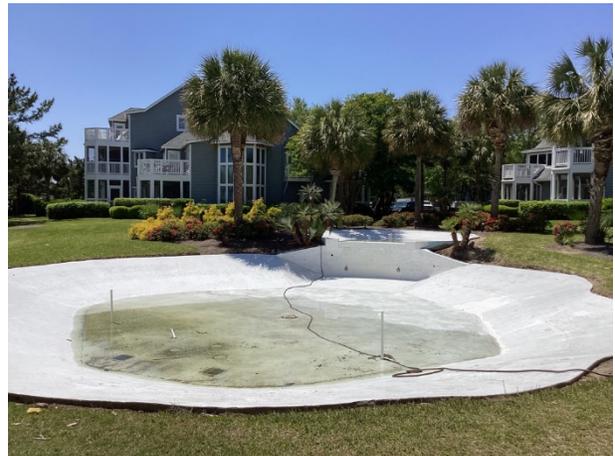
Cracks and peeling finishes evident

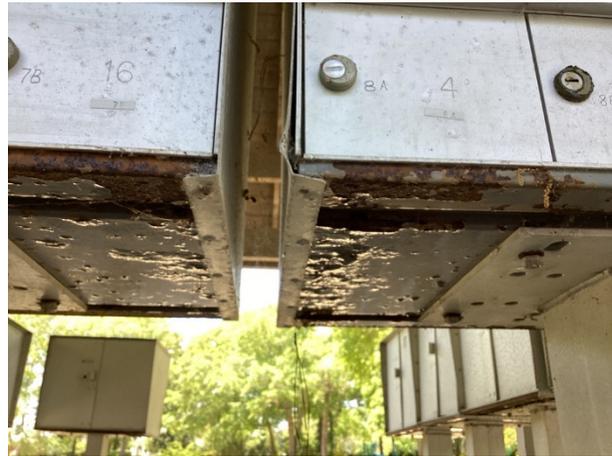
Mailbox station rust

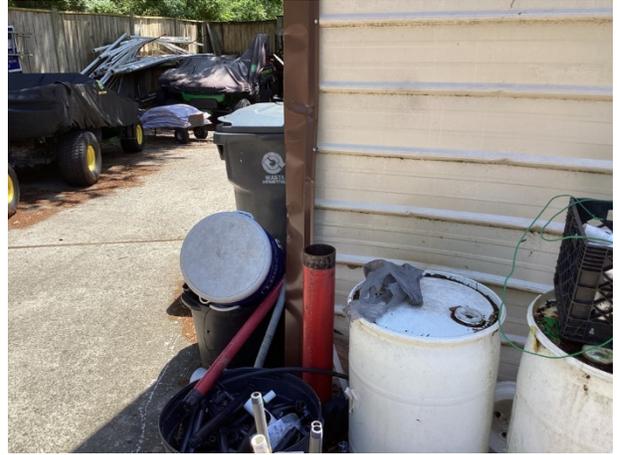
Damaged siding

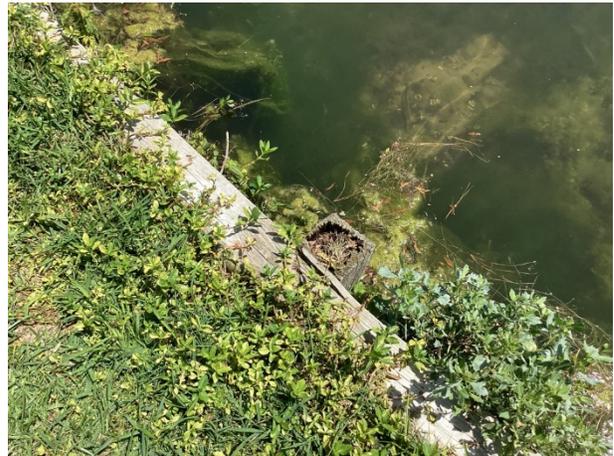
Timber rot evident

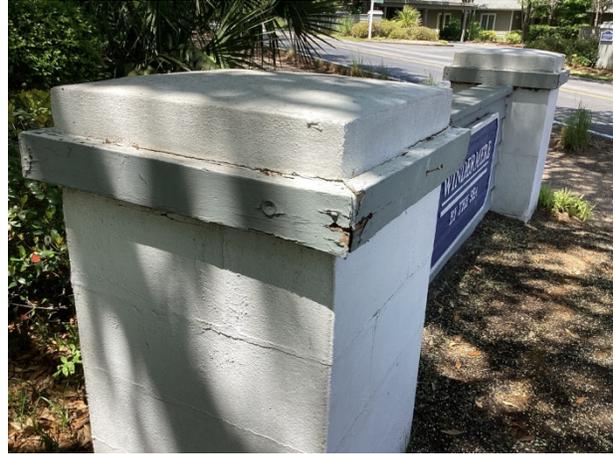
Sign deterioration

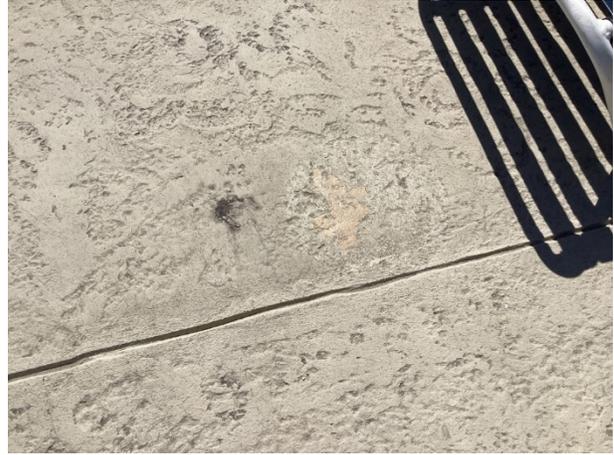
Textured coating delamination

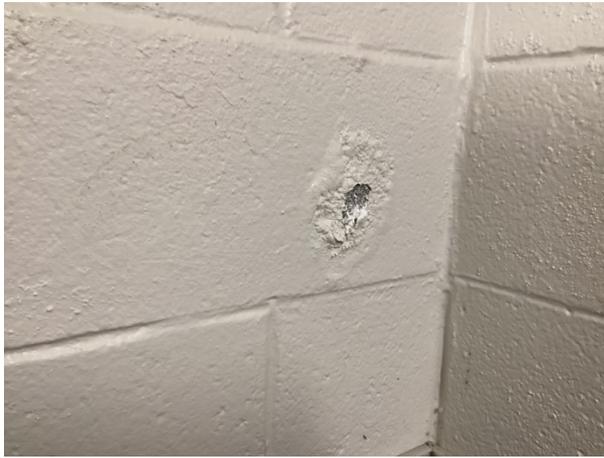
Beach rest room finish deterioration

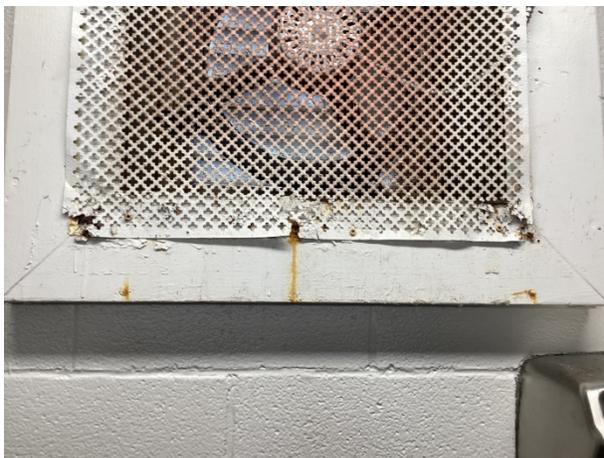
Rust at beach rest room exhaust fan

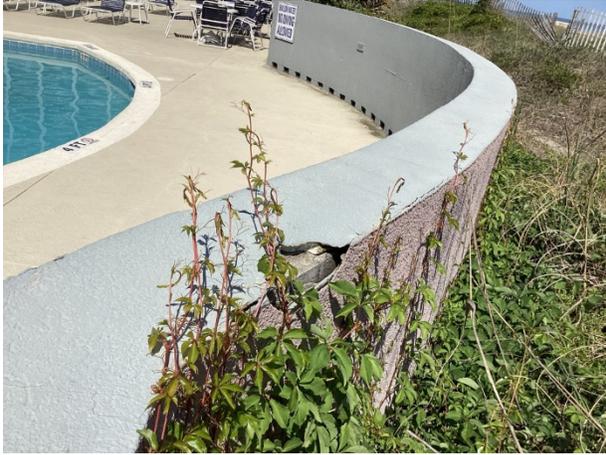
EIFS damage at pool wall

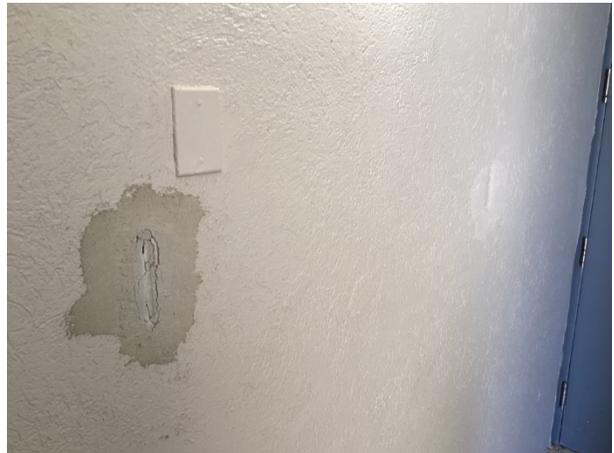
Pool house EIFS damage
