Kingston Plantation Master Association, Inc.

Inspected: May 28, 2025 • Revised on: September 15, 2025
Myrtle Beach, SC

RESERVE STUDY

Kingston Plantation

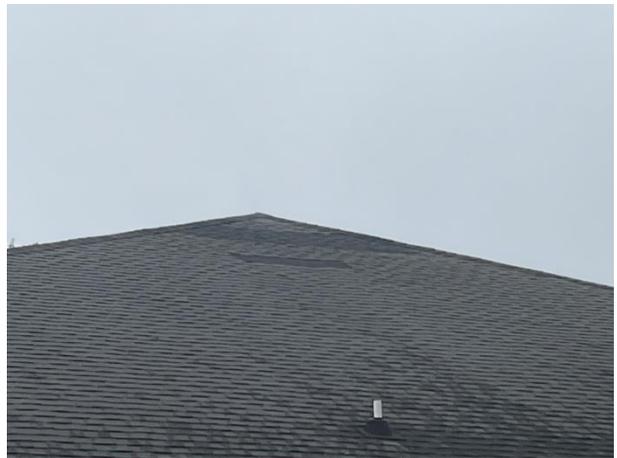
Condition: Good to fair overall with recent repairs evident from our visual inspection from the ground. Management does not report any active leaks.

Previous repair

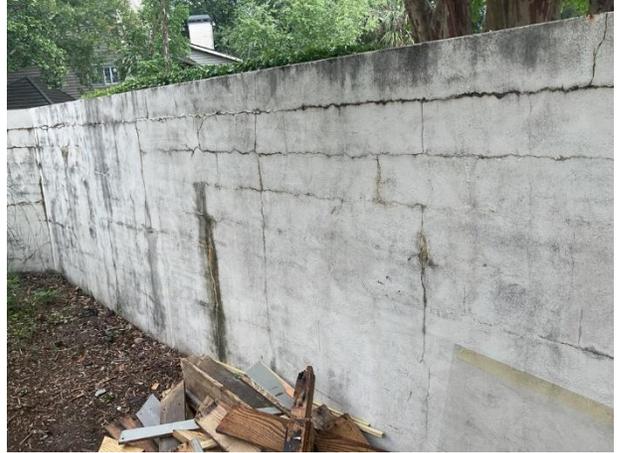
Condition: Fair overall with isolated stains and damage evident.

Stucco trash enclosure wall with stains

Useful Life: We recommend inspections, repairs and paint finish applications every six- to eight-years.

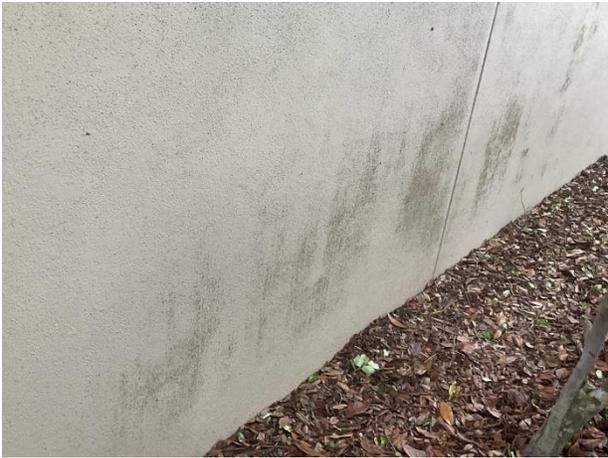
Stucco wall stains

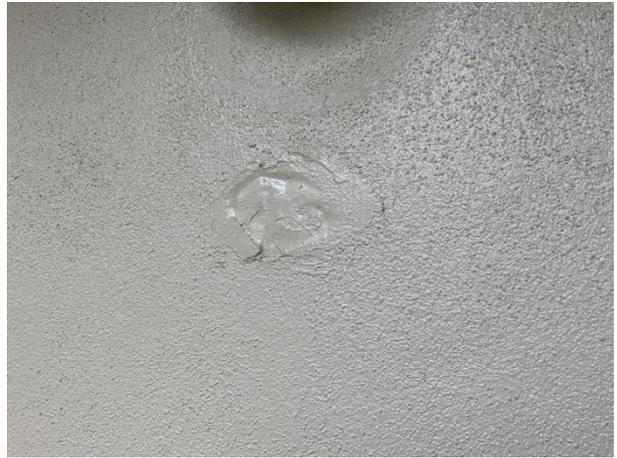
Stucco damage

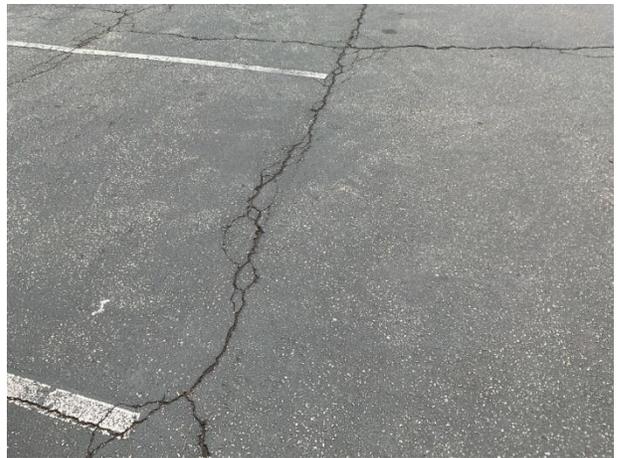
Pavement cracks at trailer parking area

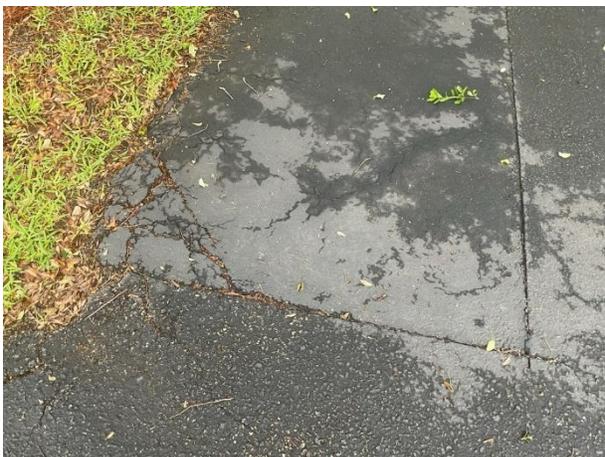
Pavement cracks at Gloucester Terrace Circle

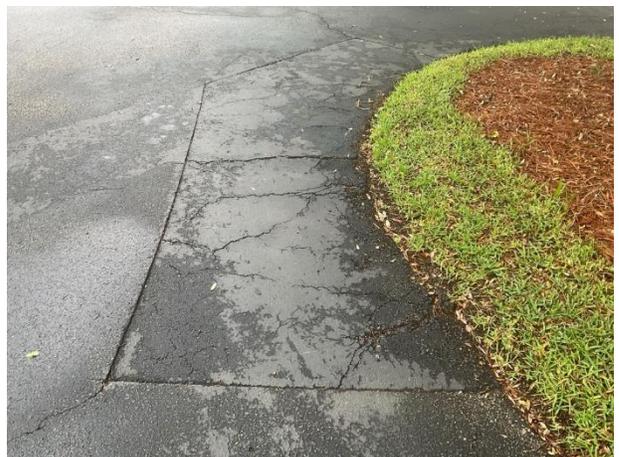
Pavement cracks and previous repairs at Gloucester Terrace Circle

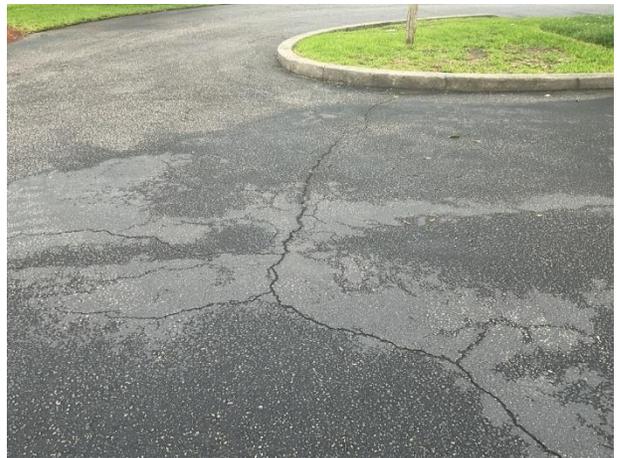
Pavement cracks at Cumberland terrace

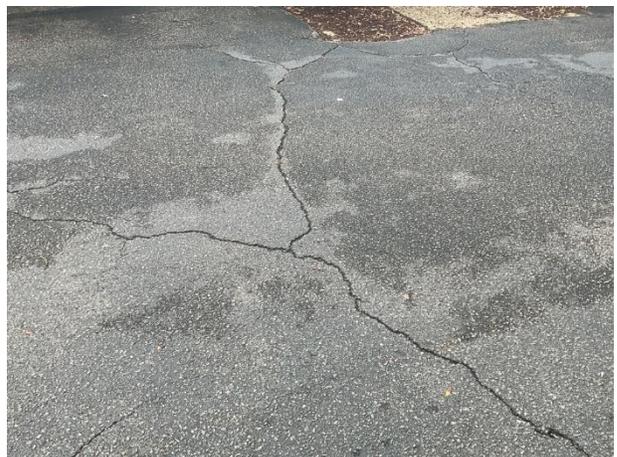
Pavement cracks Appledore

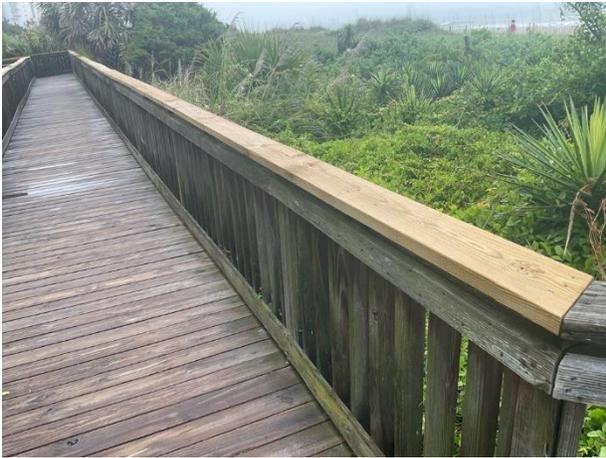
Condition: Good to fair overall condition. We note deteriorated and weathered wood deck boards and recent replacements.

Boardwalk overview with previous repairs

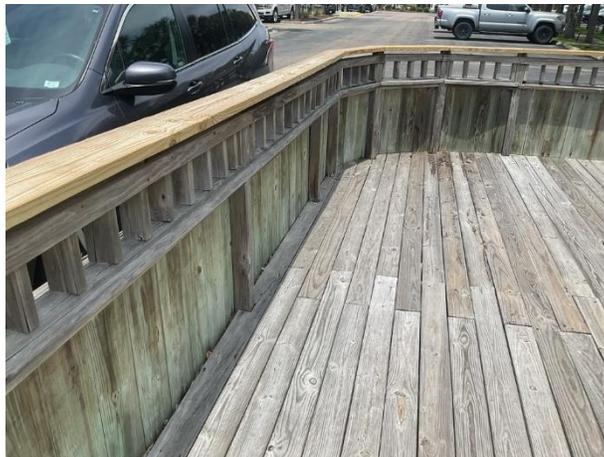
Boardwalk overview with previous repairs

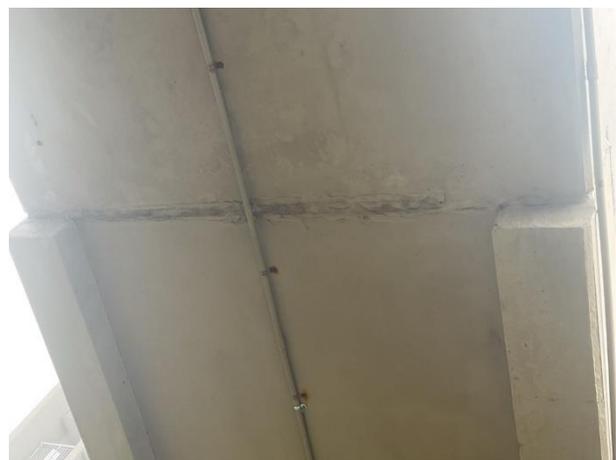
Condition: Good to fair overall with deteriorated finishes, control joint sealant deterioration, rust spots and textured coating delamination evident

Sealant deterioration at control joint

Useful Life: 10- to 15-years for capital repairs including a close-up visual inspection, patching of delaminated concrete, and routing and filling of cracked concrete

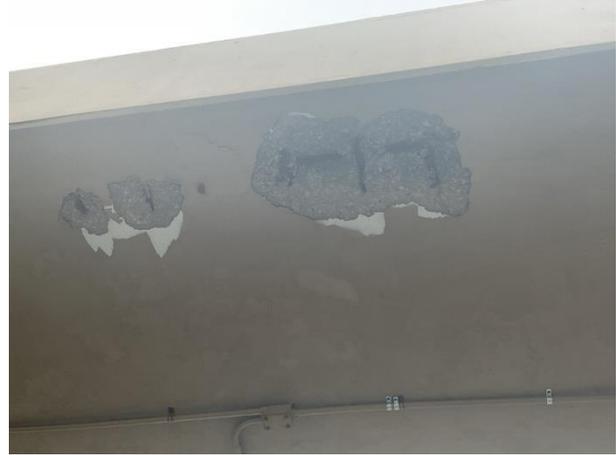
Finish deterioration

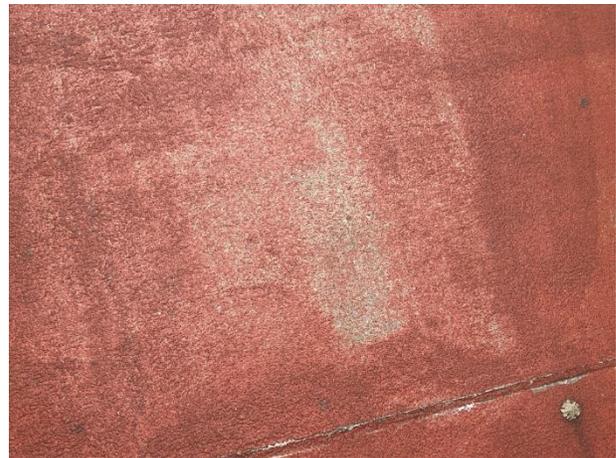
Bridge coating deterioration

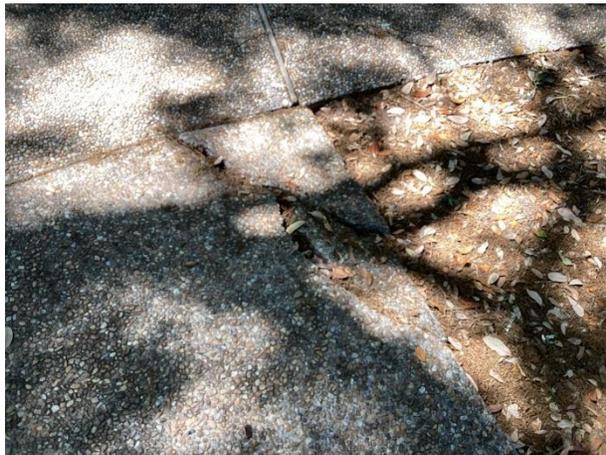
Sidewalk cracks and settlement

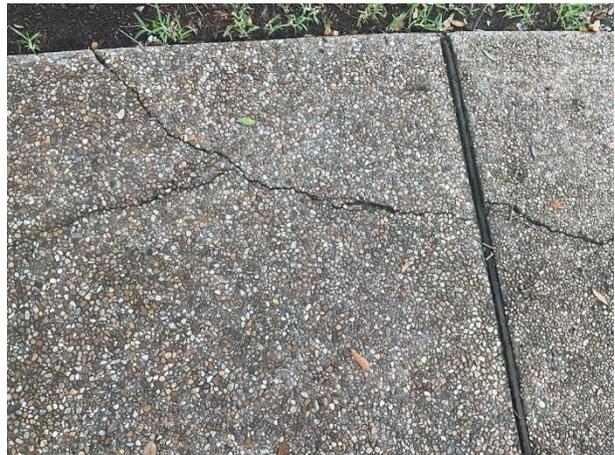
Sidewalk cracks

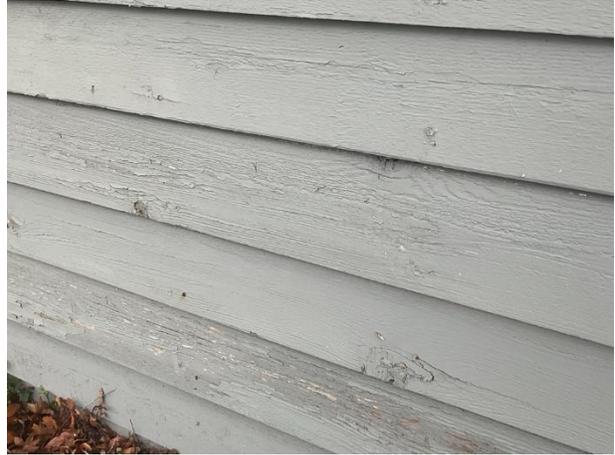
Condition: Fair to poor overall condition with areas of deteriorated wood siding

Finish and wood deterioration

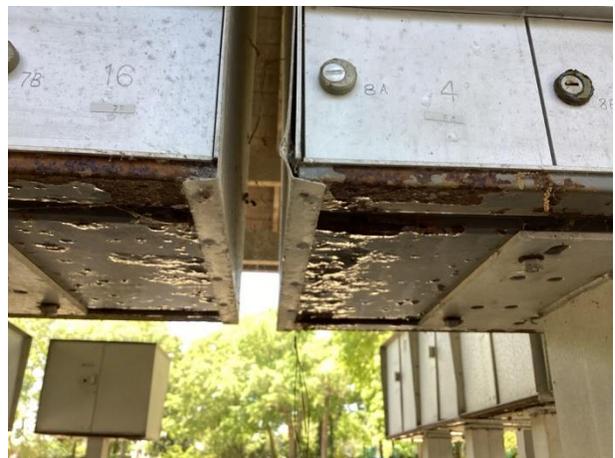
Condition: The roof and paint finishes are in good overall condition. The mailbox stations are in fair to poor condition. We note rust formation and deterioration at the undersides of the mailbox stations.

Mailbox station rust

Useful Life: Up to 15- to 20-years for the renovation of the mail stations and up to 25 years for replacement of the mailbox stations

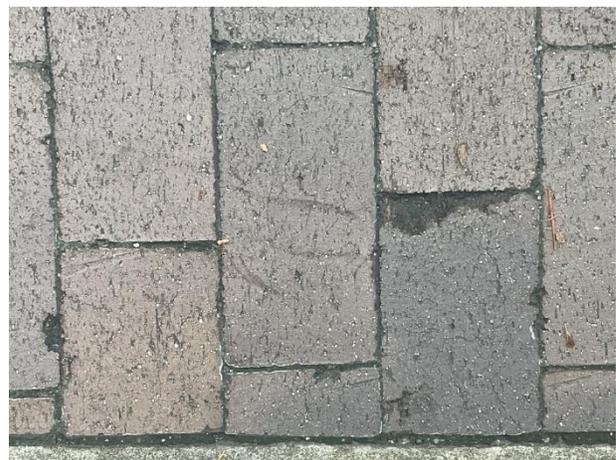
Condition: Good to fair overall with isolated paver spalls evident

Paver spalls at entrance

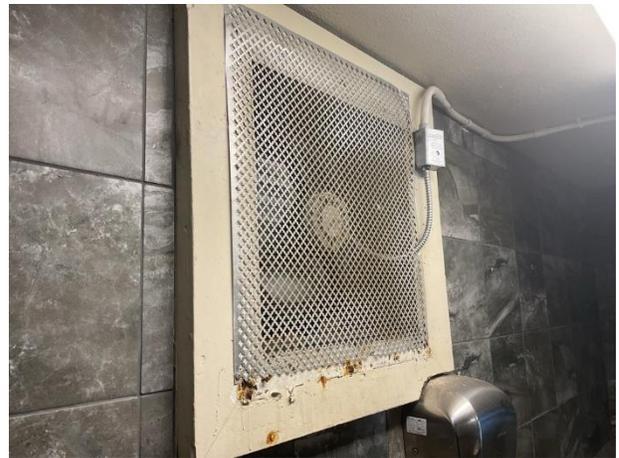
Rust at exhaust fan

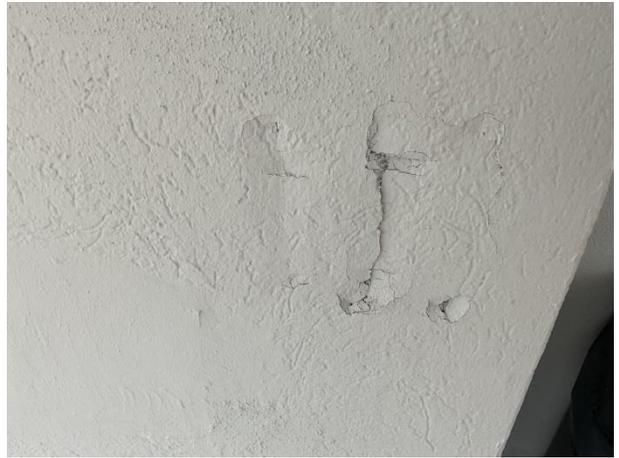
EIFS at pool house damage

Useful Life: EIFS (Exterior Insulation Finish System) wall systems have indefinitely long useful lives with timely repairs and finish applications. We recommend repairs and finish applications every six- to eight-years.
