# **RESERVE STUDY**

## **Kingston Plantation Master Association, Inc.**

**Myrtle Beach, South Carolina  
February 28, 2020**

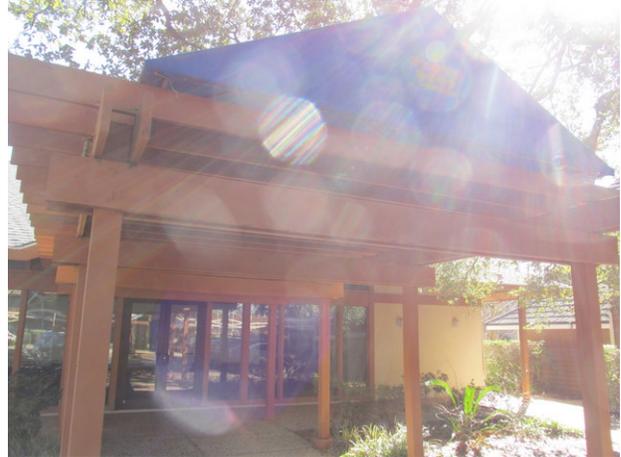
Canvas awning and wood pergola at front entrance

**Useful Life:** We include replacement of the canvas awning every 5- to 10-years and complete replacement of the frame and light fixtures every 30 years.

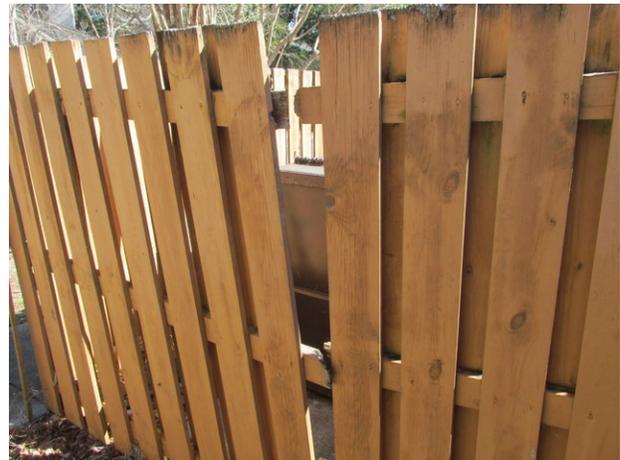
**Detached section of wood fence at trash enclosure**

**Damaged section of wood fence at trash enclosure**

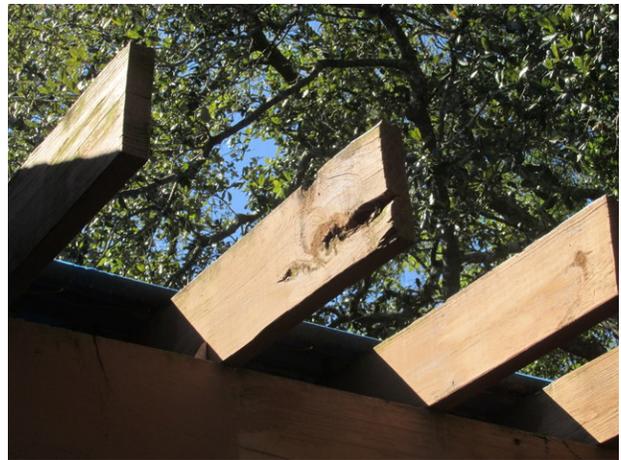
**Displaced wood member at pergola**

**Deteriorated wood member at pergola**

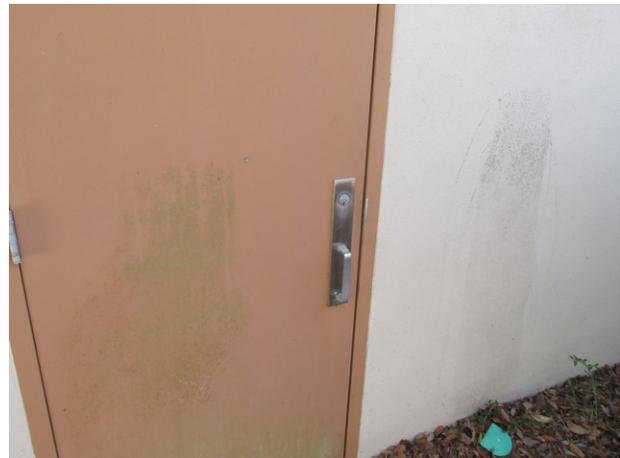
**Paint finishes at exterior wall and trim**

**Isolated stains at exterior door and wall**

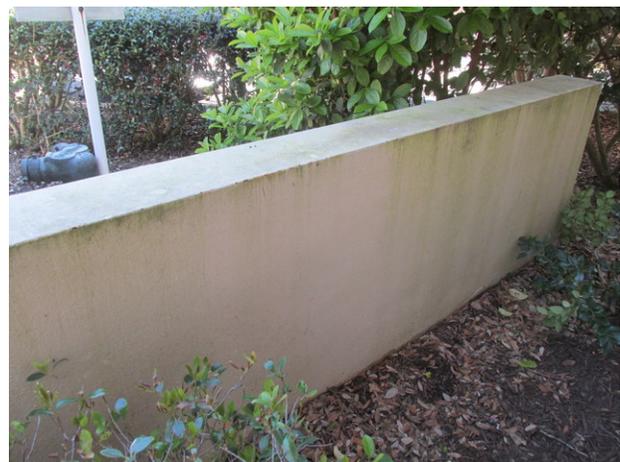
**Cracks at adjacent wall**

**Stained paint finishes at adjacent wall**

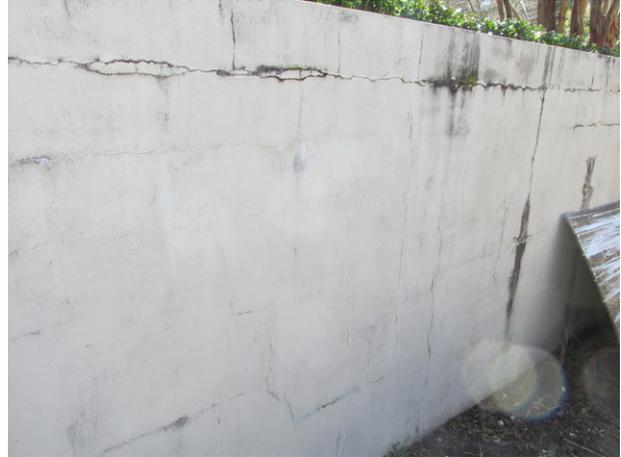
**Cracks and stained paint finishes at adjacent wall**

**Cracks and poor finishes at adjacent wall**

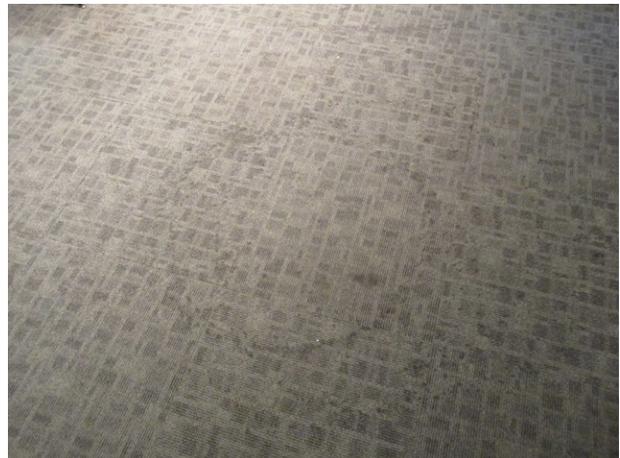
**Stained carpet floor coverings**

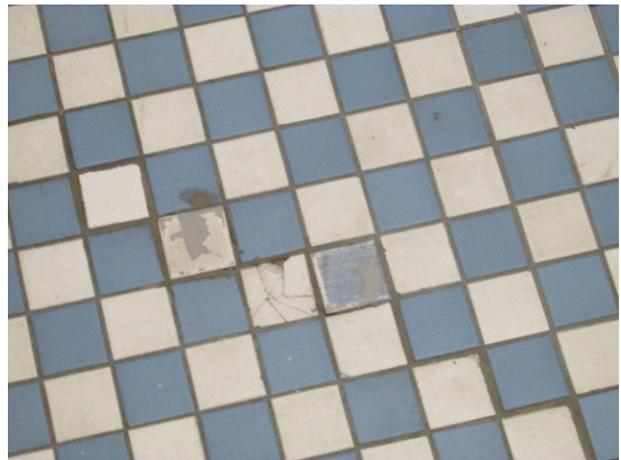
**Tile floor coverings at rest rooms**

**Damaged tile floor coverings at rest rooms**

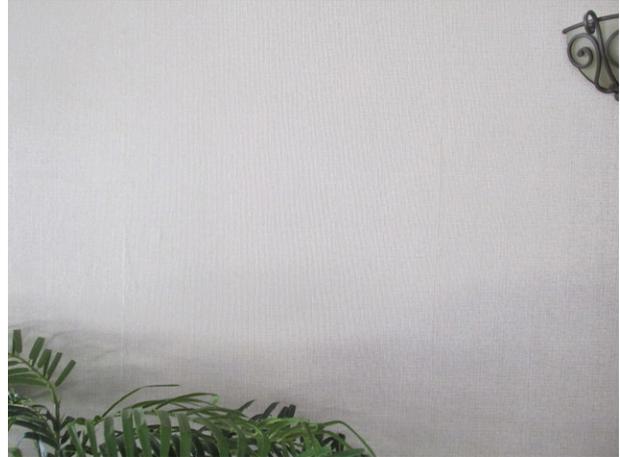
**Stains and ripple at wall coverings**

**Ripples at wall coverings**

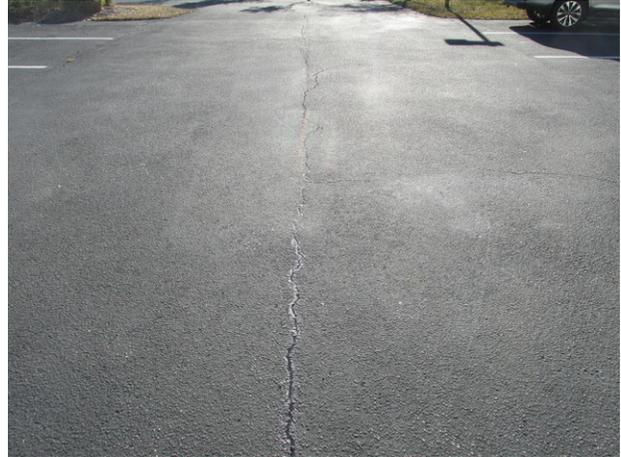
**Typical condition of asphalt pavement**

**Crack at centerline of asphalt pavement**

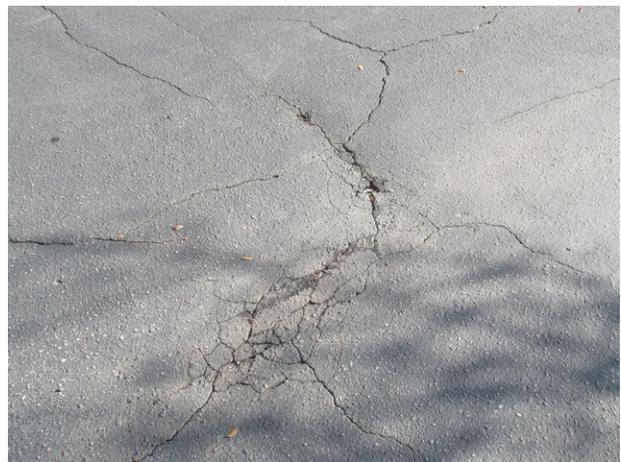
**Example of transverse crack at asphalt pavement**

**Isolated example of pavement deterioration at asphalt pavement**

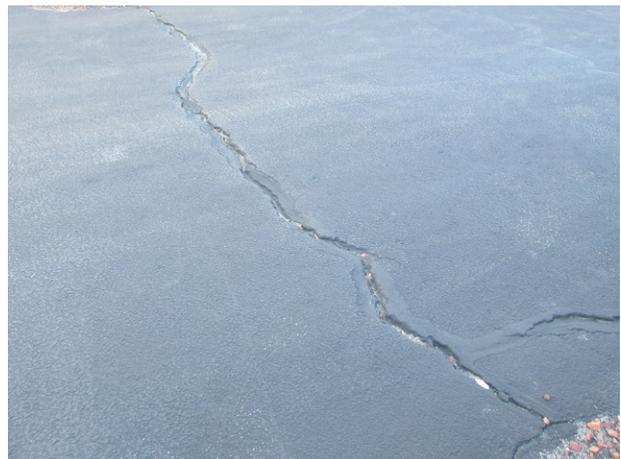
**Example of transverse cracks at asphalt pavement**

**Example of transverse crack at asphalt pavement**

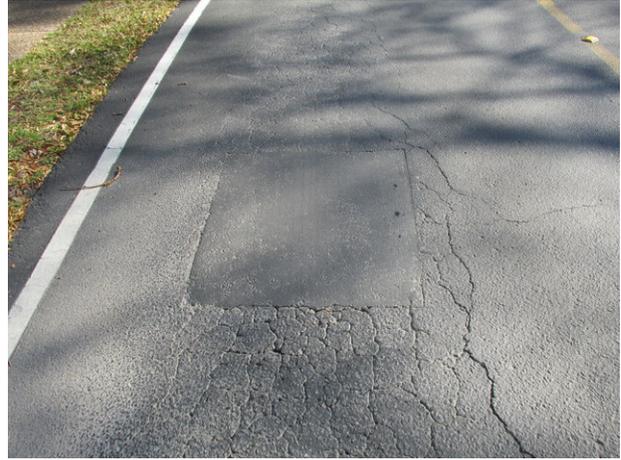
**Isolated example of alligator cracks and pavement deterioration at speedbump**

**Previous patch and alligator cracks at asphalt pavement**

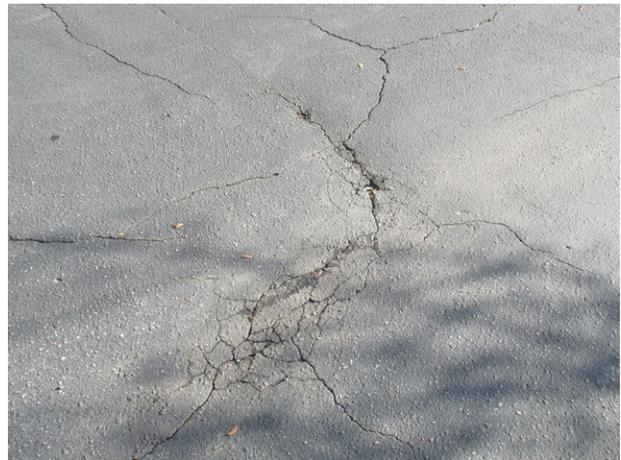
**Example of transverse crack at asphalt pavement**

**Isolated example of pavement deterioration at asphalt pavement**

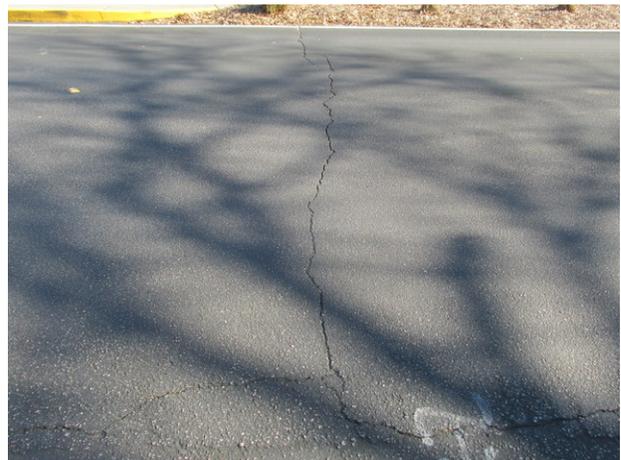
**Edge cracking at asphalt pavement**

**Example of transverse crack at asphalt pavement**

The manner of repaving is either a mill and overlay or total replacement. A mill and overlay is a method of repaving where cracked, worn and failed pavement is mechanically removed or milled until sound pavement is found. A new layer of asphalt is overlaid atop the remaining base course of pavement. Total replacement includes the removal of all existing asphalt down to the base course of aggregate and native soil followed by the application of two or more new lifts of asphalt. We recommend mill and overlayment on asphalt pavement that exhibits normal deterioration and wear. We recommend total replacement of asphalt pavement that exhibits severe deterioration, inadequate drainage, pavement that has been overlaid multiple times in the past or where the configuration makes overlayment not possible. We recommend the mill and overlay method for initial repaving followed by the total replacement method for subsequent repaving at Kingston Plantation.

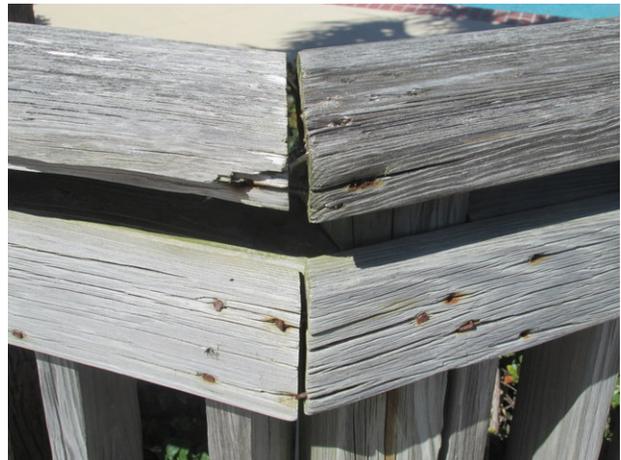
**Warped, cracked and detached wood members at railing at main boardwalk**

**Deteriorated and separated wood members at railings at main boardwalk**

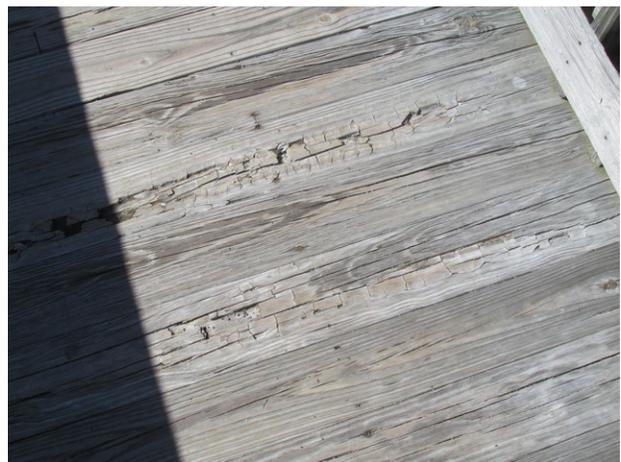
**Deteriorated wood decking at main boardwalk**

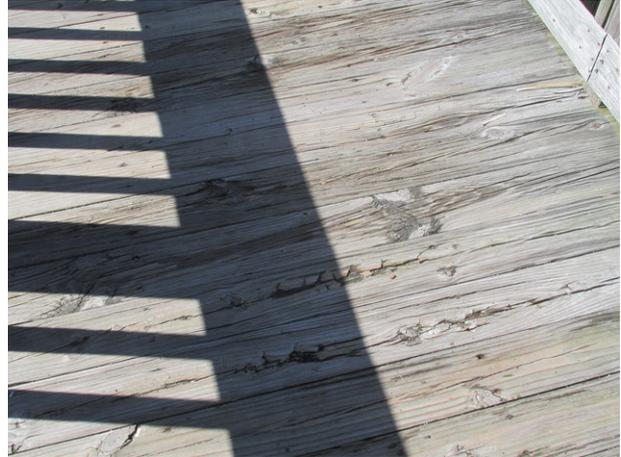
**Deteriorated wood decking at main boardwalk**

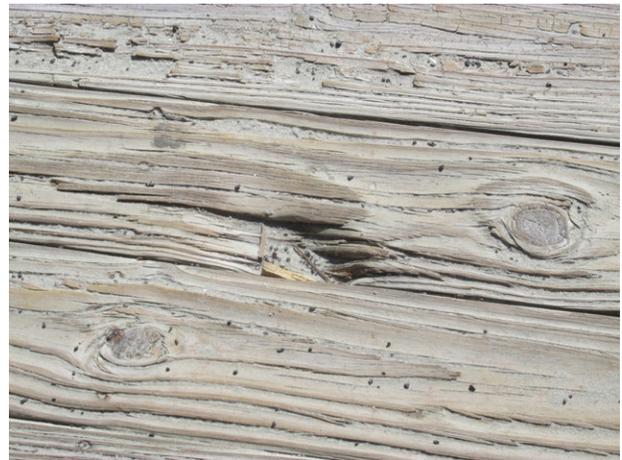
**Example of deteriorated wood decking at Brighton beach access**

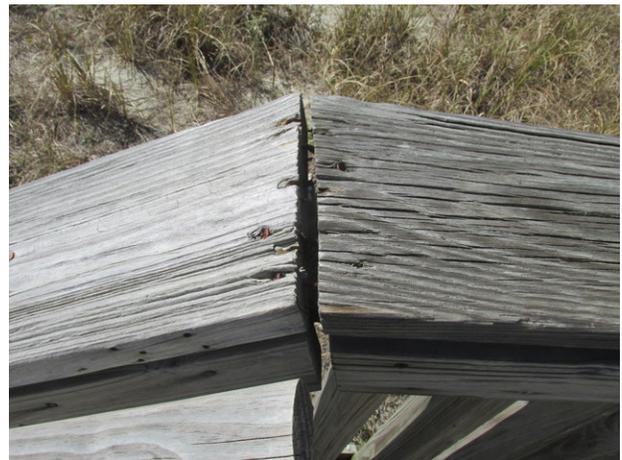
**Example of deteriorated wood railing at Brighton beach access**

**Separated wood members and toe-nailed connection at railing at Brighton beach access**

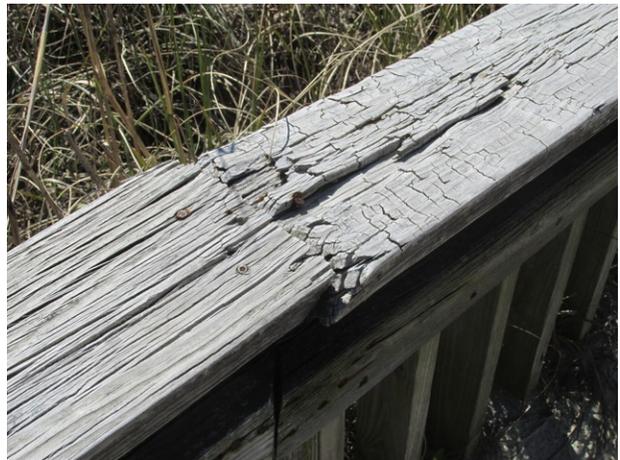
**Damaged and missing wood members at railing at Embassy Suites South beach access**

**Deteriorated wood members at railing at Embassy Suites South beach access**

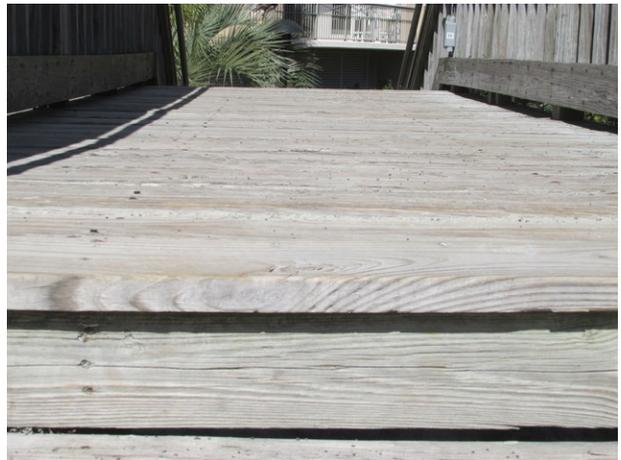
**Deteriorated decking at Margate beach access**

**Warped decking at Margate beach access**

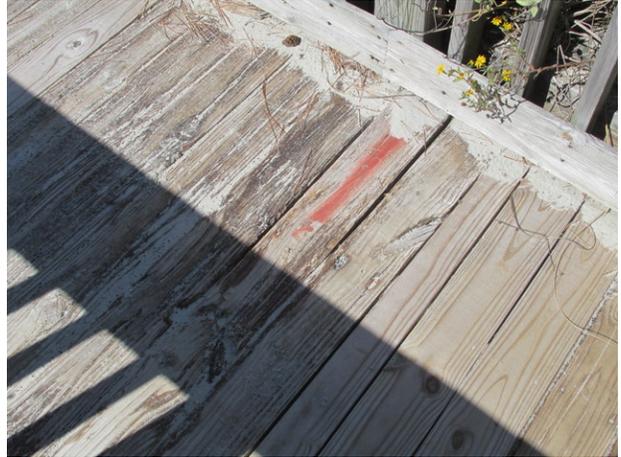
**Original wood decking at North Hampton beach access**

**Deteriorated original wood decking at North Hampton beach access**

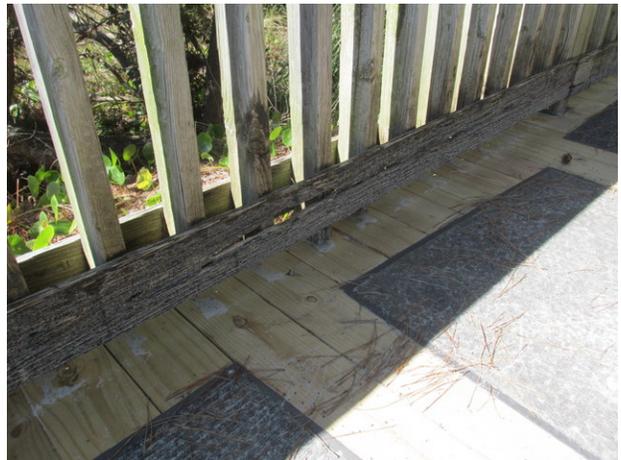
**Wood railing at North Hampton beach access**

**Deteriorated wood railing at North Hampton beach access**

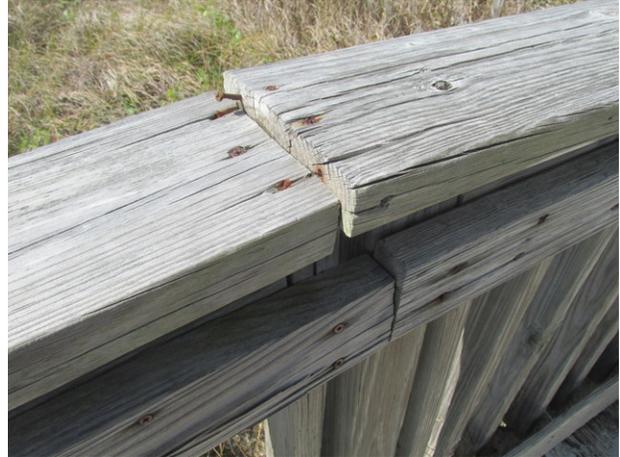
**Detached wood railing at South Hampton beach access**

**Useful Life:** We include replacement of the decking, railings and light fixtures every 15- to 20-years with complete replacement of the beach accesses every 35 years.

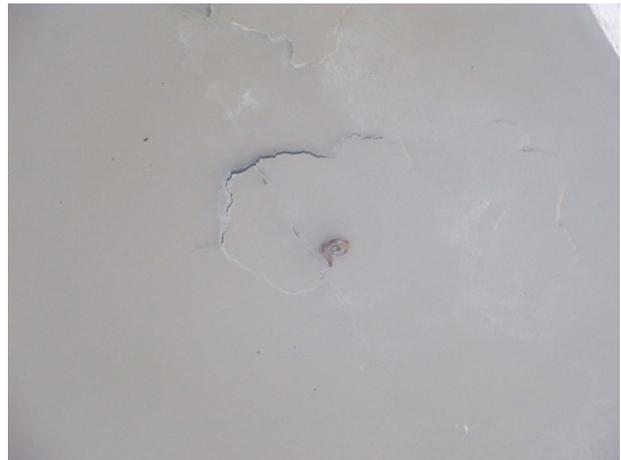
Rust formation and cracked concrete at underside of bridge

**Useful Life:** We estimate a useful life of up to 30 years with the benefit of capital repairs including a close-up visual inspection, patching of delaminated concrete, and routing and filling of cracked concrete. The Association should fund these interim repairs through the operating budget.

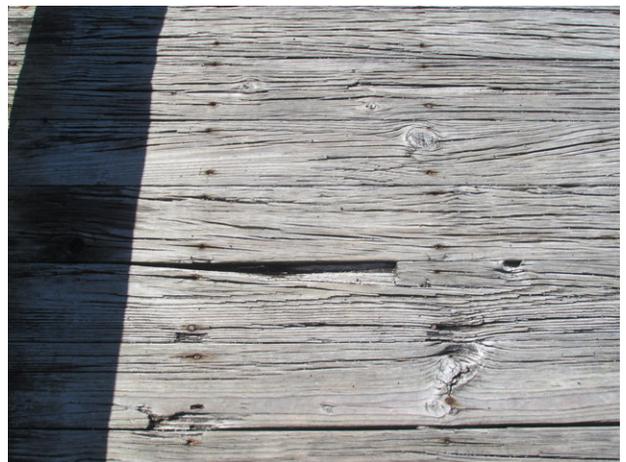
**Deteriorated wood member at sidewalk bridge**

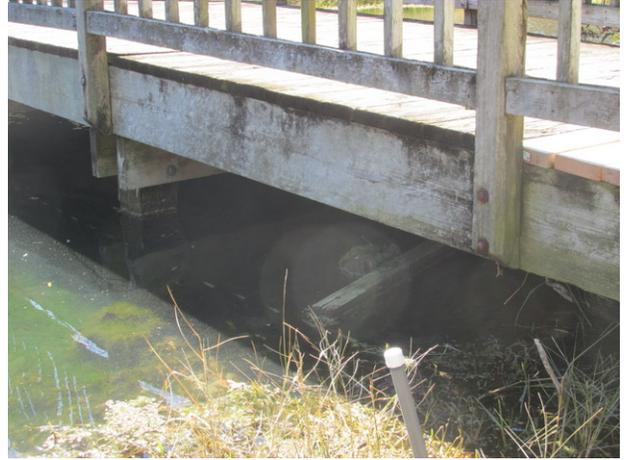
**Detached wood members at St. James bridge frame/foundation**

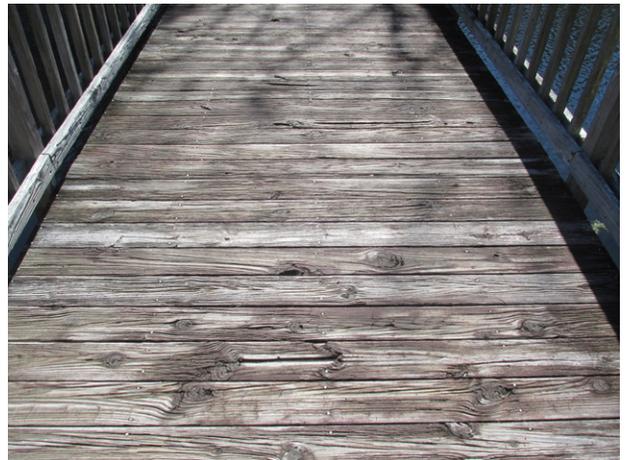
**Wood decking and railings at St. James bridge**

**Deteriorated wood decking at St. James bridge**

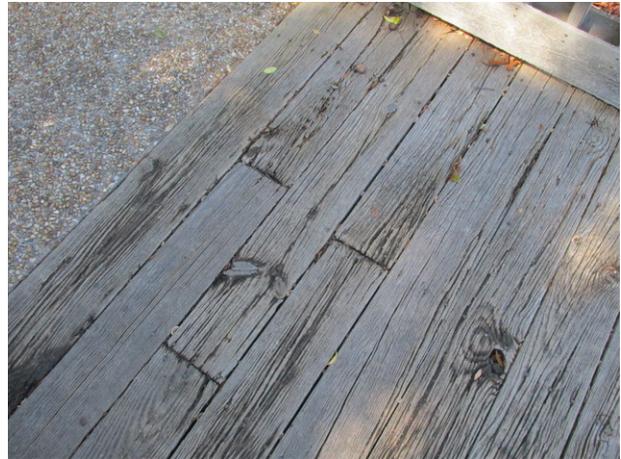
**Wood decking and railings at West Hyde Park mail station bridge**

**Deteriorated wood decking at West Hyde Park mail station bridge**

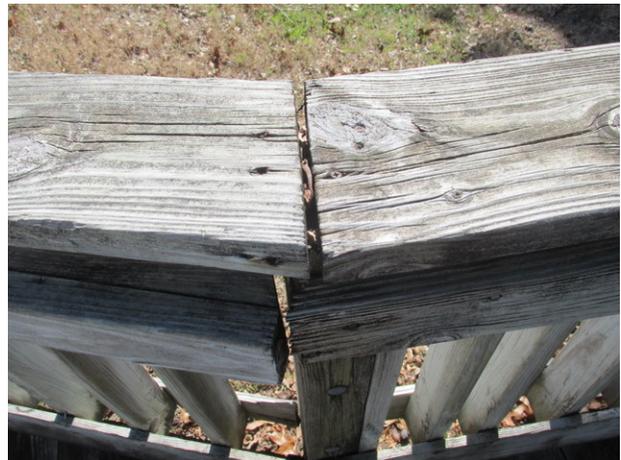
**Deteriorated wood decking at West Hyde Park mail station bridge**

**Separated wood railing at West Hyde Park mail station bridge**

**Useful Life:** We include replacement of the decking, railings and light fixtures every 15- to 20-years with complete replacement of the bridges every 35 years.

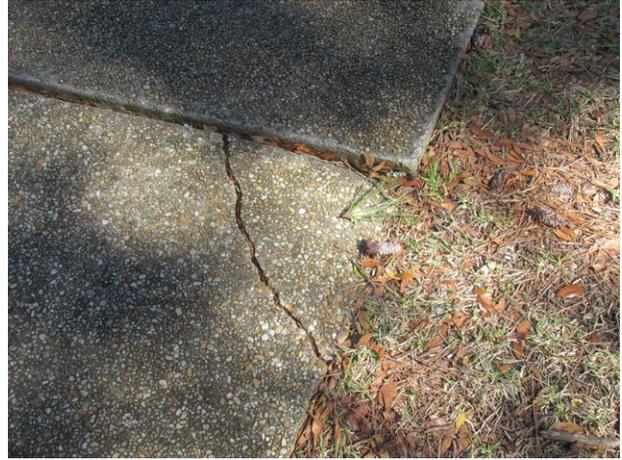
**Cracked section of sidewalk**

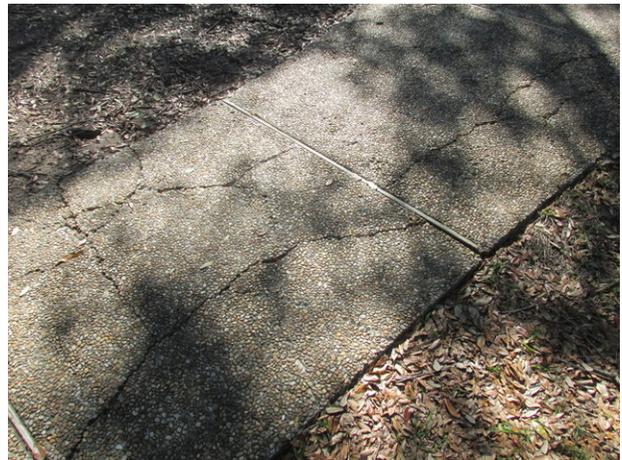
**Cracked and deteriorated section of sidewalk**

**Cracked and deteriorated sections of sidewalk**

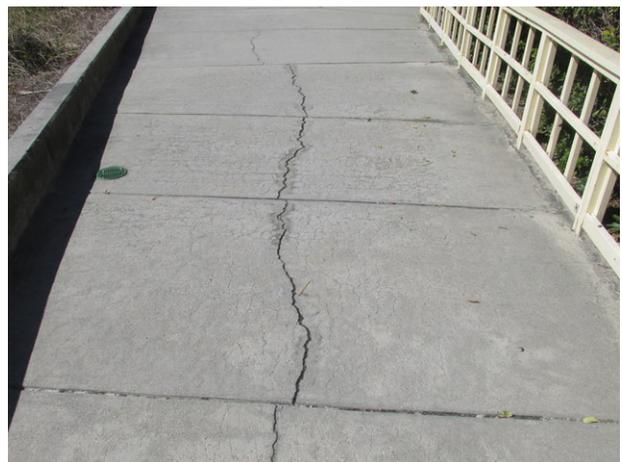
**Example of trip hazard at sidewalk**

**Cracked sections of sidewalk**

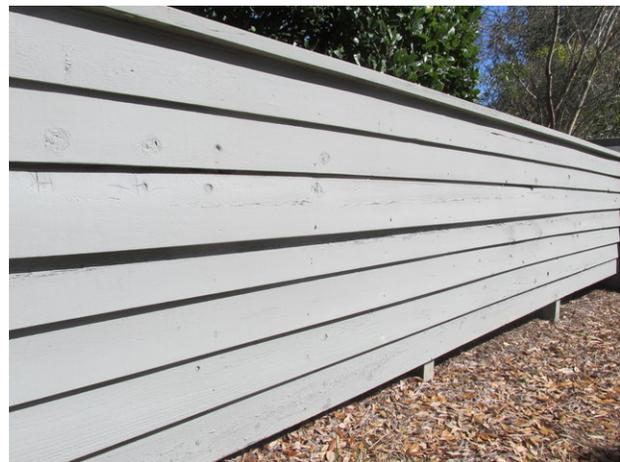
Deteriorated wood siding

Warped wood siding

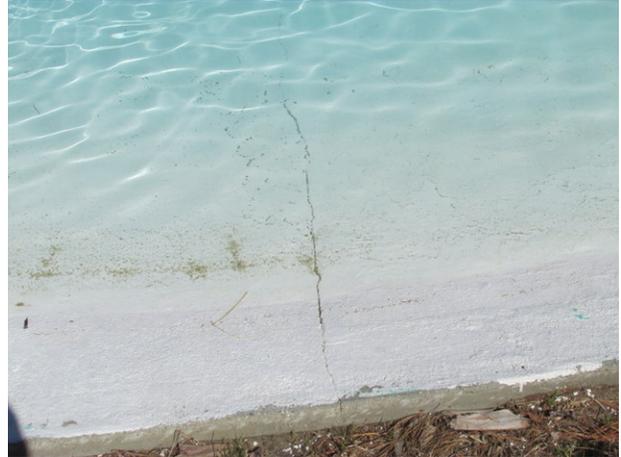
**Cracked concrete at edge of fountain**

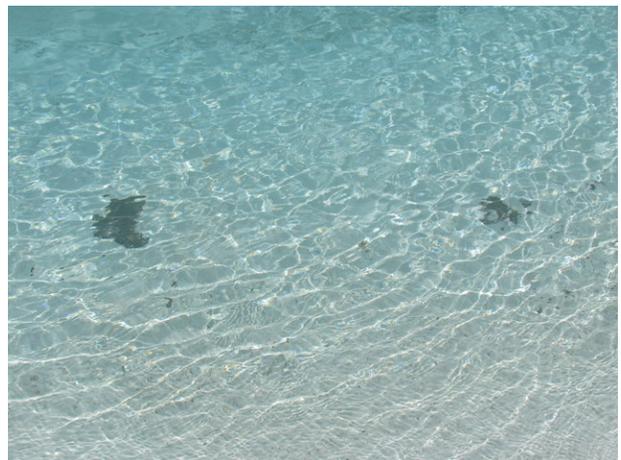
**Deteriorated finish at fountain**

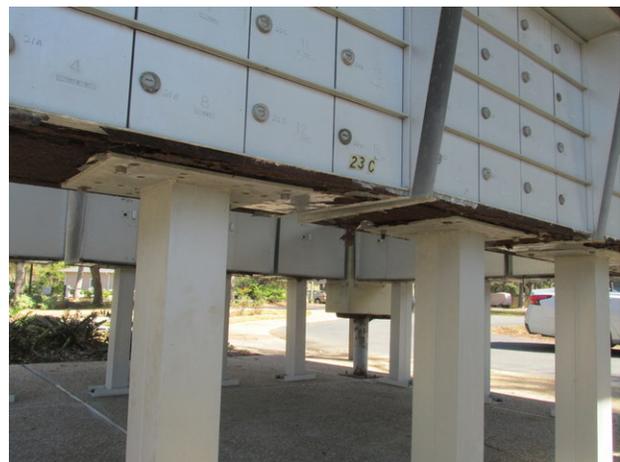
**Mailbox stations at Richmond Park**

**Rust formation and deterioration at mailbox stations at Richmond Park**

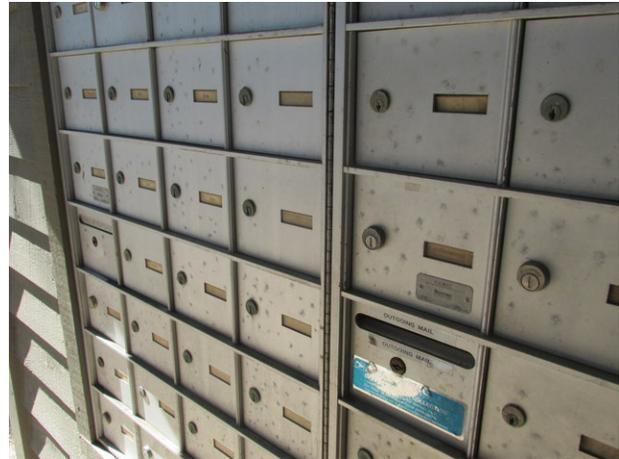
**Mailbox stations at West Hyde Park**

**Deterioration of finish at mailbox stations at West Hyde Park**

**Useful Life:** Up to 25 years for both renovation of the mail stations and replacement of the mailbox stations

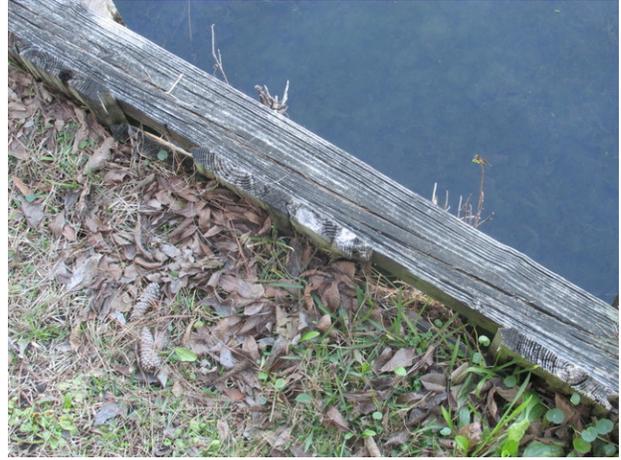
**Leaning section of timber bulkhead at Lake Arrowhead**

**Wood deterioration at bulkhead at Lake Arrowhead**

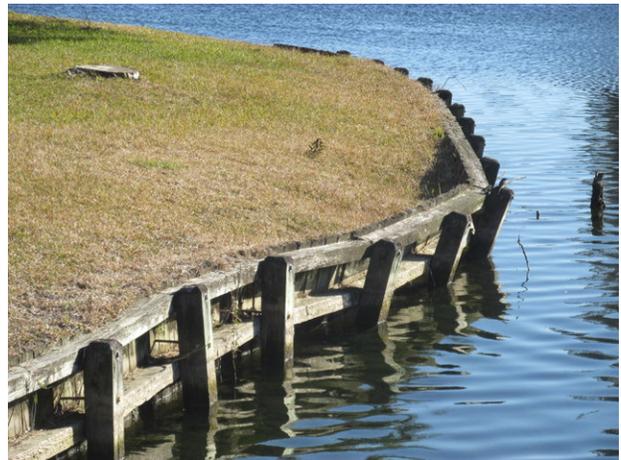
**Wood deterioration at bulkhead at Lake Arrowhead**

**Leaning section of timber bulkhead at Lake Arrowhead**

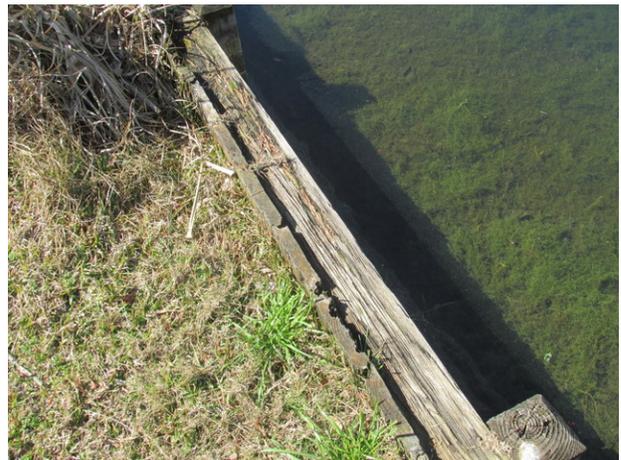
**Leaning section of timber bulkhead at Lake Arrowhead**

**Wood deterioration at bulkhead at Lake Arrowhead**

**Useful Life:** Up to 25 years

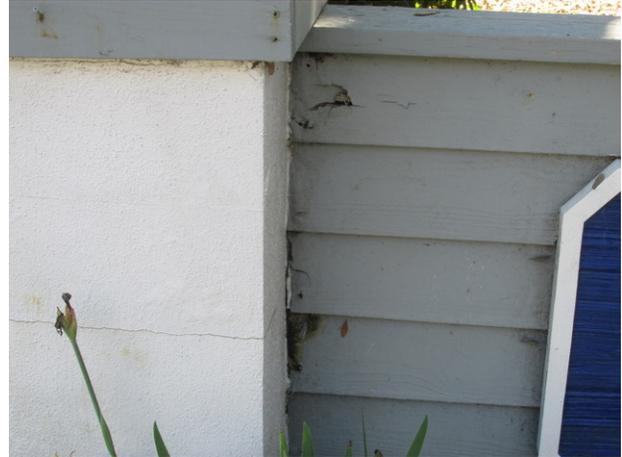
**Monument signage at Windermere by the Sea**

**Deteriorated wood siding at monument at Windermere by the Sea**
