RESERVE STUDY

Kingston Plantation Master Association, Inc.

Myrtle Beach, South Carolina
April 27, 2022

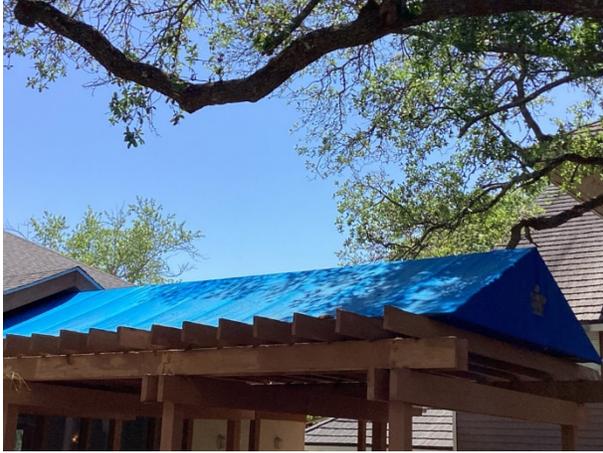
Condition: Fair overall with rust evident. The Association informs us of plans to replace the awning in the near future.

Awning

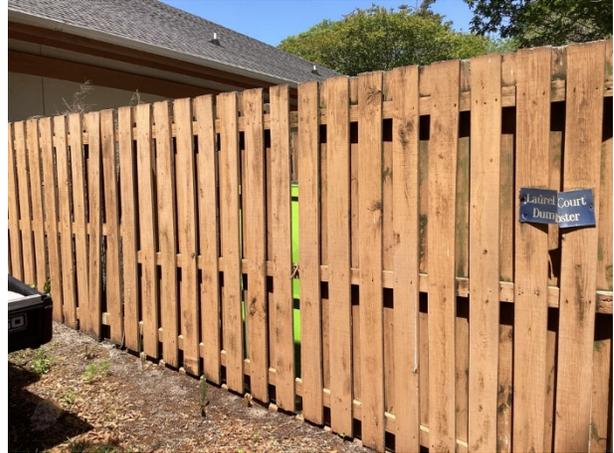
Trash enclosure fence

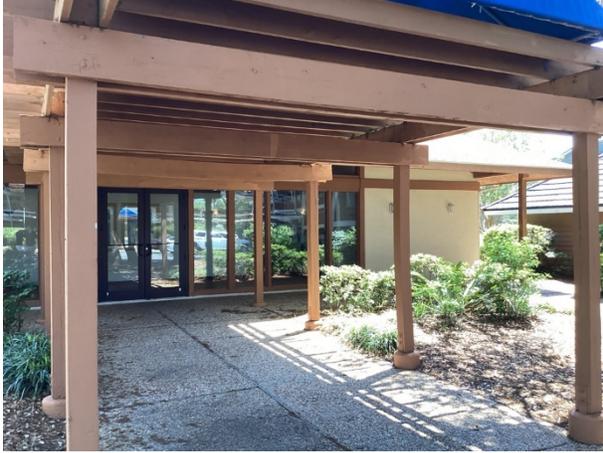
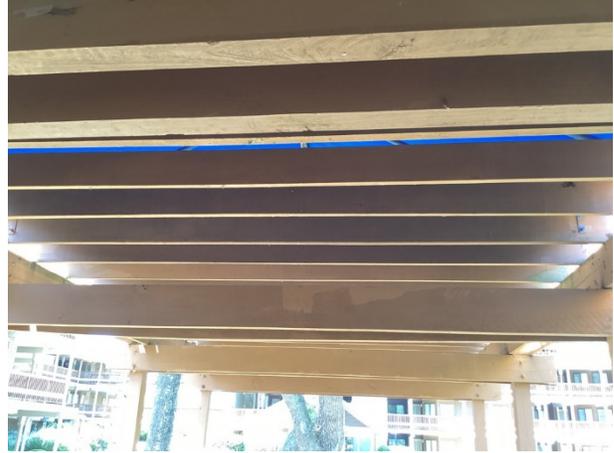
Condition: Fair overall. The Association informs us of plans to conduct minor repairs funded through the operating budget in the near future.

Pergola

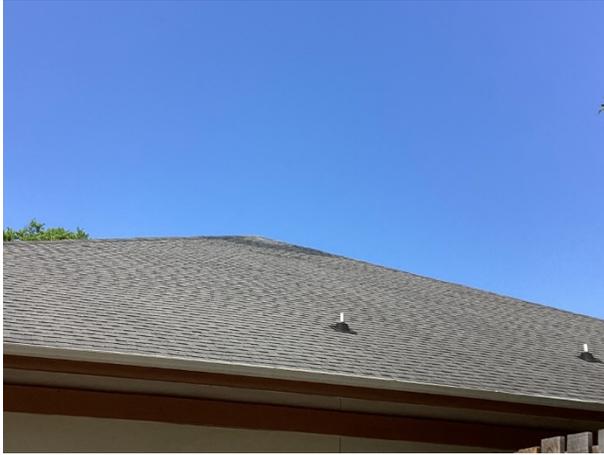
Condition: Good to fair overall with recent repairs evident from our visual inspection from the ground. Management does not report any active leaks.

Meeting House roof – repairs evident

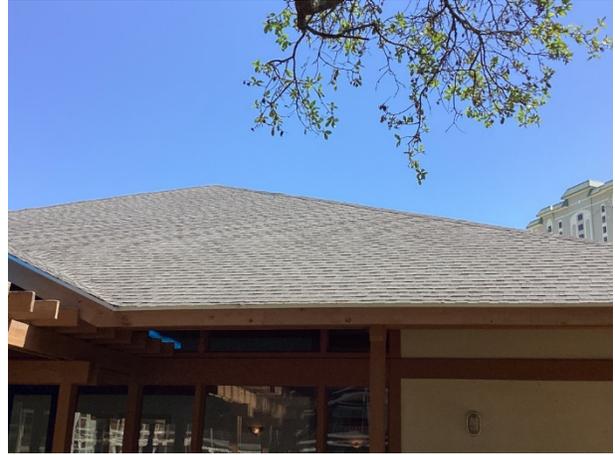
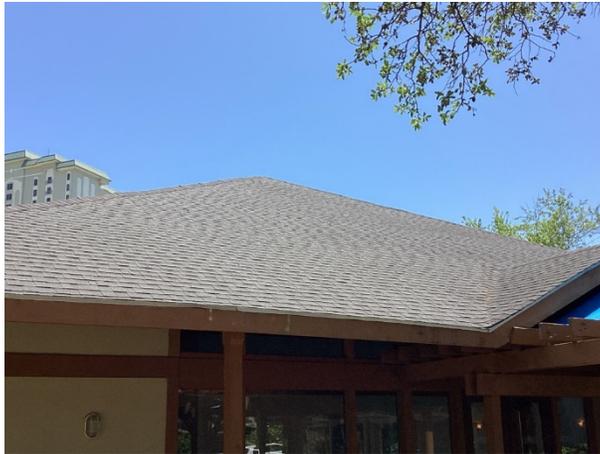
Meeting House roof

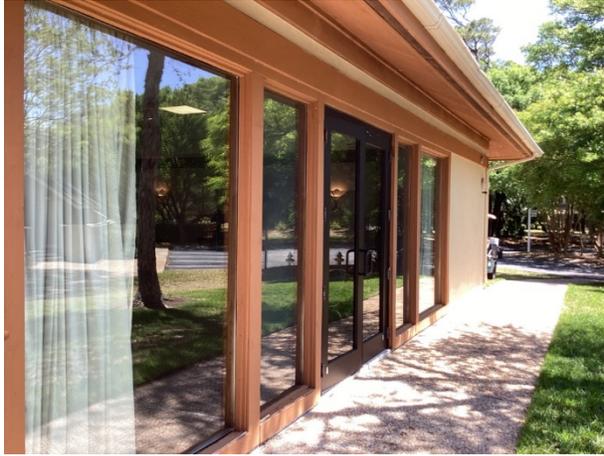
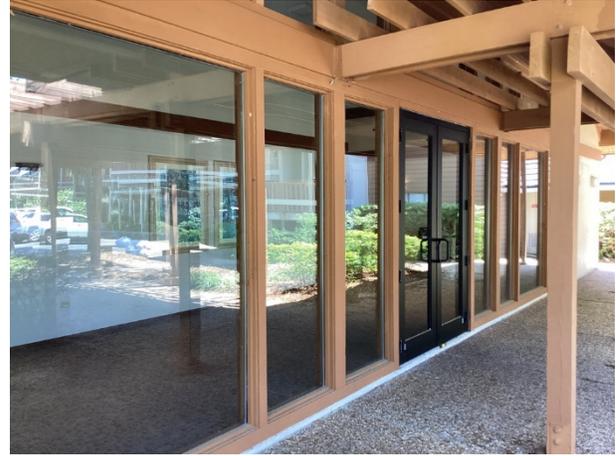
Condition: Good to fair overall with no significant deterioration evident.

Meeting House windows and doors

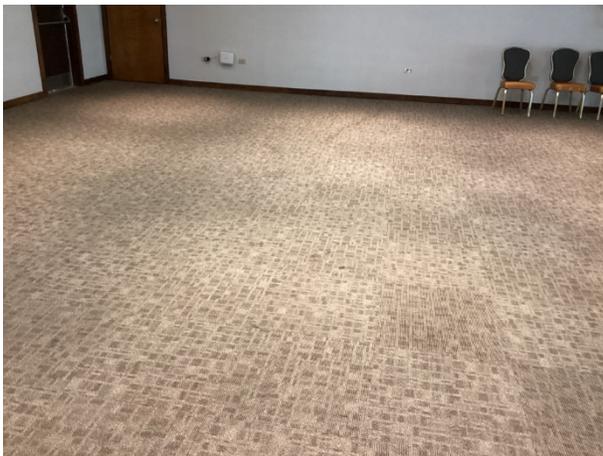
Condition: Fair overall with stains evident

Carpet floor coverings

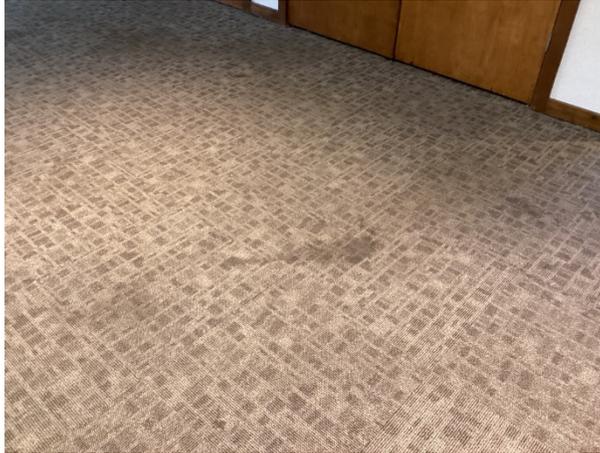
Stains evident

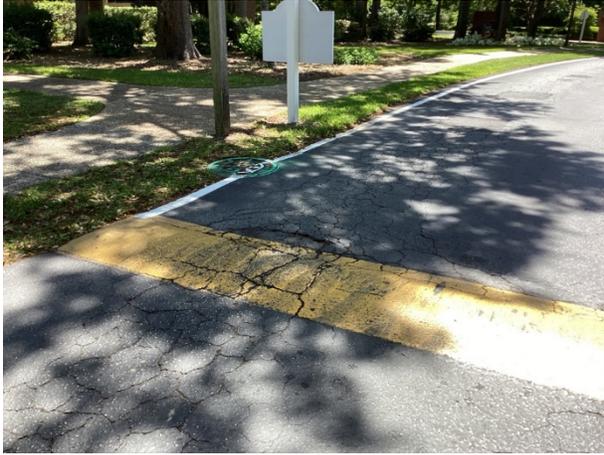
Condition: Fair overall with cracks, settlement and alligator cracks evident.

Alligator cracks and settlement at Plantation Lakes Drive

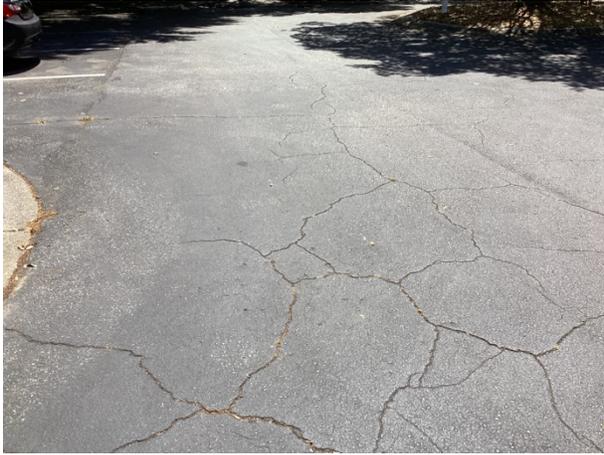
Pavement cracks at Hartland Drive

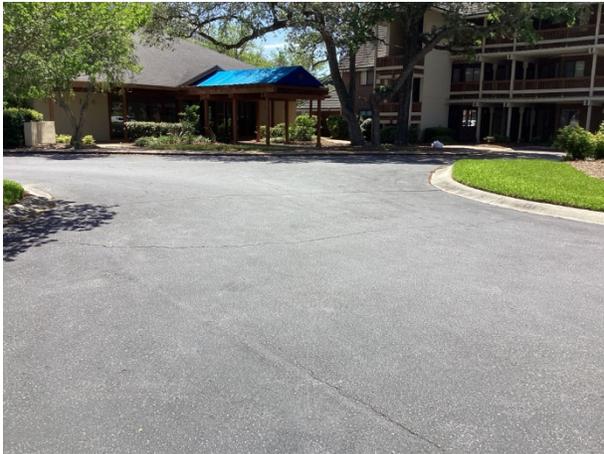
Pavement cracks at Laurel Court

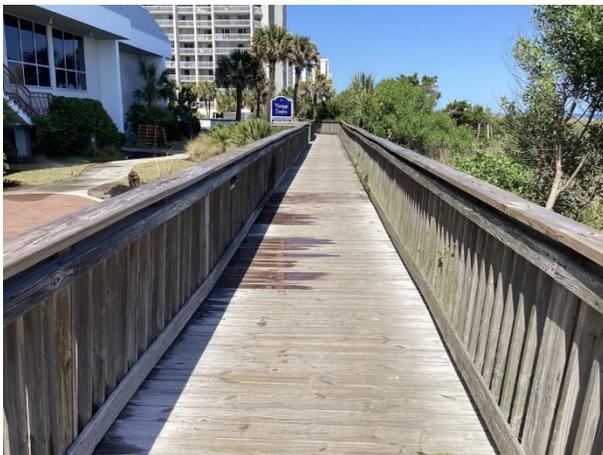
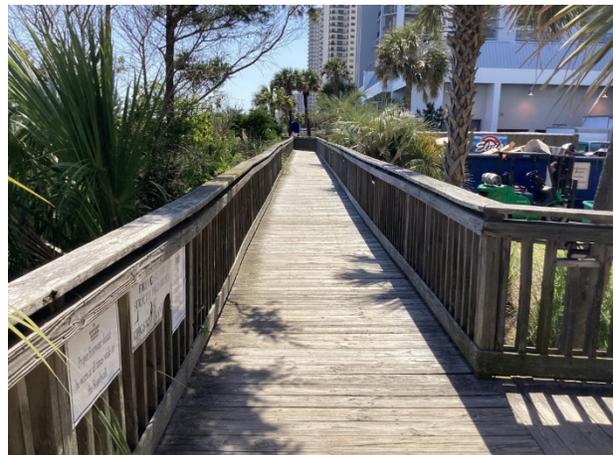
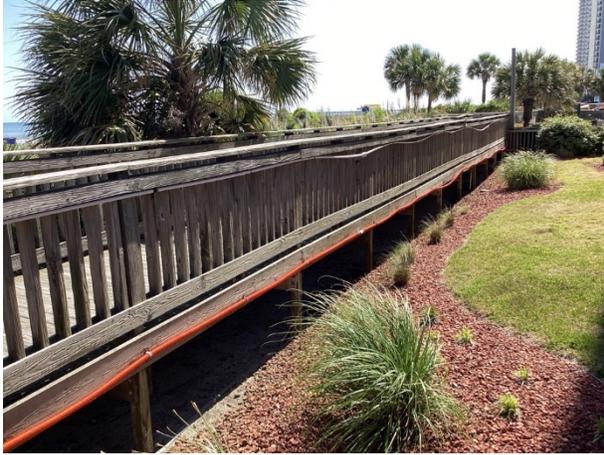
Condition: Fair overall condition. We note warped and split wood members, deteriorated and weathered wood deck boards and recent replacements. The Association informs us of plans to replace the Boardwalk in the near future.

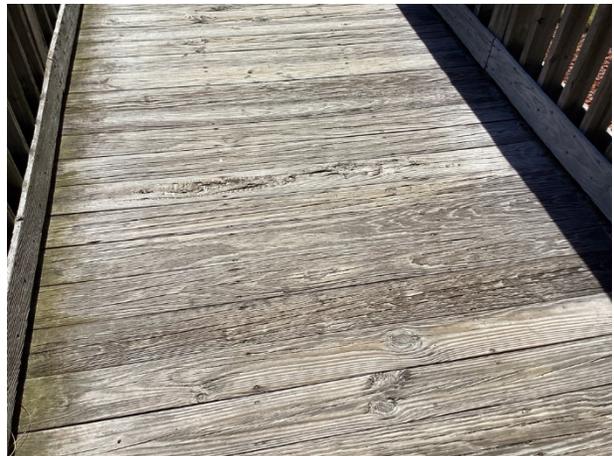
Deck weathering

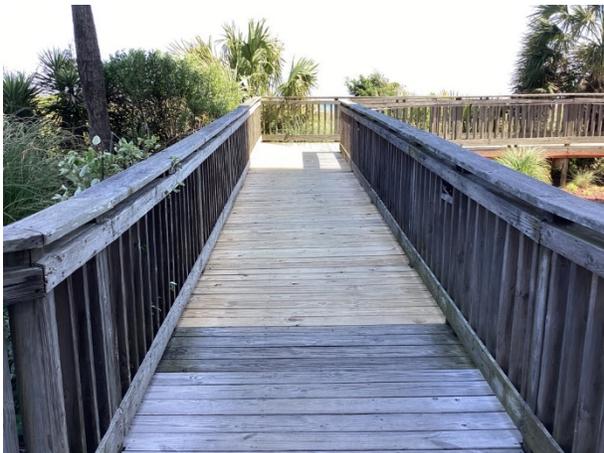
Boardwalk with wood decking recent replacements

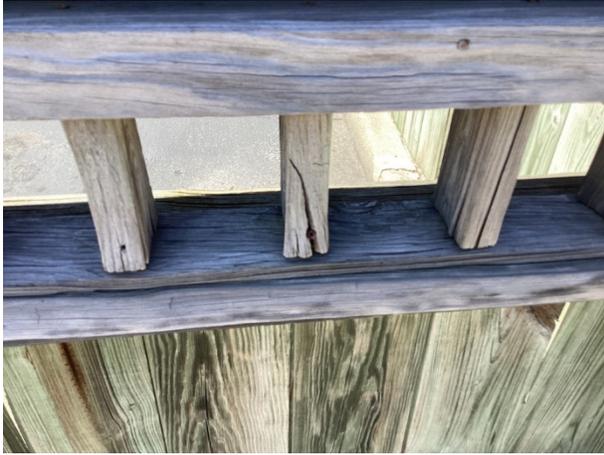
Deteriorated wood

- Annually:
 - Inspect to identify and correct any unsafe conditions
 - Secure loose fasteners and replace deteriorated fasteners
 - Replace deteriorated wood components
 - Check railing stability and fasteners
- Every three years:
 - Power wash with algaecide and application of sealer/stain if applicable

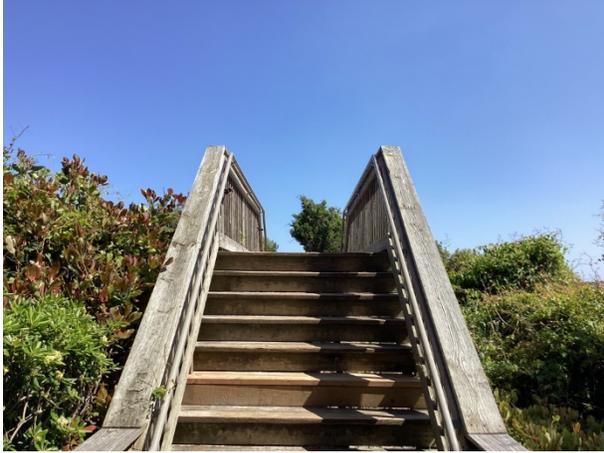
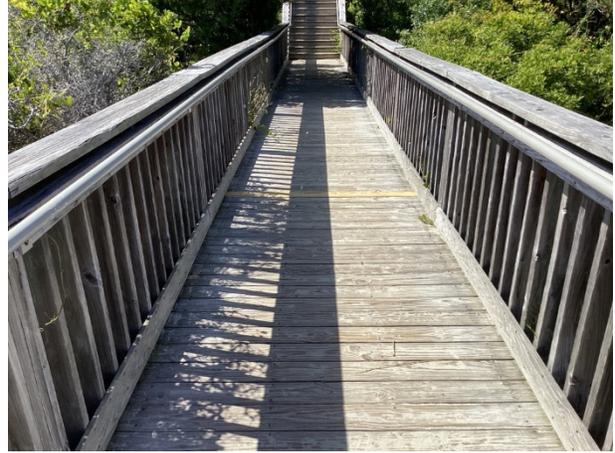
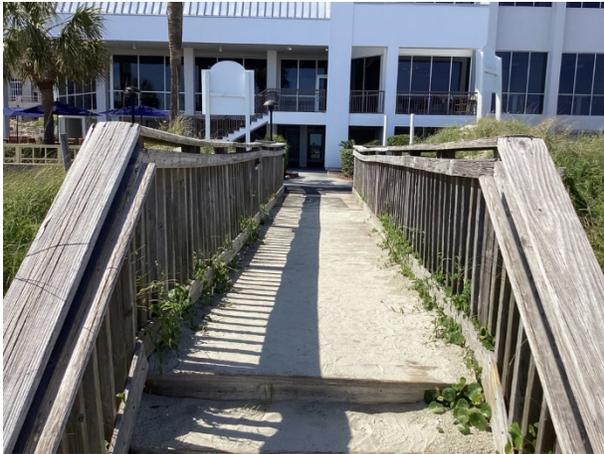
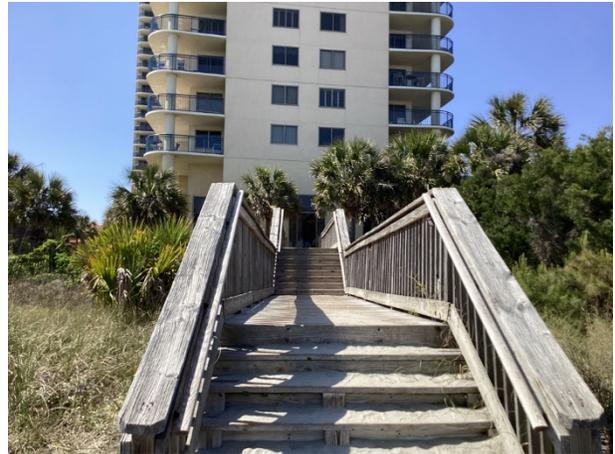
Condition: Fair overall condition. We note warped and split wood railings, deteriorated and weathered wood deck boards, exposed and rusted nails. The Association informs us of plans to replace the Margate Beach Access in the near future.

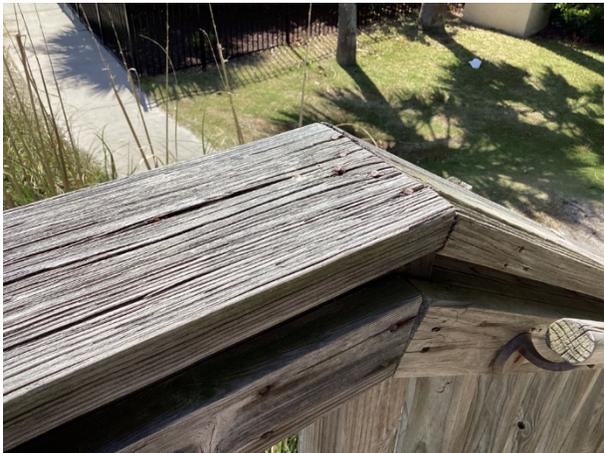
Popped and rusted nails evident

- Annually:
 - Inspect to identify and correct any unsafe conditions
 - Secure loose fasteners and replace deteriorated fasteners
 - Replace deteriorated wood components
 - Check railing stability and fasteners
- Every three years:
 - Power wash with algaecide and application of sealer/stain if applicable

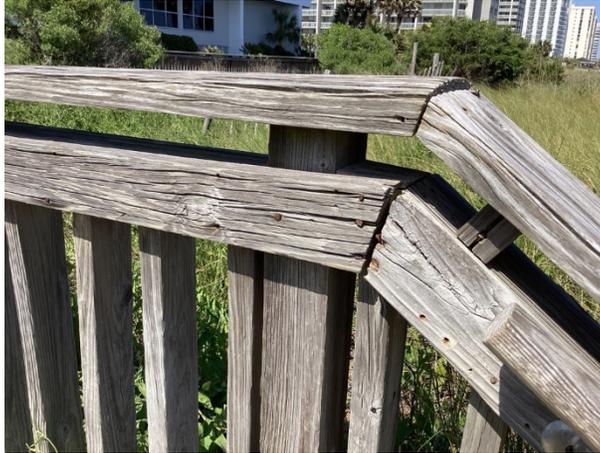
Wood deterioration at beach access railings

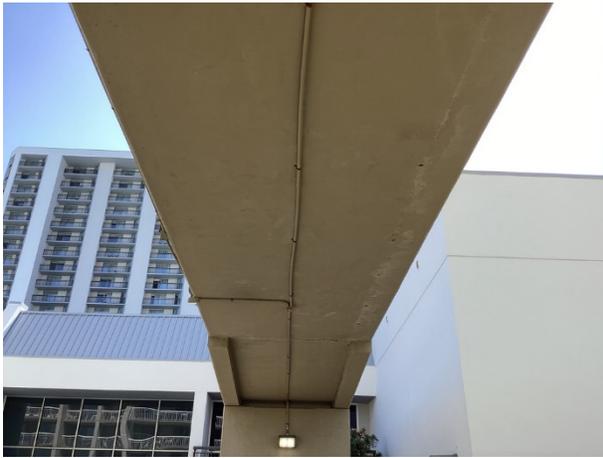
Bridge underside

Condition: Good to fair overall with deteriorated finishes, control joint sealant deterioration, rust spots and textured coating delamination evident

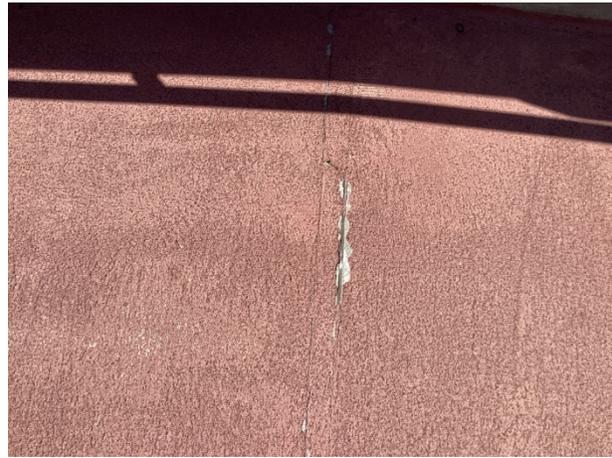
Coating delamination at bridge surface

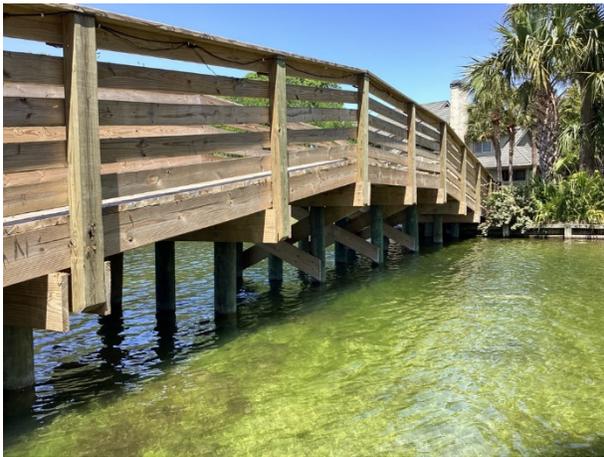
East Laurel Court bridge

Condition: Ranges from good to poor. We note warped and split wood railings, deteriorated and weathered wood deck boards, exposed and rusted nails.

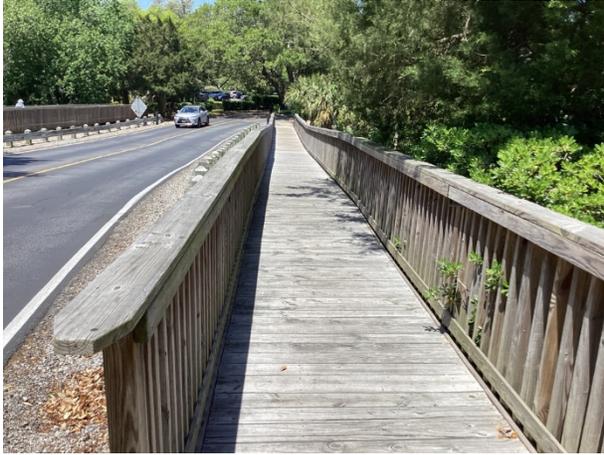
Laurel Court west bridge deck boards

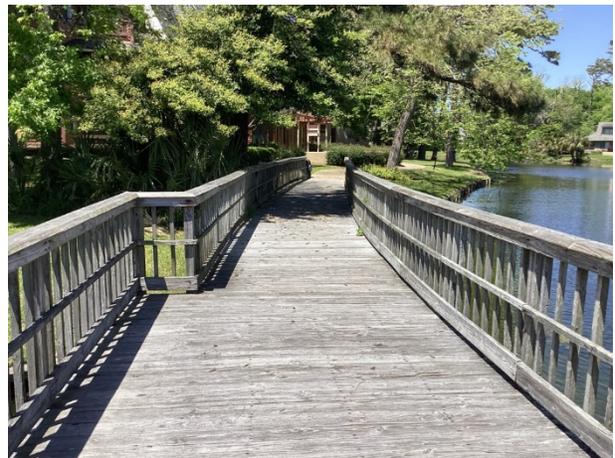
Repairs evident

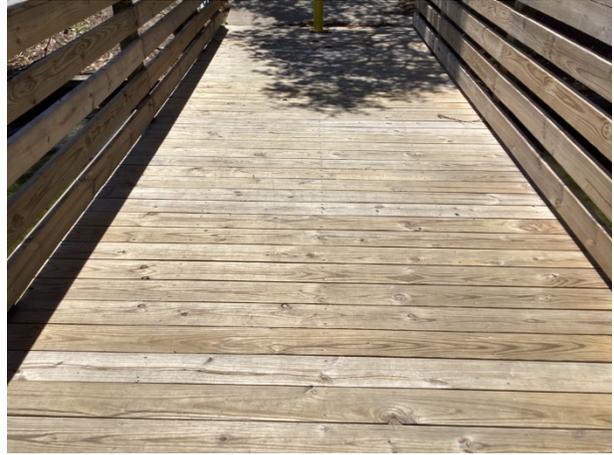
Wood deck boards

- Annually:
 - Inspect to identify and correct any unsafe conditions
 - Secure loose fasteners and replace deteriorated fasteners
 - Replace deteriorated wood components
 - Check railing stability and fasteners
- Every three years:
 - Power wash with algaecide and application of sealer/stain if applicable

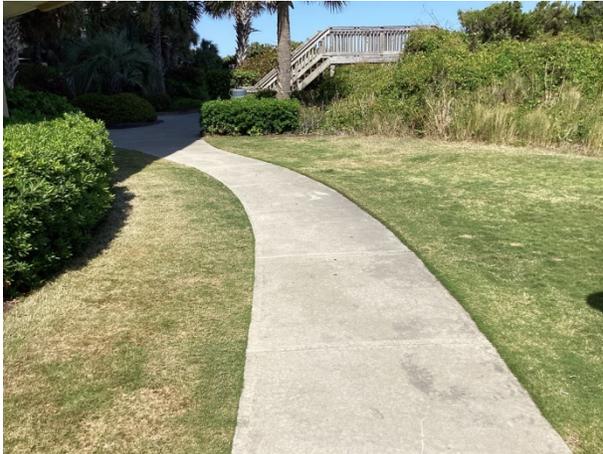
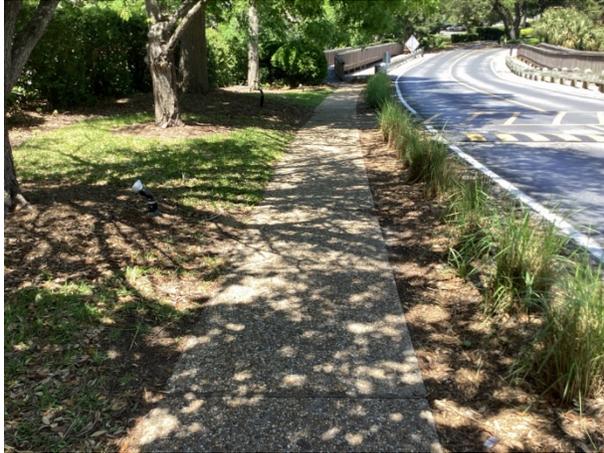
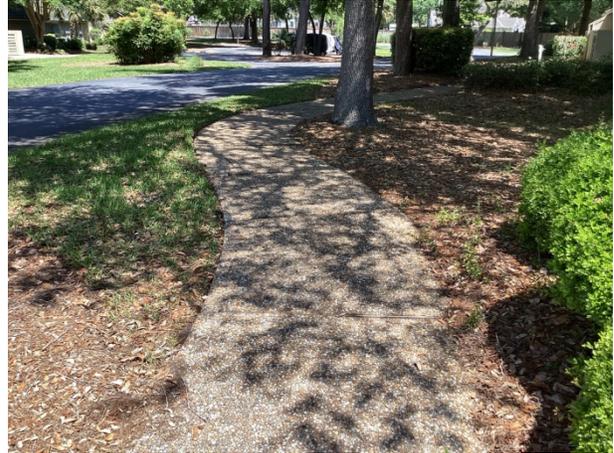
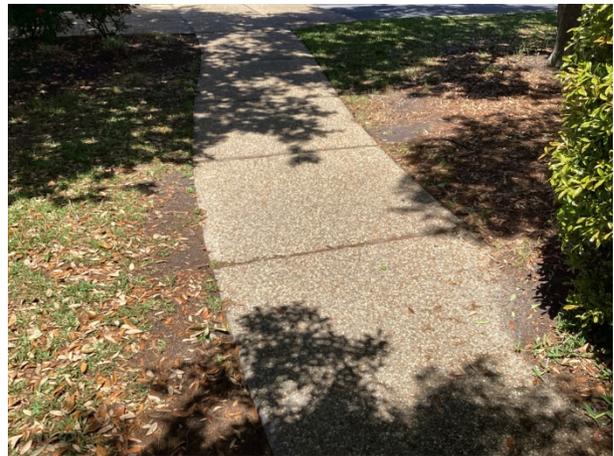
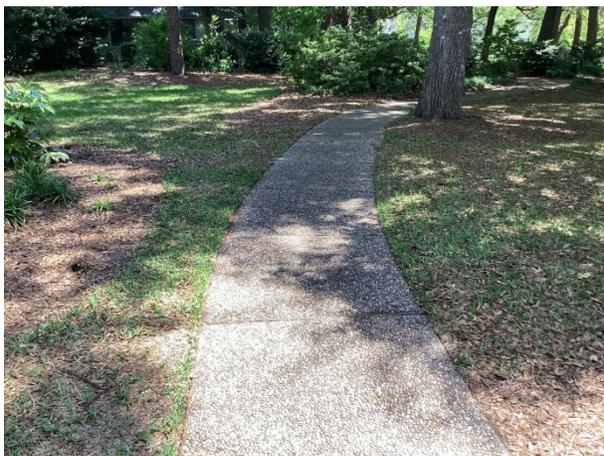
Condition: Good to fair overall with cracks, trip hazards and settlement evident.

- Annually:
 - Inspect and repair major cracks, spalls and trip hazards
 - Mark with orange safety paint prior to replacement or repair
 - Repair or perform concrete leveling in areas in immediate need of repair or possible safety hazard

Expenditure Detail Notes: Expenditure timing and costs are depicted in the **Reserve Expenditures** table in Section 3. We estimate that up to 62,775 square feet of concrete sidewalks, or fifty percent (50%) of the total, will require replacement during the next 30 years. Our cost estimate for replacement is based on information provided to us by the Association.

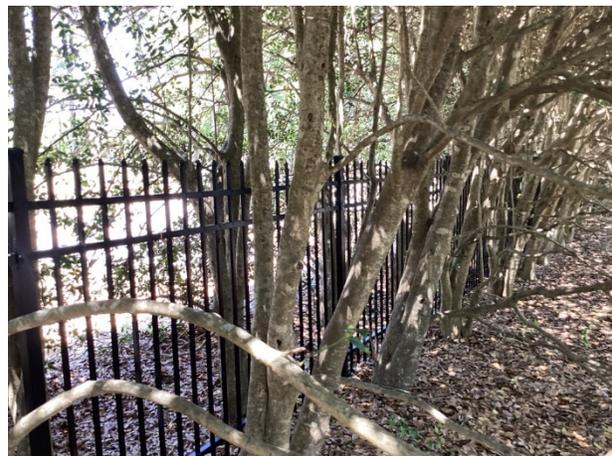
Condition: Good to fair overall with vegetation overgrowth evident at the west perimeter fence

Aluminum fence at Cumberland Terrace – note vegetation overgrowth

- Annually:
 - Inspect and repair loose fasteners or sections, and damage
 - Repair leaning sections and clear vegetation from fence areas which could cause damage

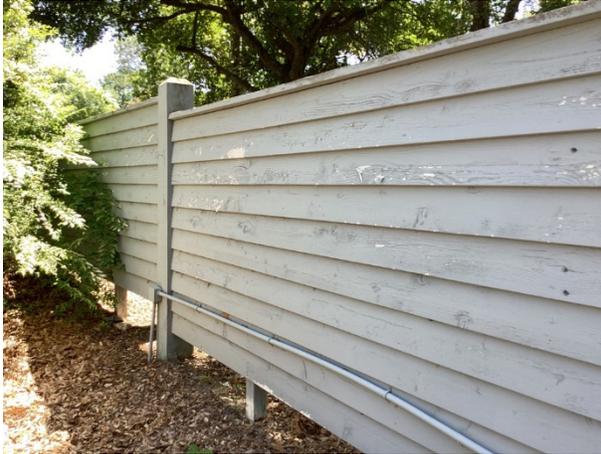
Wood fence

Condition: Fair to poor overall condition with areas of deteriorated wood siding

- Annually:
 - Inspect and repair loose sections, finish deterioration and damage
 - Repair leaning sections and clear vegetation from fence areas which could cause damage

Expenditure Detail Notes: Expenditure timing and costs are depicted in the **Reserve Expenditures** table in Section 3. The Association should anticipate periodic partial replacements due to the non-uniform nature of wood deterioration. Along with these partial replacements, the Association should apply periodic paint applications as needed and fund these activities through the operating budget.

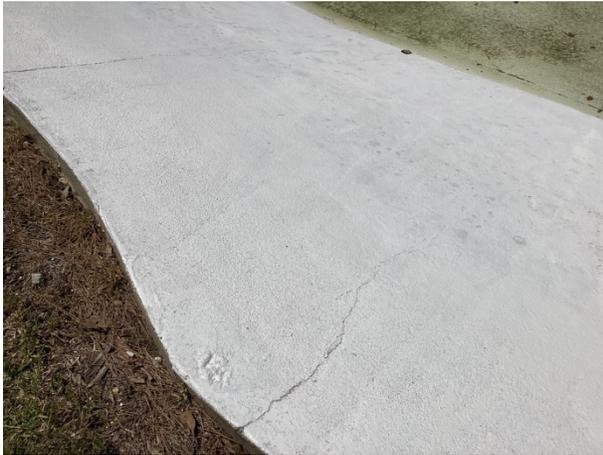
Condition: Fair to poor overall with cracks, finish deterioration and peeling evident. Representatives of the Association inform us of leaks.

Concrete cracks

Component Detail Notes: Finish replacement provides the opportunity to inspect the fountain structure and to allow for partial repairs of the underlying concrete surfaces as needed. To maintain the integrity of the fountain structure, we recommend the Association budget for the following:

- Removal and replacement of the finish
- Replacement of fountains as needed
- Concrete structure repairs as needed

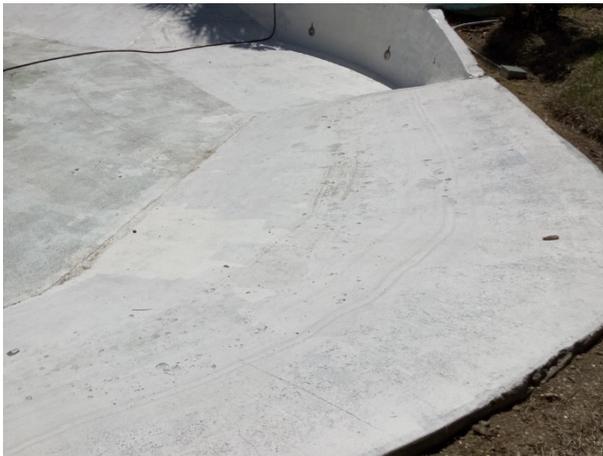
Cracks and peeling finishes evident

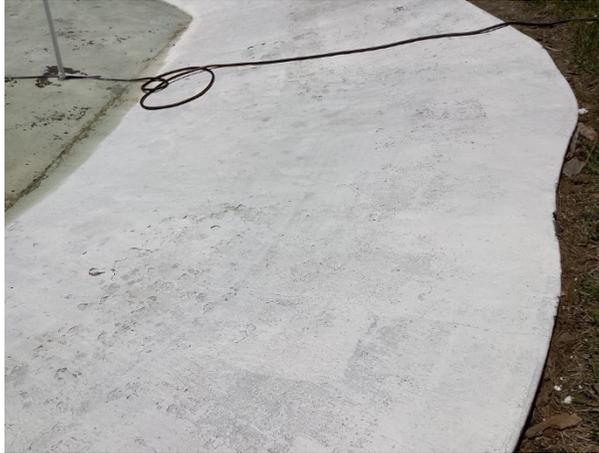
Paint peeling and chipping Evident

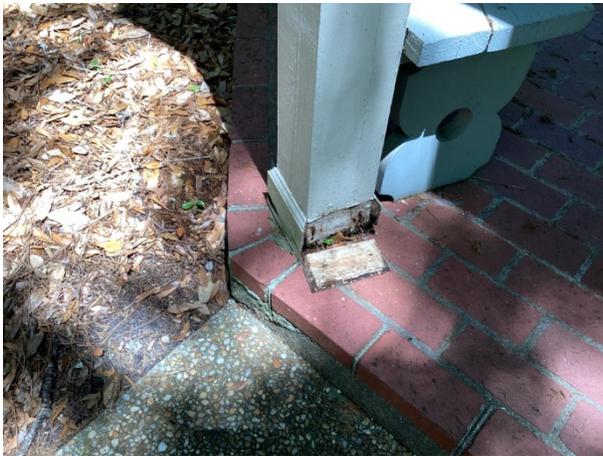
Condition: Good to fair overall with wood deterioration evident

Wood deterioration

Expenditure Detail Notes: Expenditure timing and costs are depicted in the **Reserve Expenditures** table in Section 3. Our cost is based on information provided by the Association. We recommend the Association budget for paint applications and repairs through the operating budget.

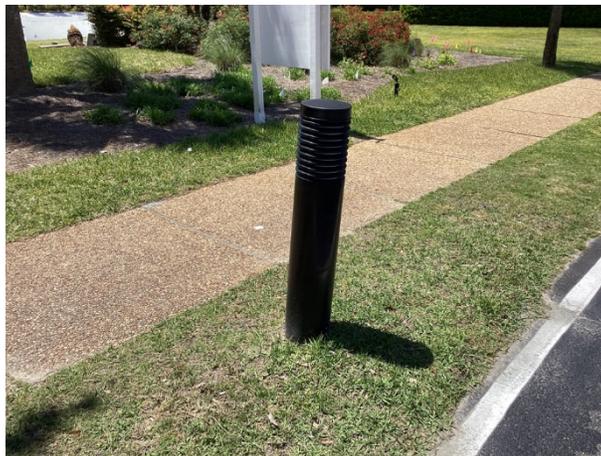
Condition: Fair overall. The Association informs us of plans to begin replacements of the bollard light fixtures in 2023.

Bollard light fixtures

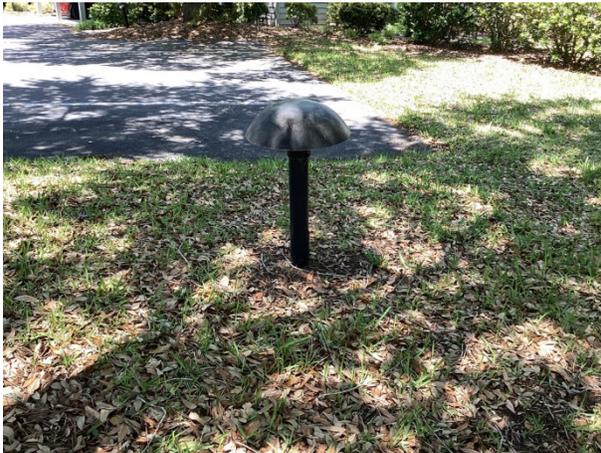
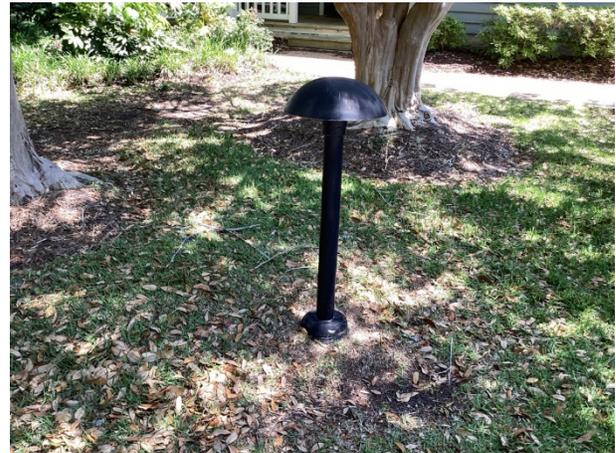
Condition: Fair overall. The Association informs us of plans to begin replacements of the mushroom light fixtures in 2023.

Mushroom landscape fixtures

Mushroom light fixture

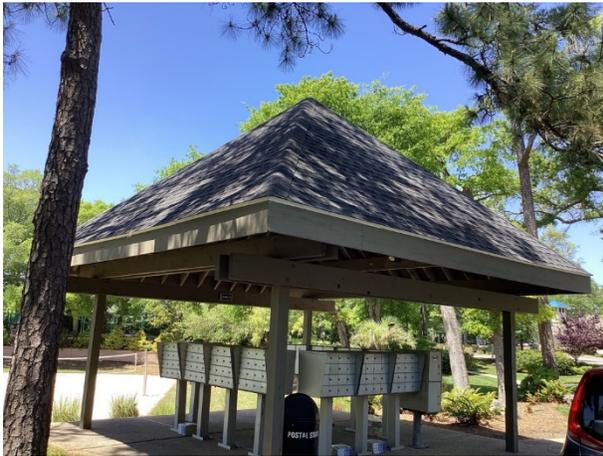
Condition: The roof and paint finishes are in good overall condition. The mailbox stations are in fair to poor condition. We note rust formation and deterioration at the undersides of the mailbox stations.

Mailbox kiosk overview

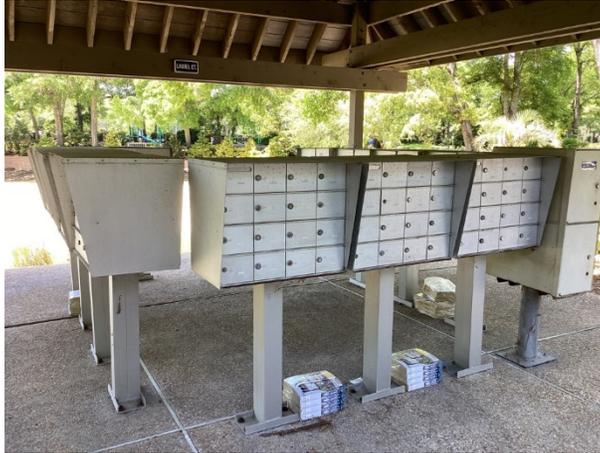
Mailbox stations

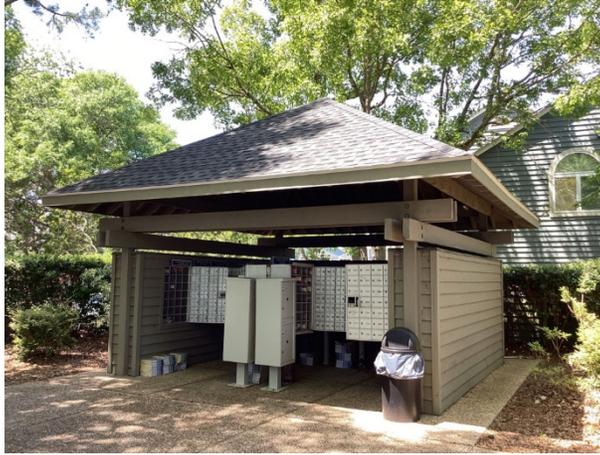
Condition: The roof and paint finishes are in good overall condition. The mailbox stations are in fair to poor condition. We note finish deterioration at the mailbox stations.

West Hyde park mailbox kiosk

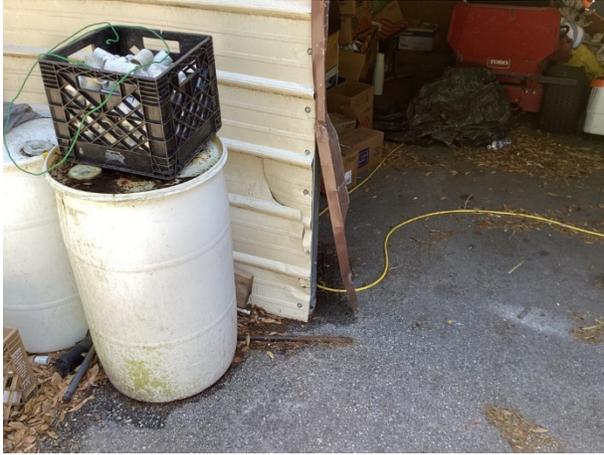
Condition: Fair overall with damaged siding evident

Damaged siding

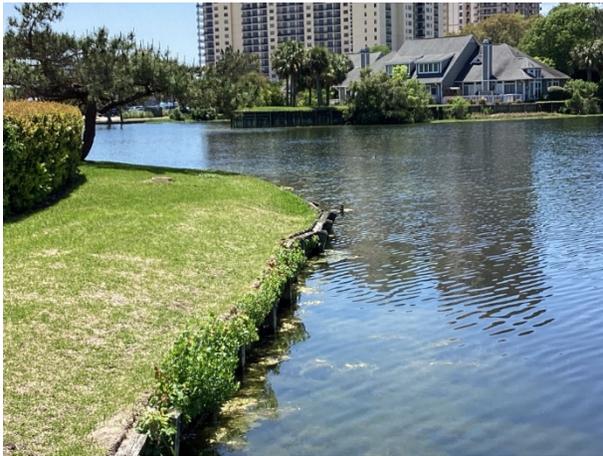
Conditions: Fair to poor overall with leaning sections and wood rot evident. The Association informs us of plans to replace the bulkhead at Lake Arrowhead in two phases beginning in 2022.

Bulkhead lean

Expenditure Detail Notes: Expenditure timing and costs are depicted in the **Reserve Expenditures** table in Section 3. Our cost estimate for replacement is based on information provided to us by the Association. Our cost for repairs includes allowances for a complete inspection and partial replacement of up to twenty percent (20%) of the bulkheads.

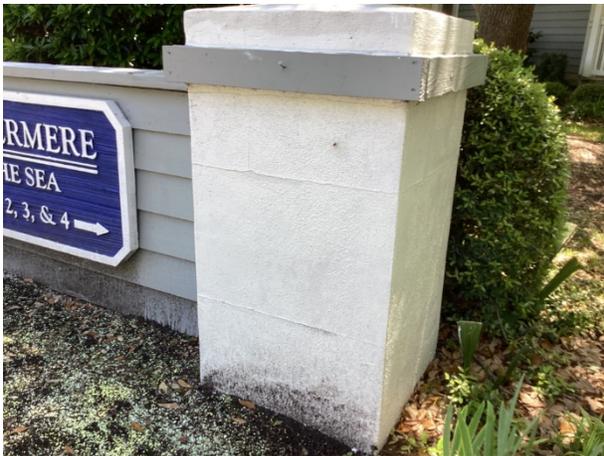
Condition: Fair to poor overall. We note efflorescence, deteriorated wood and stucco cracks evident.

Stucco cracks

Expenditure Detail Notes: Expenditure timing and costs are depicted in the **Reserve Expenditures** table in Section 3. Our cost for renovation includes repairs to the masonry and replacement of the remaining components listed above.

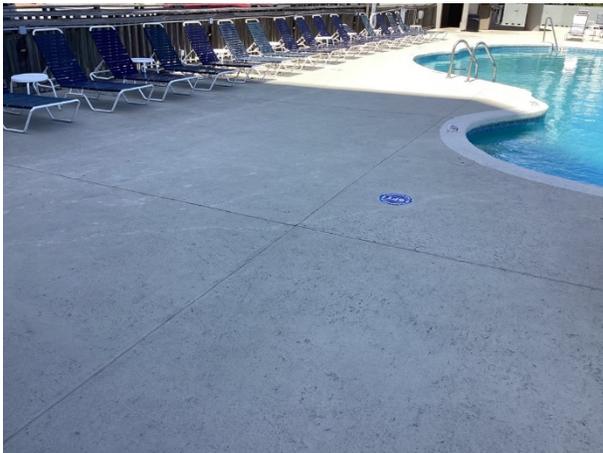
Condition: Fair overall with cracks and coating deterioration evident

Beach Concrete pool deck overview

- Selective cut out and replacements of up to ten percent (10%) of concrete
- Crack repairs as needed
- Mortar joint repairs
- Caulk replacement
- Coating replacement

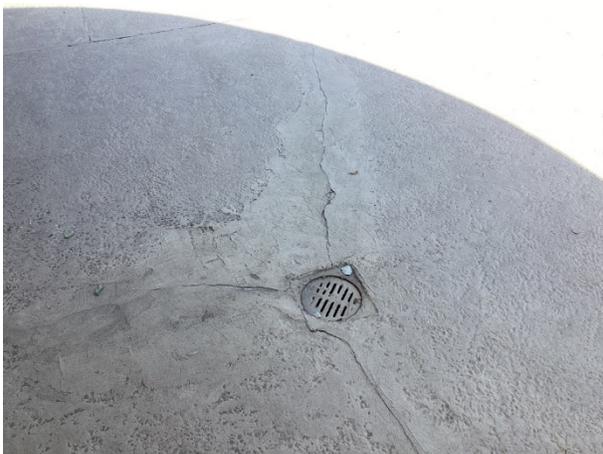
Concrete cracks at beach pool

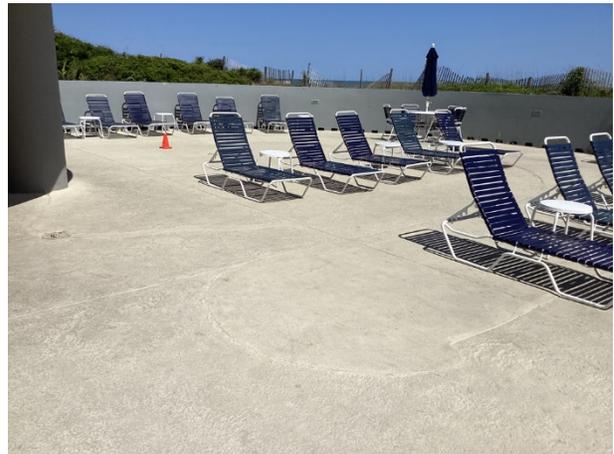
Beach concrete pool deck overview

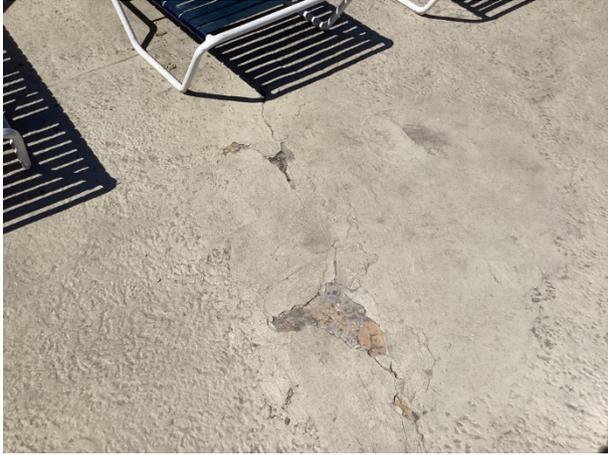
Textured coating delamination

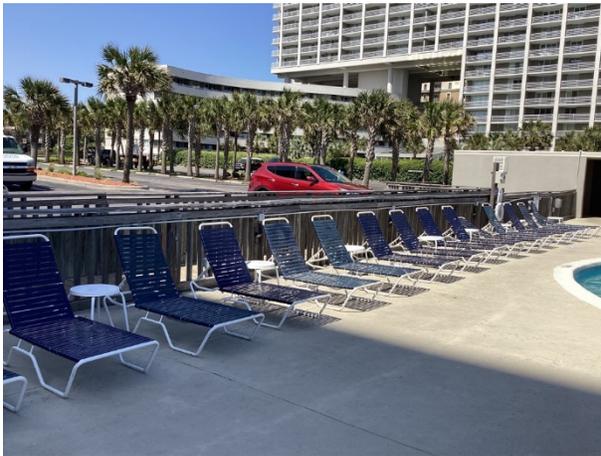
Condition: Good to fair overall

Beach Pool furniture

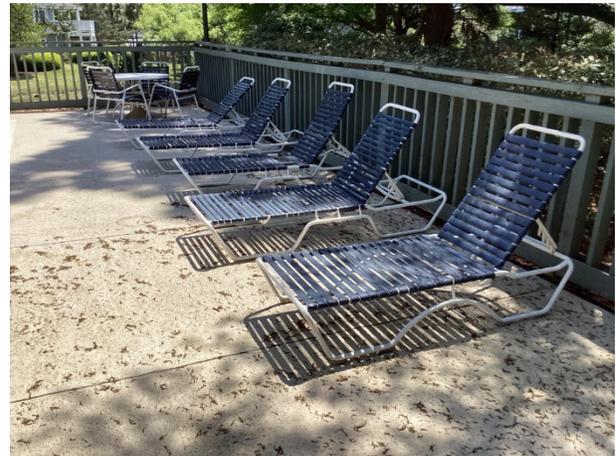
Saint James Pool furniture

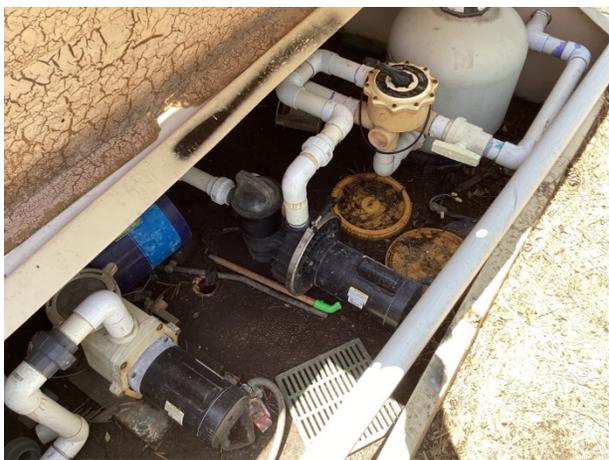
Condition: Reported satisfactory without operational deficiencies

Fountain pumps and filters

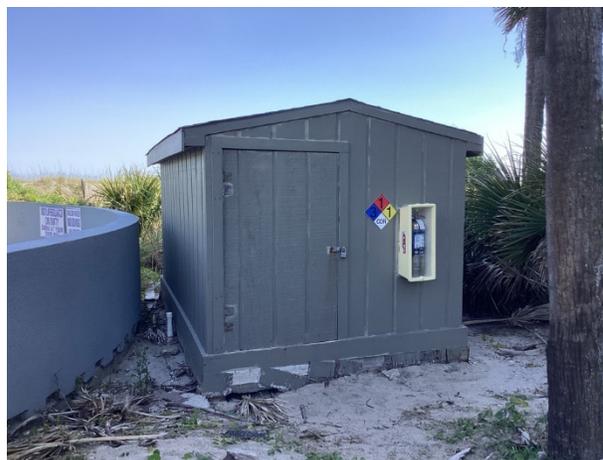
Enclosure

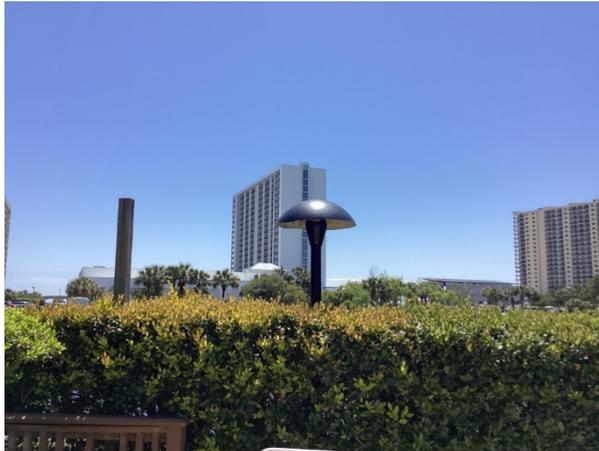
Condition: Fair overall. The Association informs us plans to replace the light poles in the near future.

Laurel Court pool light poles and fixtures

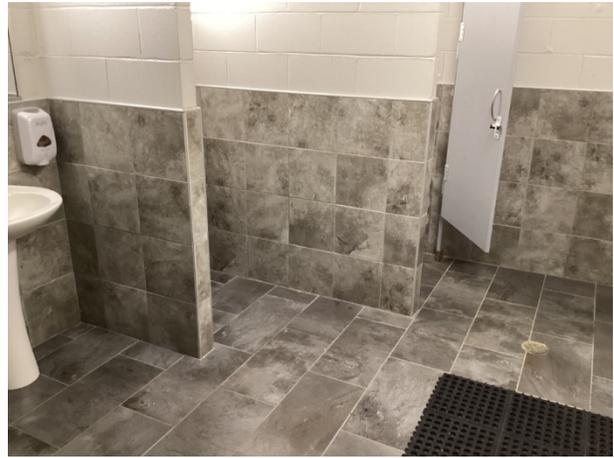
Condition: Good to fair overall with rust evident at the exhaust fan

Beach pool Rest room overview

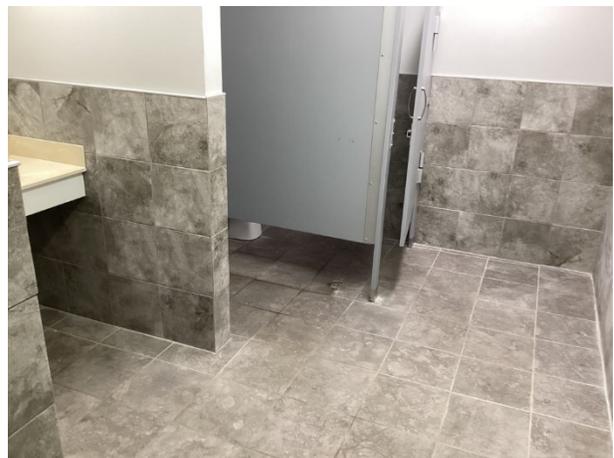
St. James Rest room overview

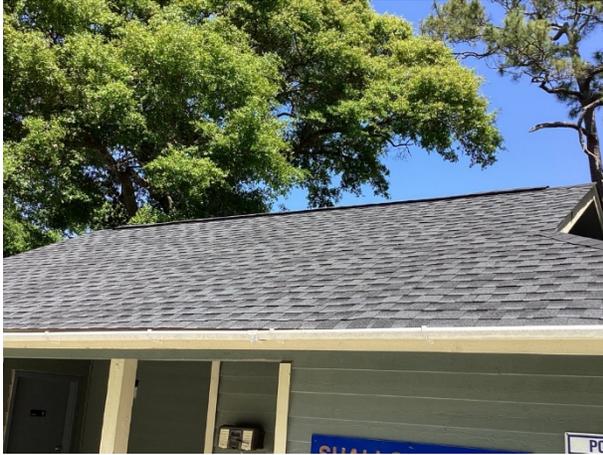
Condition: Good overall with no visible deterioration evident from our visual inspection from the ground. Management do not report a history of leaks.

Saint James pool house roof

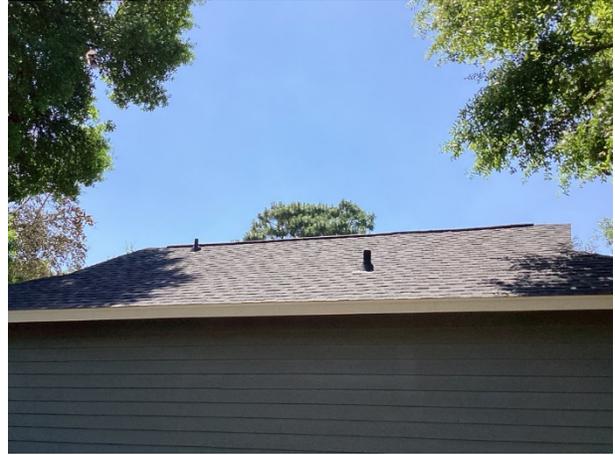
Saint James pool house Roof overview

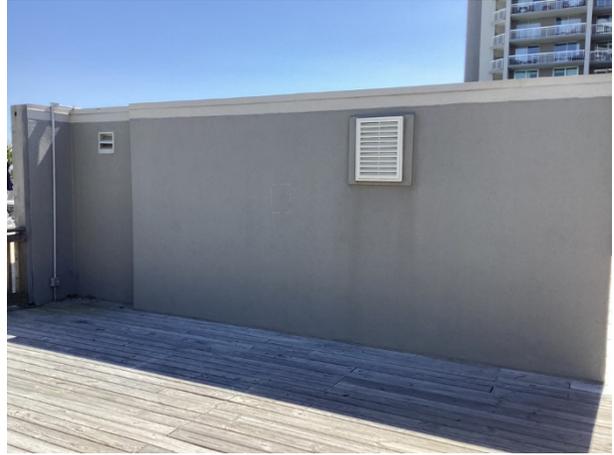
Condition: Fair overall with damage and deterioration evident

EIFS overview at pool House

application of the new finish coat, the contractor should remove and replace all loose, cracked or deteriorated sections of the EIFS walls. The contractor should then wash the surface to remove all dirt or chalking of the prior paint finish.

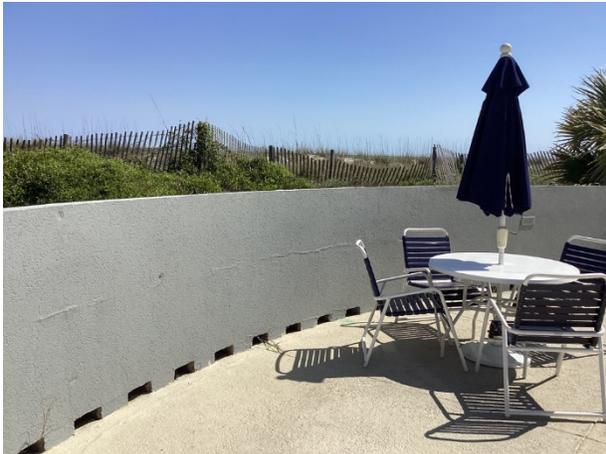
EIFS at pool wall

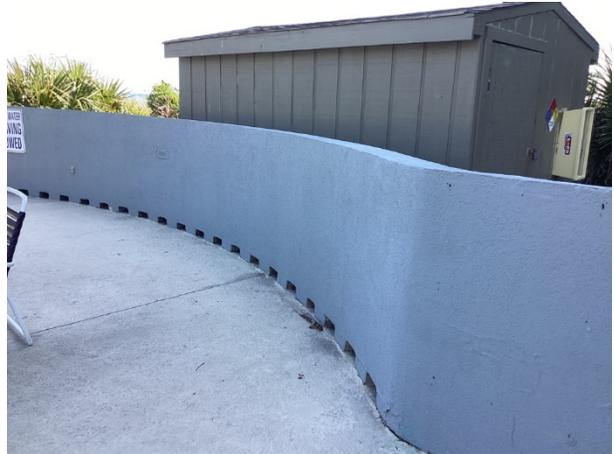
EIFS at pool wall

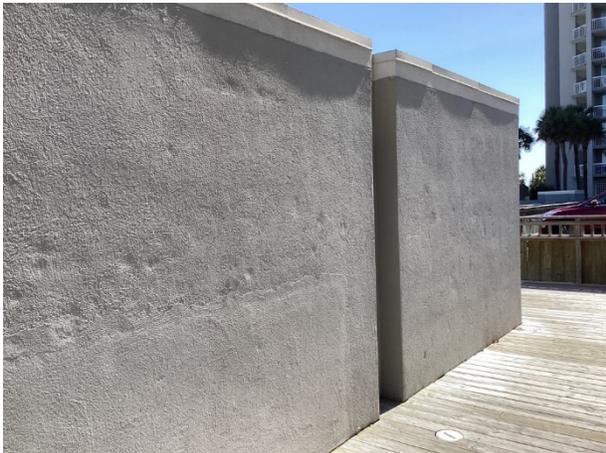
EIFS at pool house

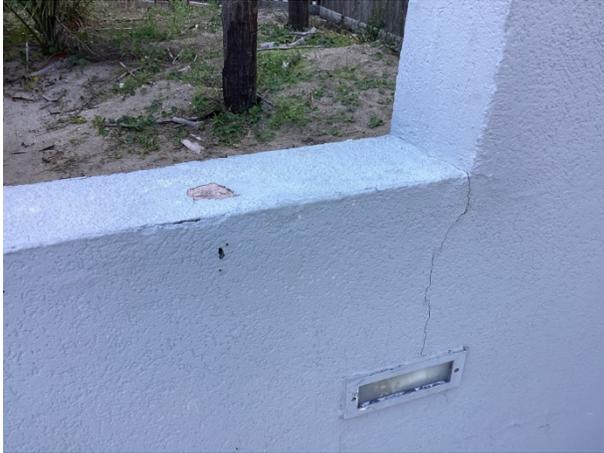
EIFS deterioration and cracks

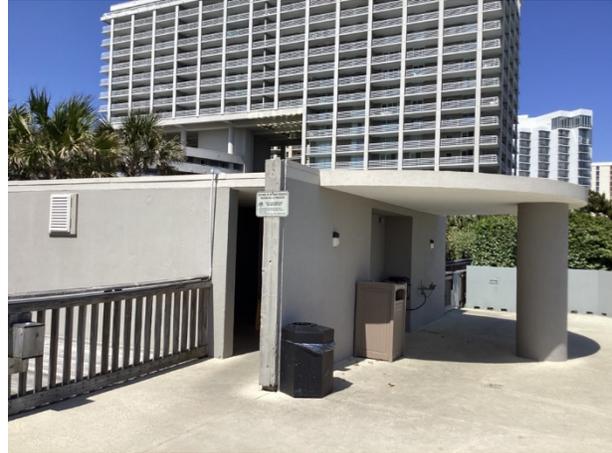
Pool house EIFS overview

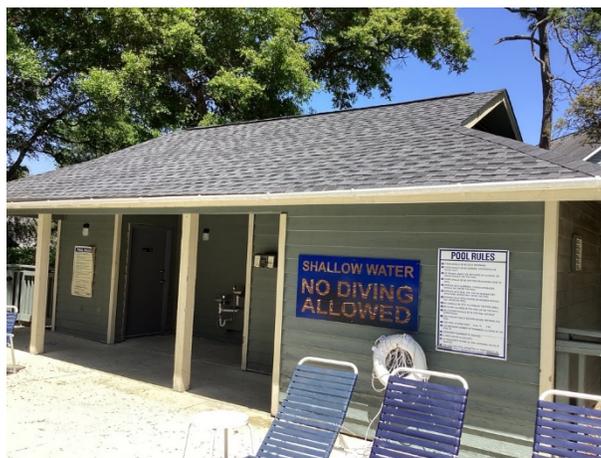
Condition: The siding is in fair overall condition

Pool house overview

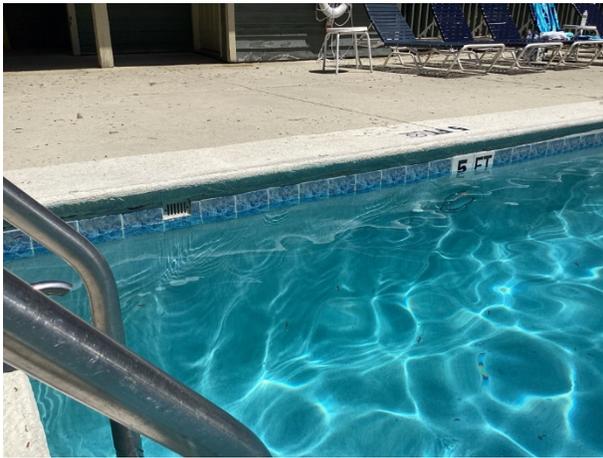
Condition: Good overall

St. James Pool plaster finish with tile perimeter

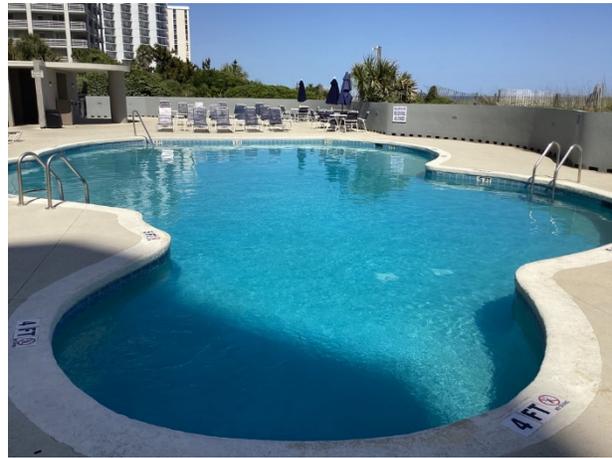
Beach Pool plaster overview
