RESERVE STUDY

Kingston Plantation Master Association, Inc.

Myrtle Beach, South Carolina
April 27, 2022

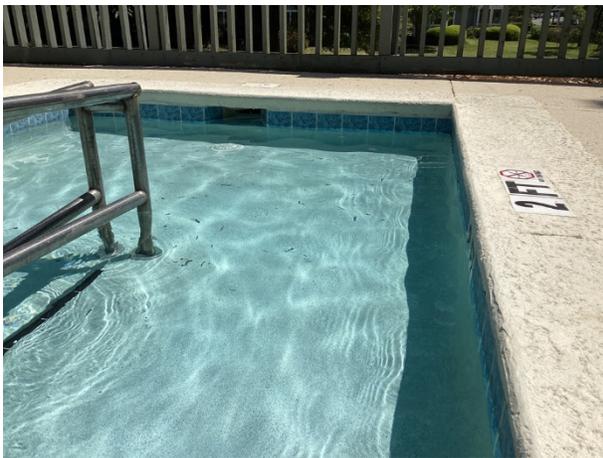
St. James Pool plaster finish with tile perimeter

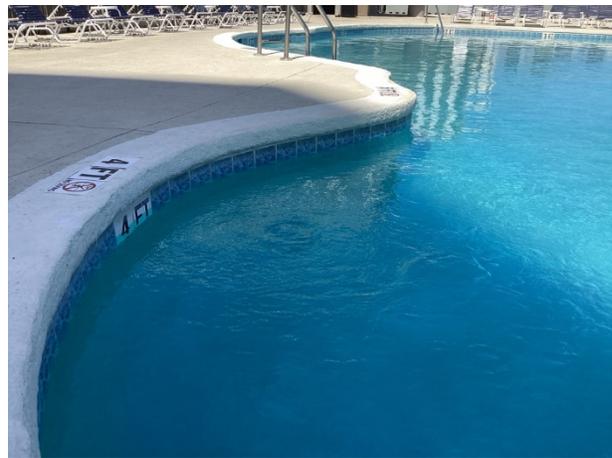
Beach Pool plaster finish with tile perimeter

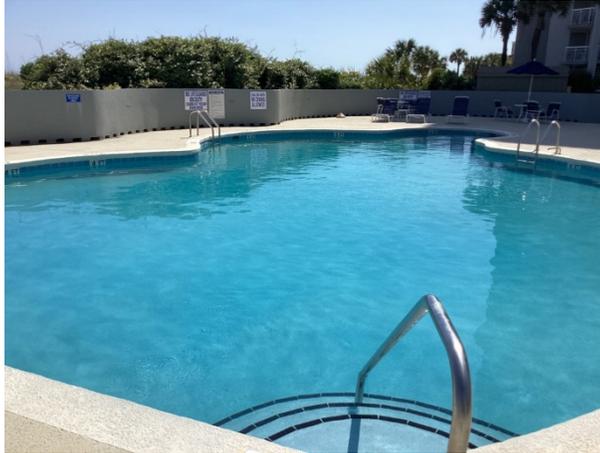
Beach Pool plaster overview
