Kingston Plantation Master Association, Inc.

Inspected: May 28, 2025 • Revised on: September 15, 2025
Myrtle Beach, SC

RESERVE STUDY

Kingston Plantation

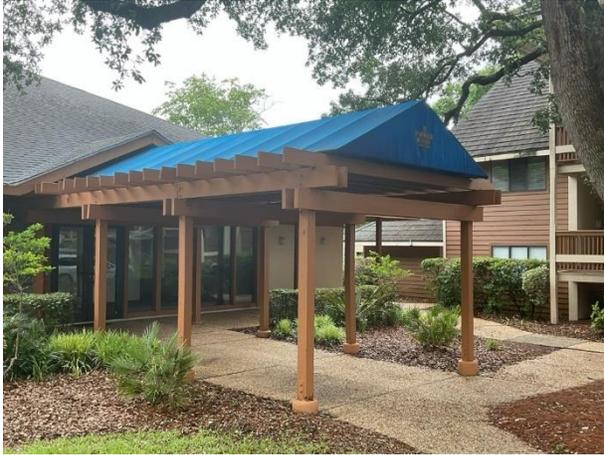
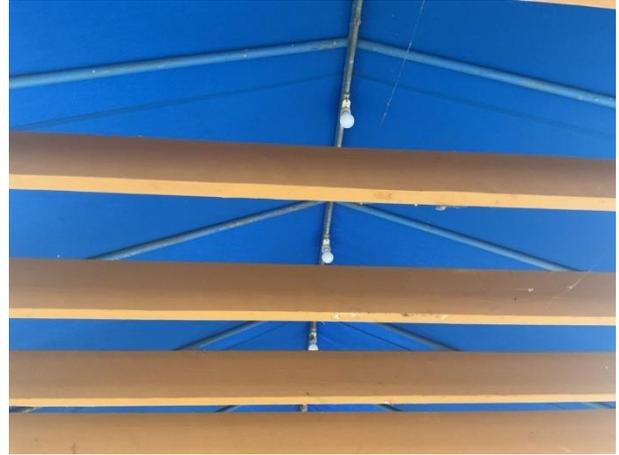
Condition: Fair overall with rust evident.

Awning overview

Awning canvas cover

History: The canvas was last replaced in 2017. Management informs us of plans to replace the awnings canvas in 2025

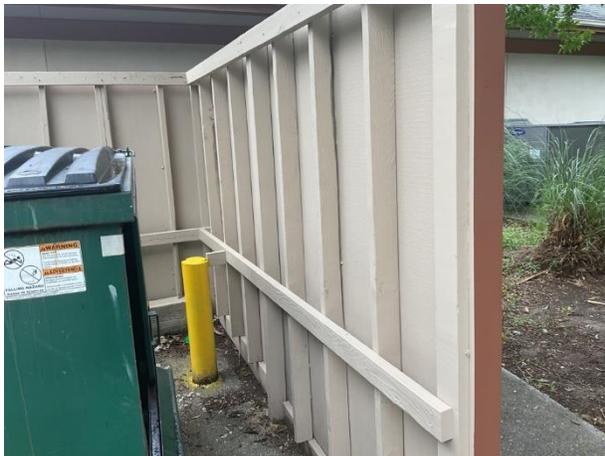
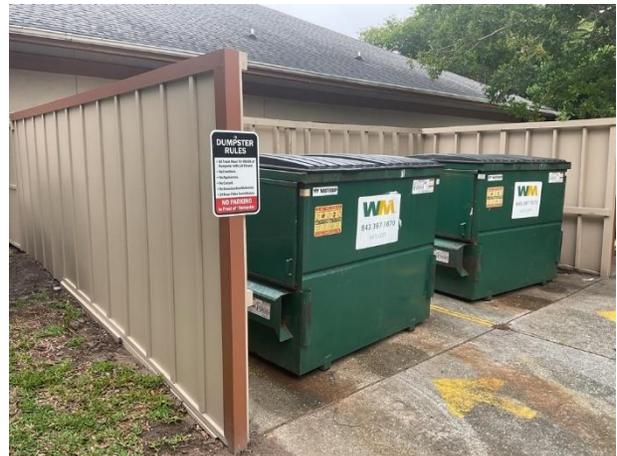
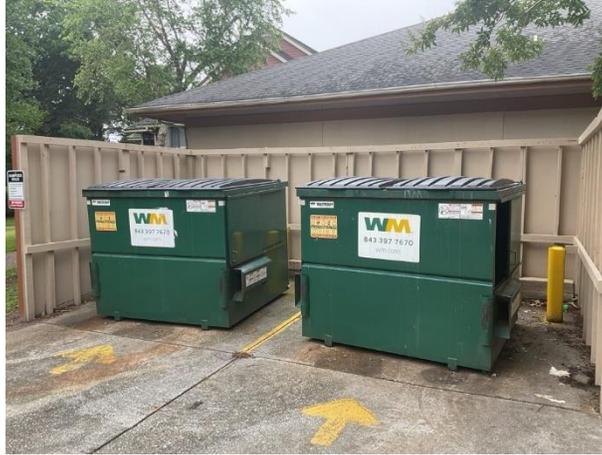
Condition: Good overall with no visible deterioration

Wood fence

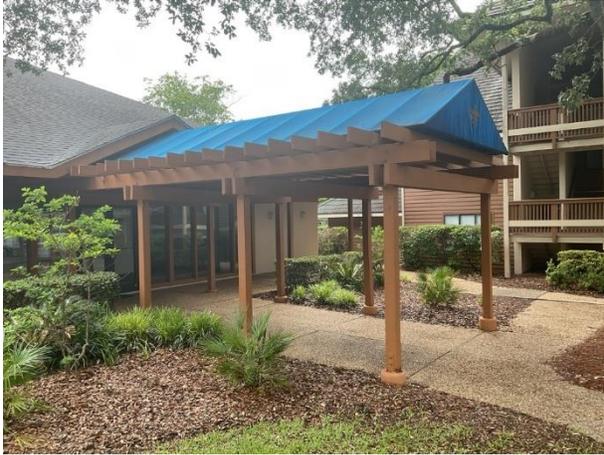
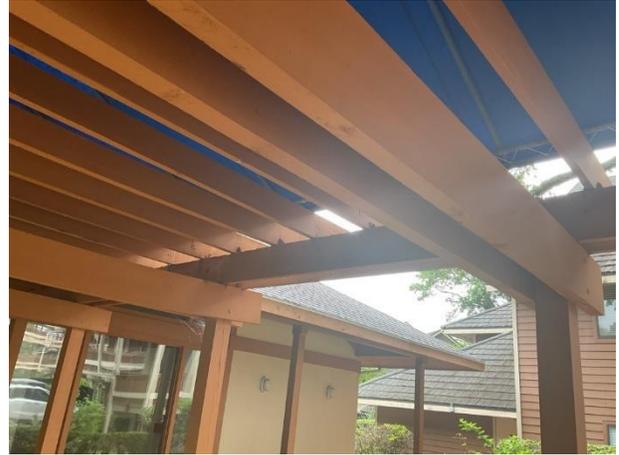
Condition: Good overall

Pergola

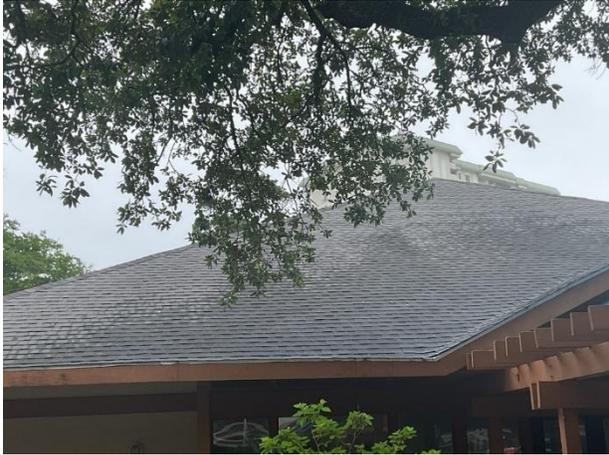
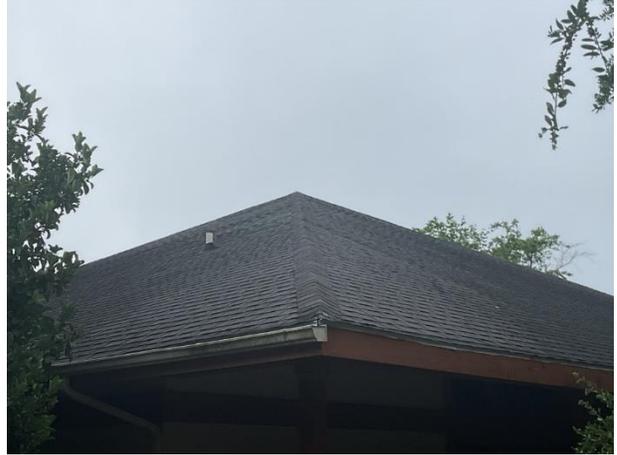
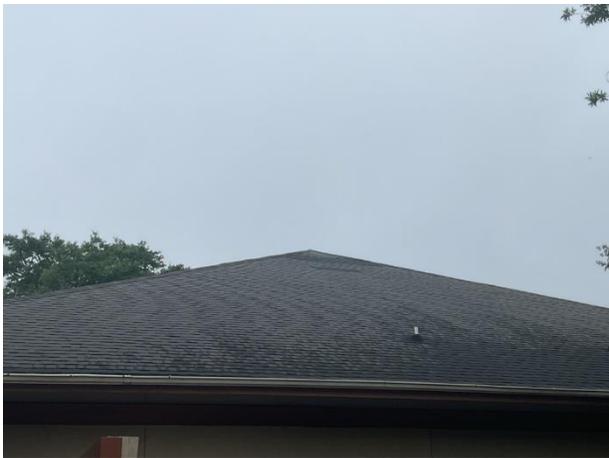
Condition: Good to fair overall with recent repairs evident from our visual inspection from the ground. Management does not report any active leaks.

Roof overview

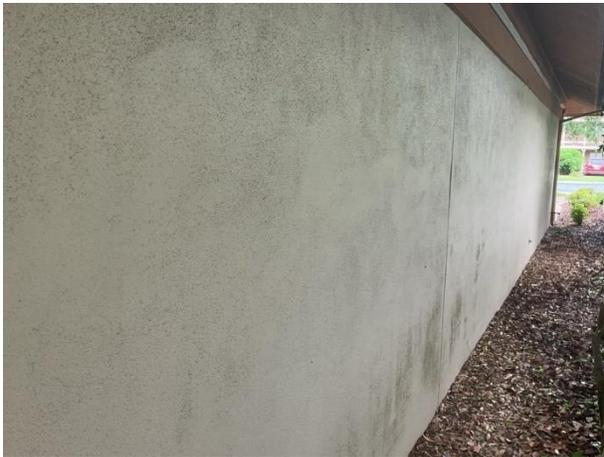
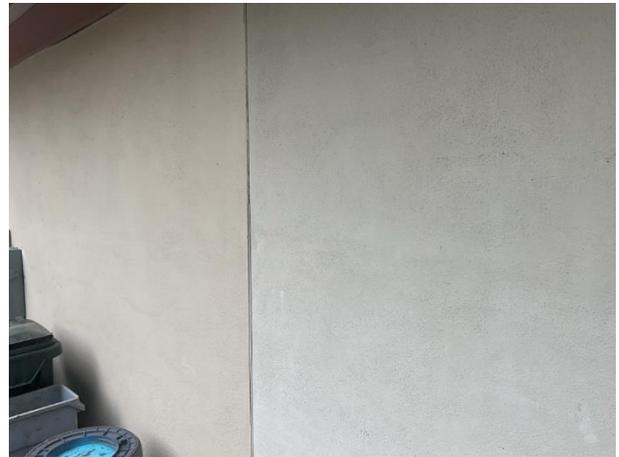
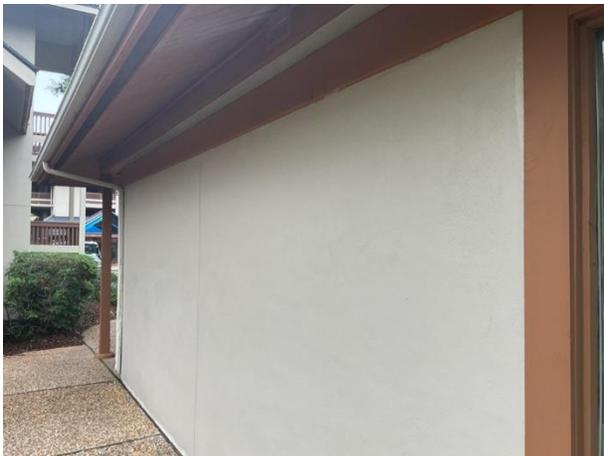
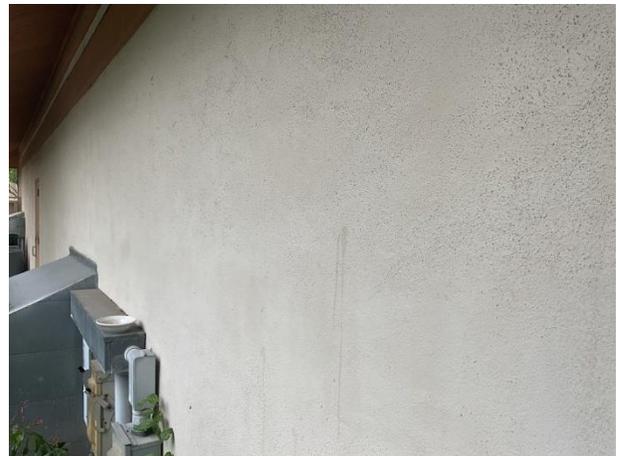
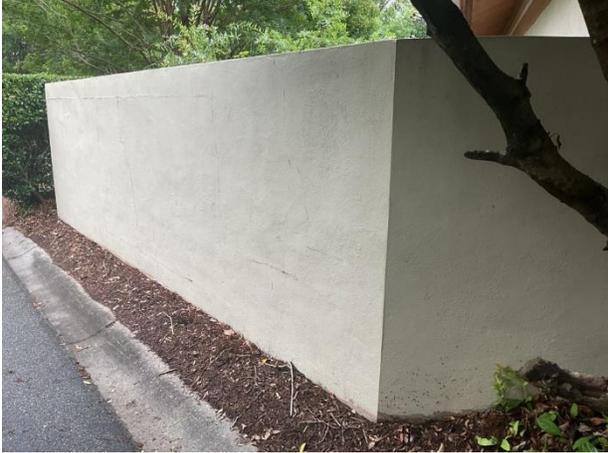
Condition: Fair overall with isolated stains and damage evident.

Stucco wall finishes

Stucco trash enclosure wall

History: The date of the last painting event is unknown at this time. Management informs us of plans to paint in 2025.

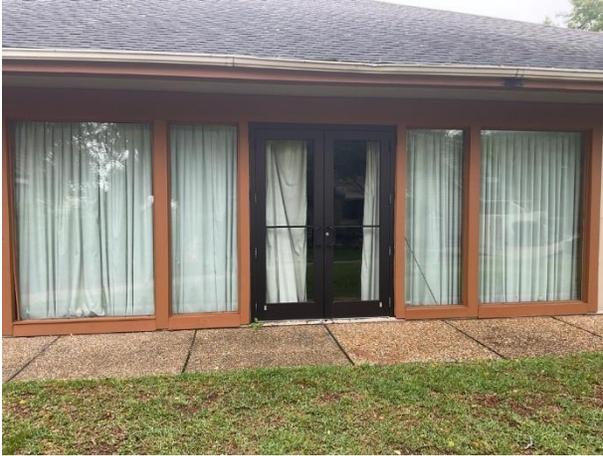
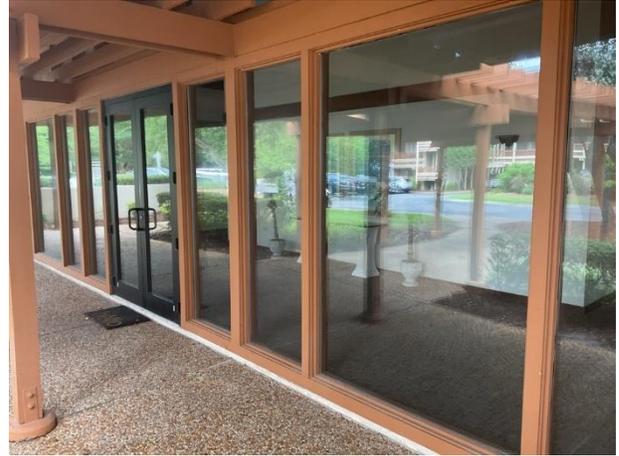
Condition: Good to fair overall with no visible deterioration

Meeting House windows and doors

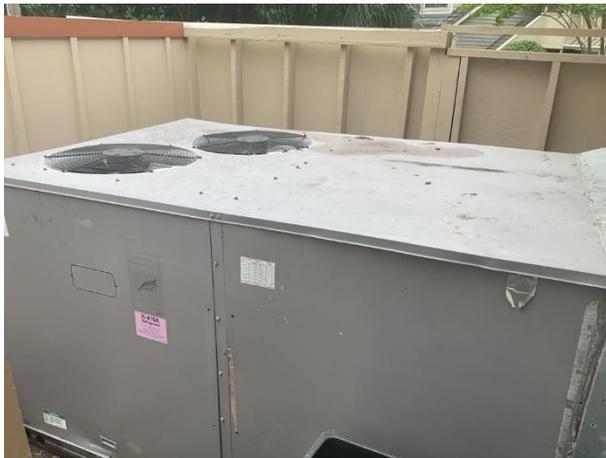
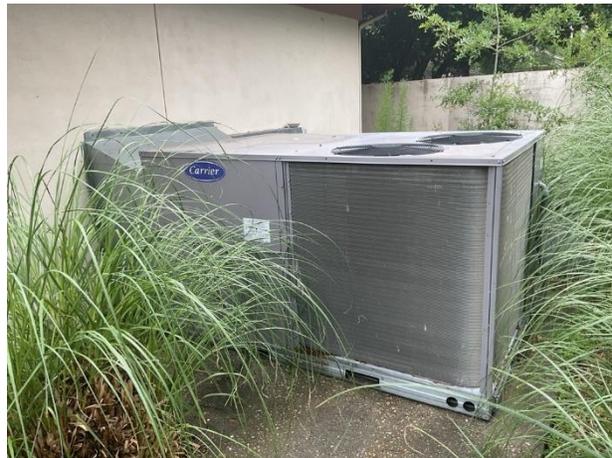
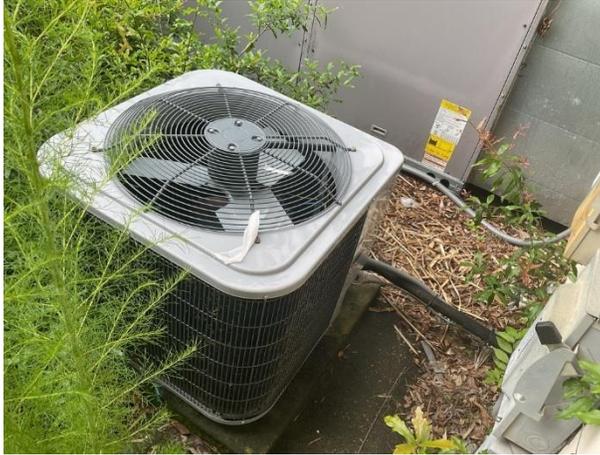
Condition: Reported satisfactory without operational deficiencies

Heating and cooling units

Split system condensing unit

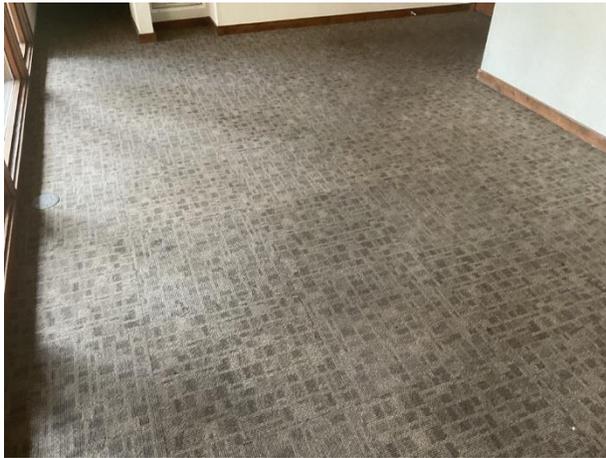
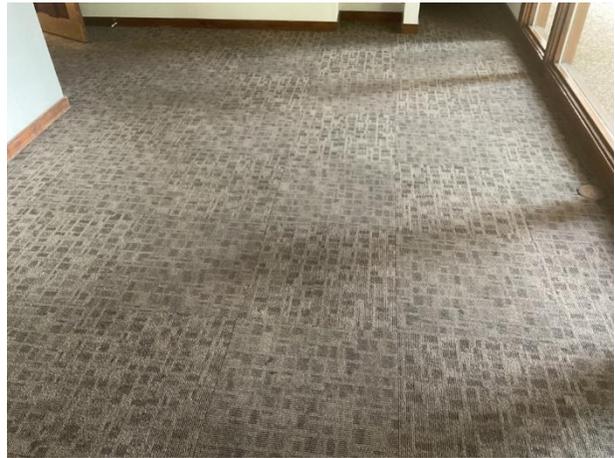
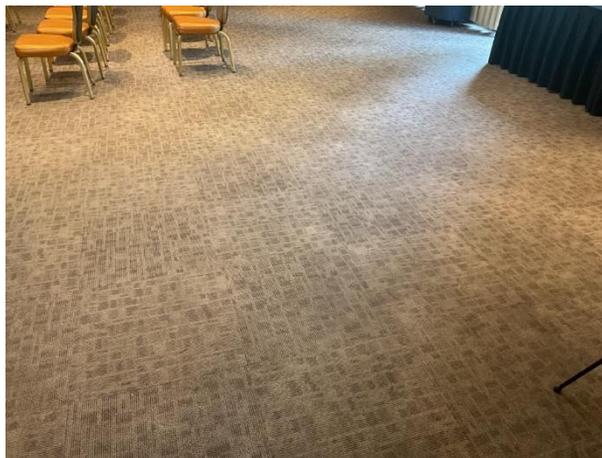
Condition: Good to fair overall with no significant deterioration evident.

Carpet floor coverings

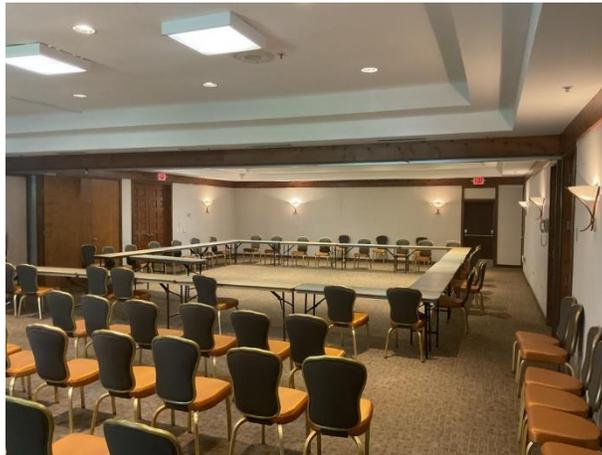
Condition: Good to fair overall

Furnishings

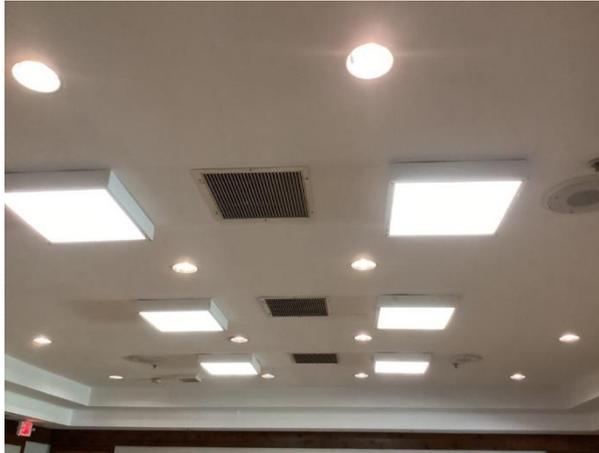
Condition: Reported satisfactory overall

Meeting House ceiling fixtures

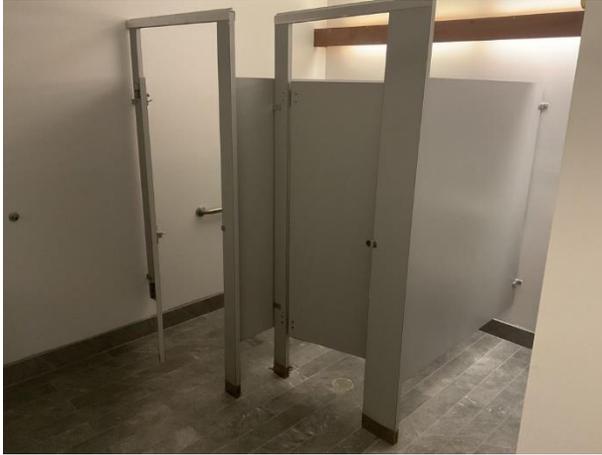
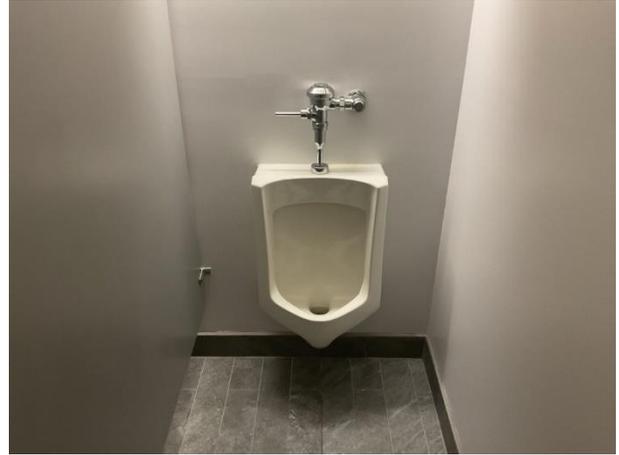
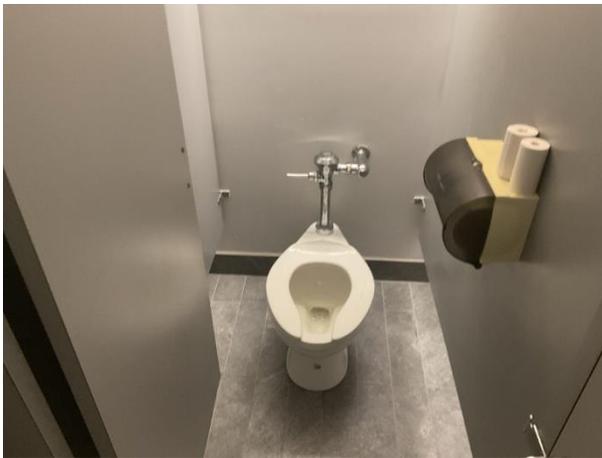
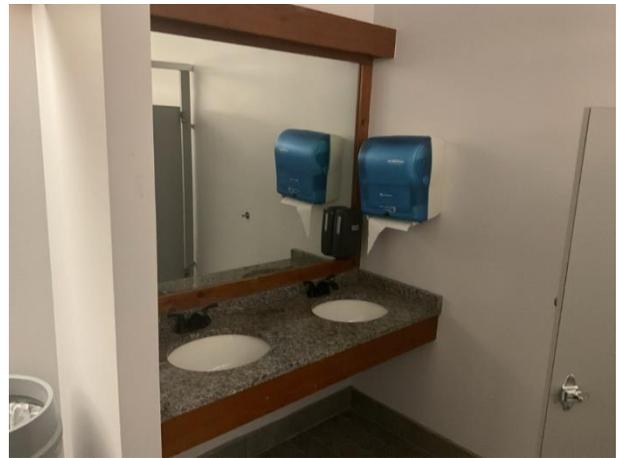
Condition: Good to fair overall

Meeting House rest room

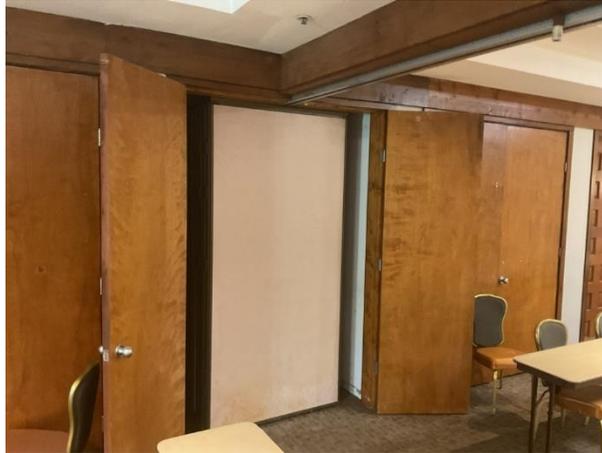
Condition: Fair overall

Room Divider

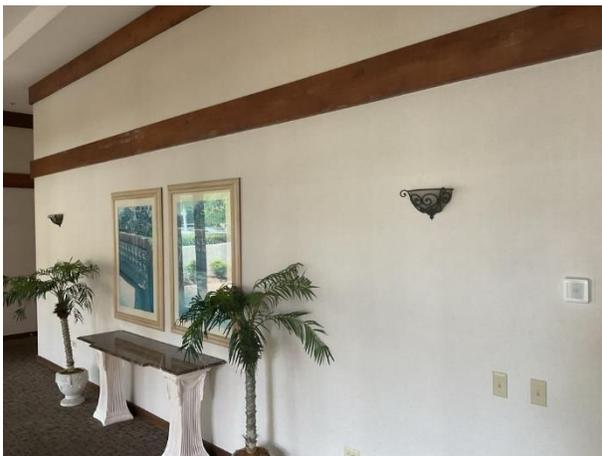
Condition: Good to fair overall

Lobby finishes

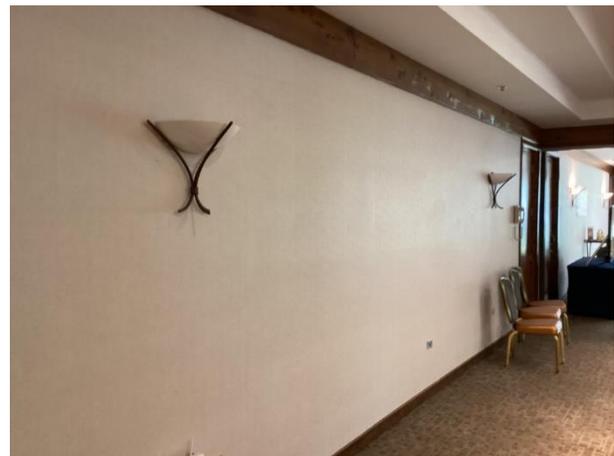
Wall coverings and fixtures

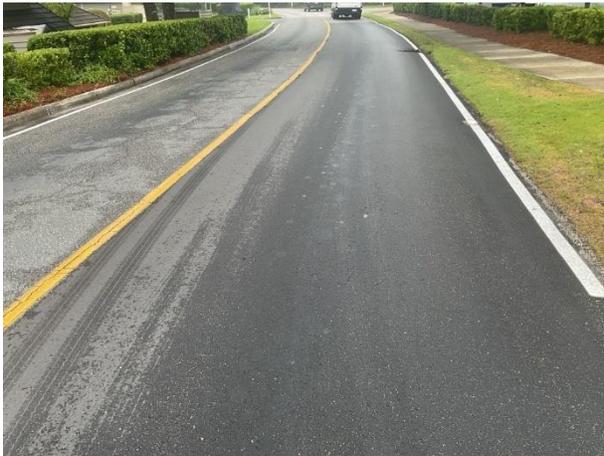
Condition: Good overall with no significant deterioration evident

Pavement overview at Plantation Lakes Drive

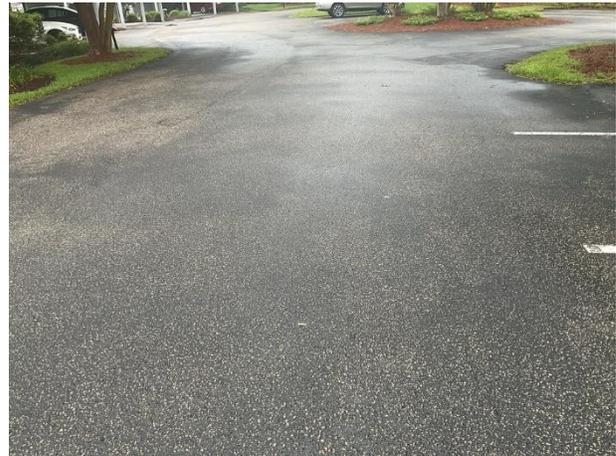
Pavement overview at Gloucester Terrace Circle

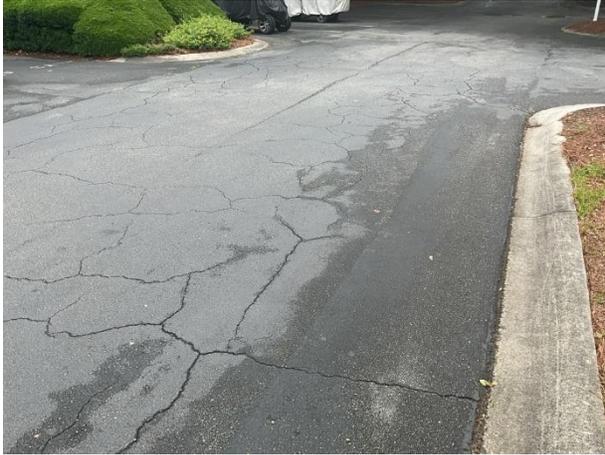
Laurel oaks overview with cracks

- Inspect for settlement, large cracks and trip hazards, and ensure proper drainage
- Repair areas which could cause vehicular damage such as potholes
- As needed:
 - Perform crack repairs and patching

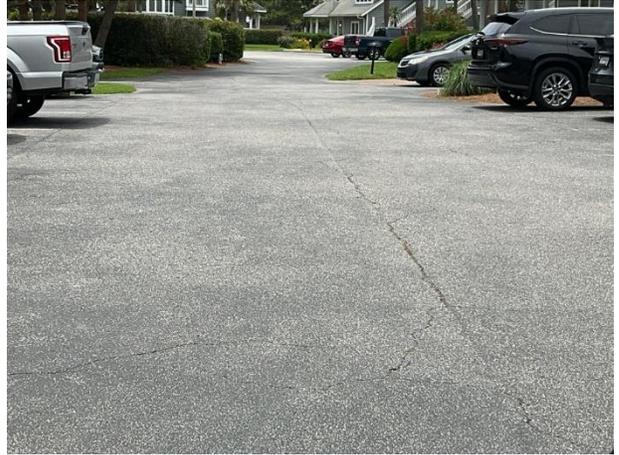
Windmere By the Sea overview

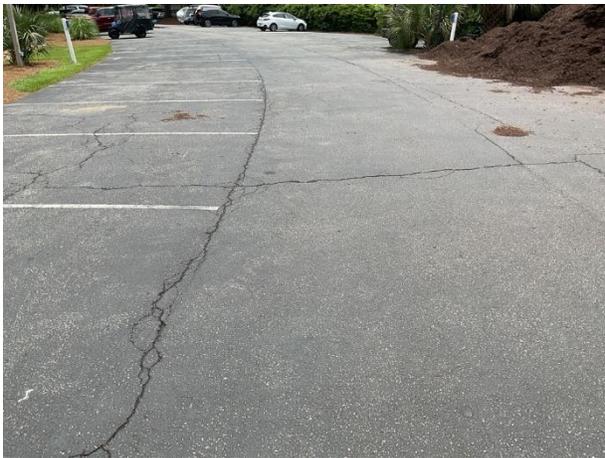
Trailer parking area overview

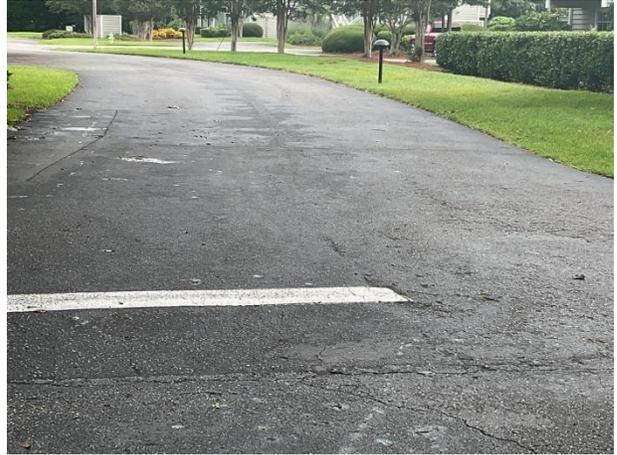
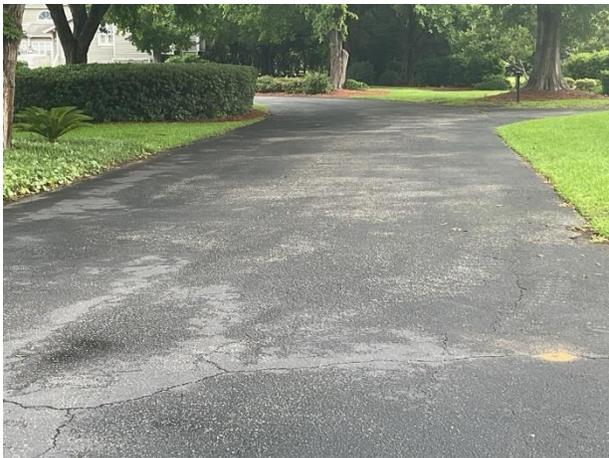
Pavement overview Cumberland terrace

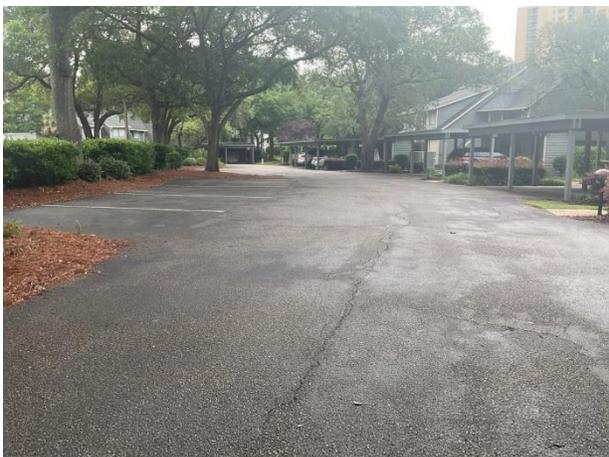
Pavement overview Appledore circle

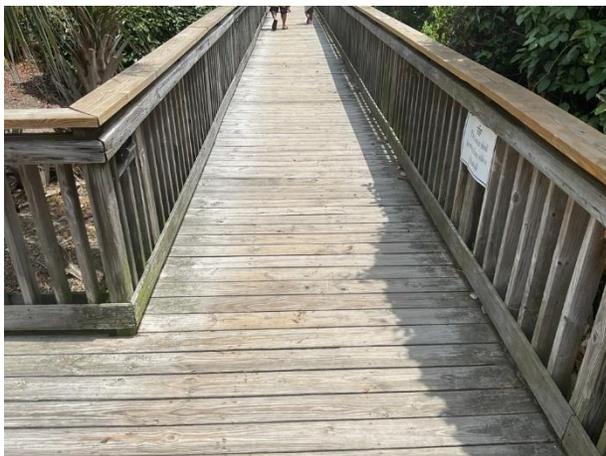
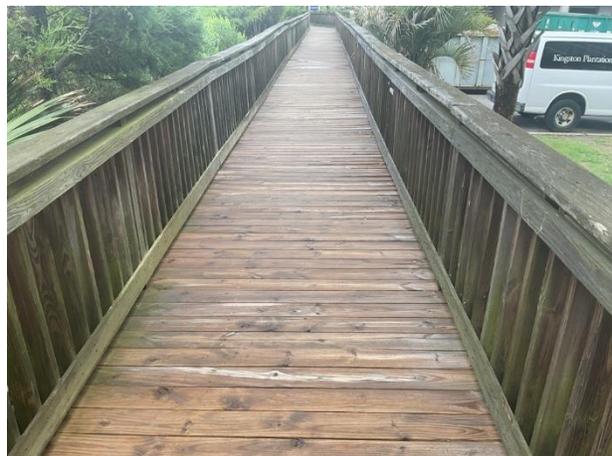
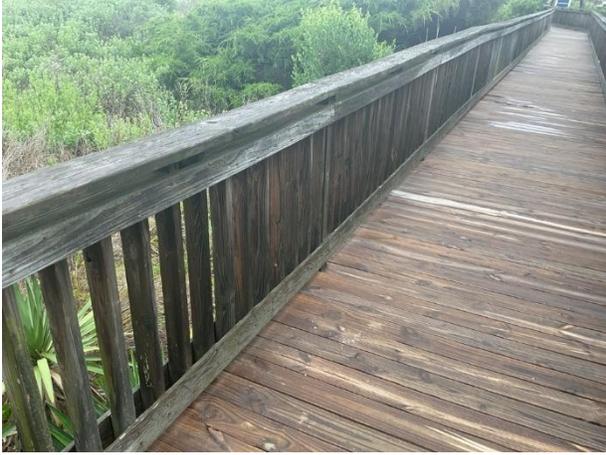
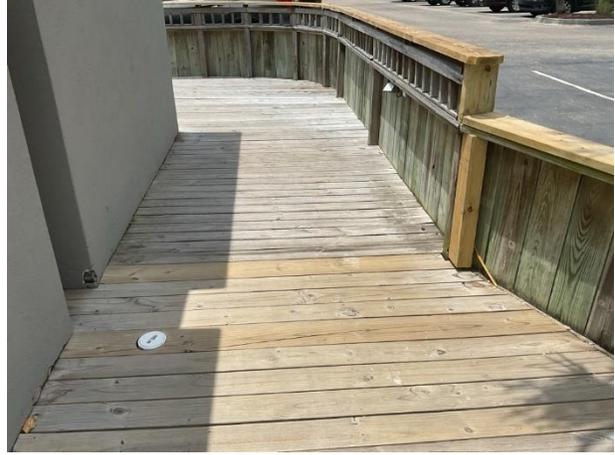
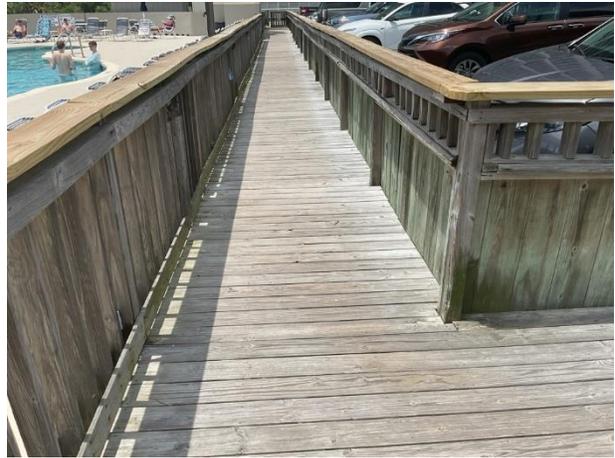
Condition: Good to fair overall condition. We note deteriorated and weathered wood deck boards and recent replacements.

Boardwalk overview

- Annually:
 - Inspect to identify and correct any unsafe conditions
 - Secure loose fasteners and replace deteriorated fasteners
 - Replace deteriorated wood components
 - Check railing stability and fasteners
- Every three years:
 - Power wash with algaecide and application of sealer/stain if applicable

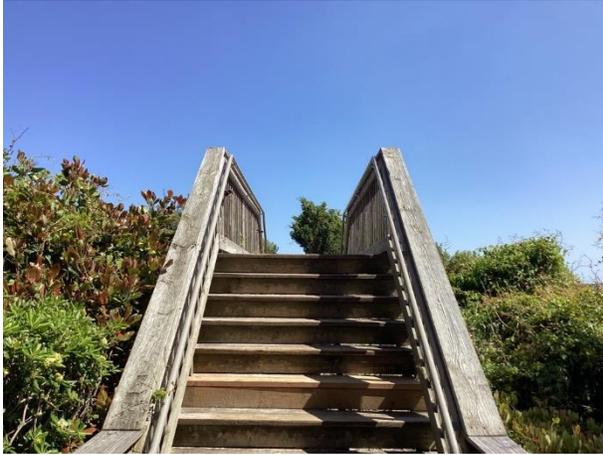
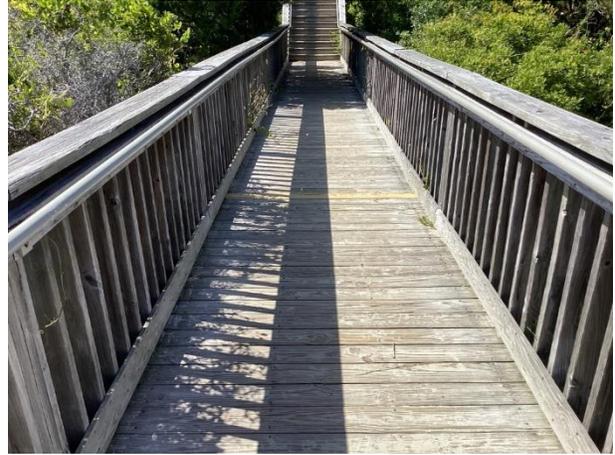
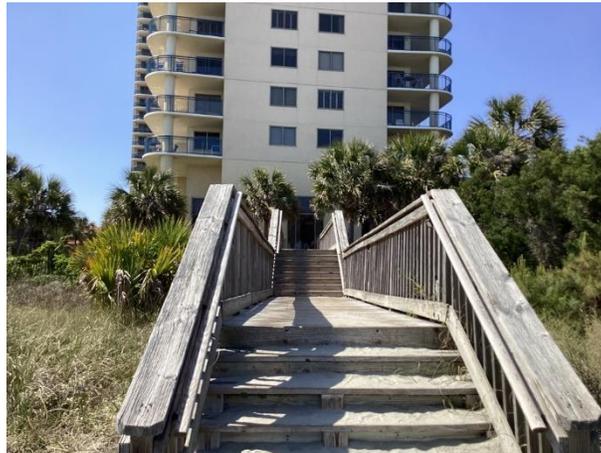
Beach Access

Condition: Fair overall condition. We note deteriorated and weathered wood deck boards, exposed and rusted nails.

- Annually:
 - Inspect to identify and correct any unsafe conditions
 - Secure loose fasteners and replace deteriorated fasteners
 - Replace deteriorated wood components
 - Check railing stability and fasteners
- Every three years:
 - Power wash with algaecide and application of sealer/stain if applicable

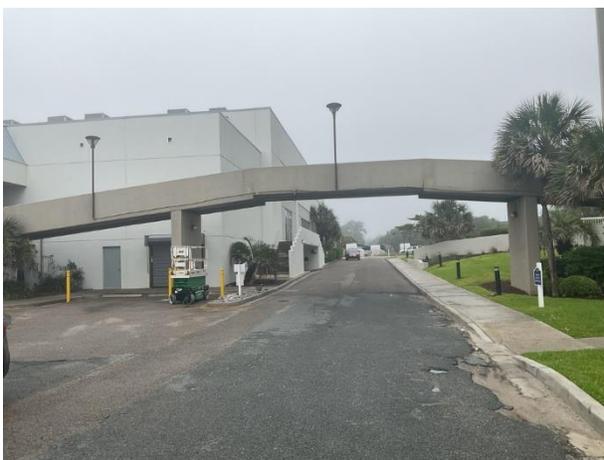
Condition: Good to fair overall with deteriorated finishes, control joint sealant deterioration, rust spots and textured coating delamination evident

Pedestrian bridge overview

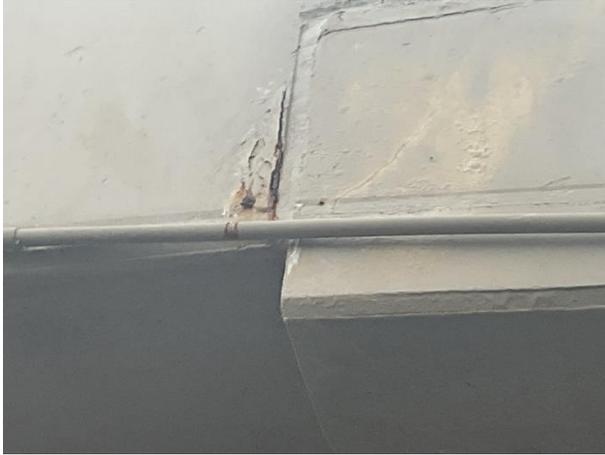
Rust spots evidence

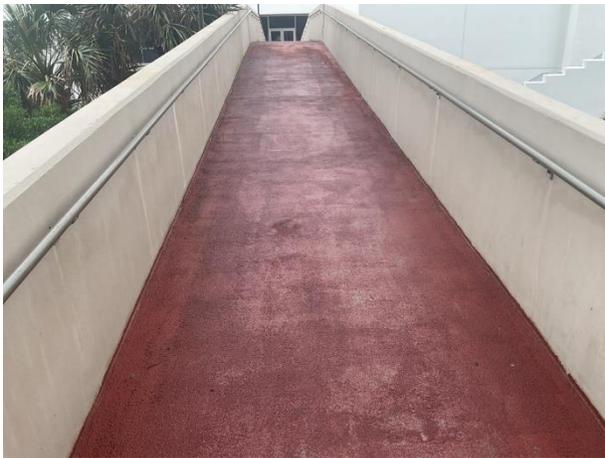
Bridge overview

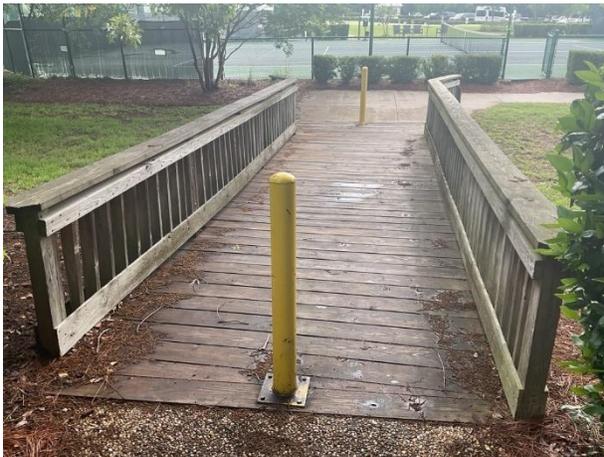
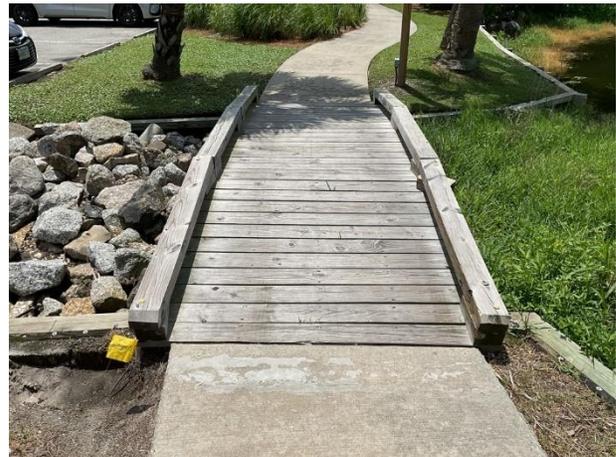
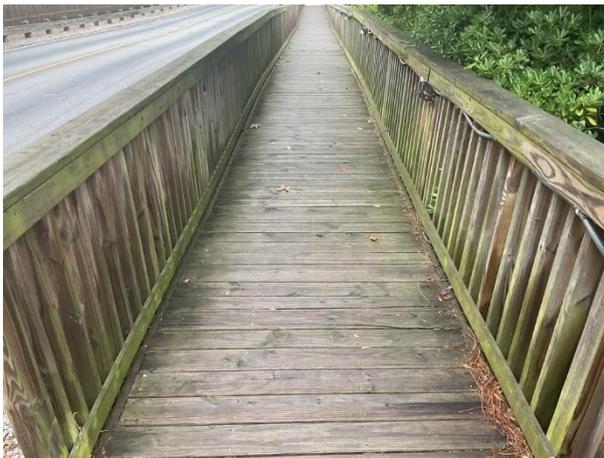
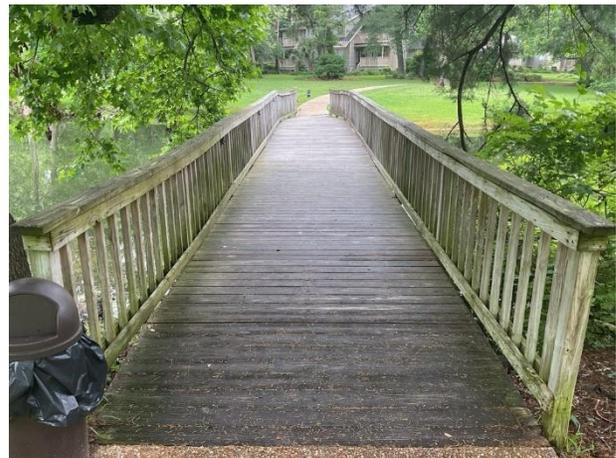
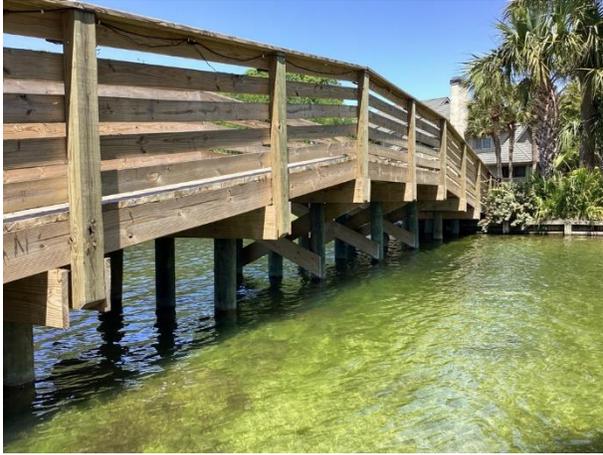
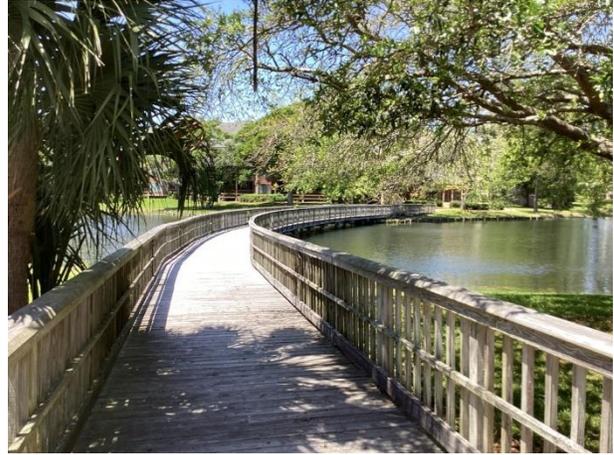
Condition: Ranges from Good to fair. We note deteriorated and weathered wood deck boards, exposed and rusted nails.

- Annually:
 - Inspect to identify and correct any unsafe conditions
 - Secure loose fasteners and replace deteriorated fasteners
 - Replace deteriorated wood components
 - Check railing stability and fasteners
- Every three years:
 - Power wash with algaecide and application of sealer/stain if applicable

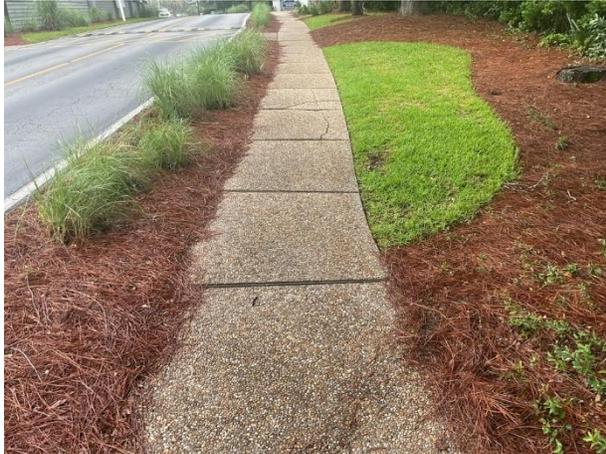
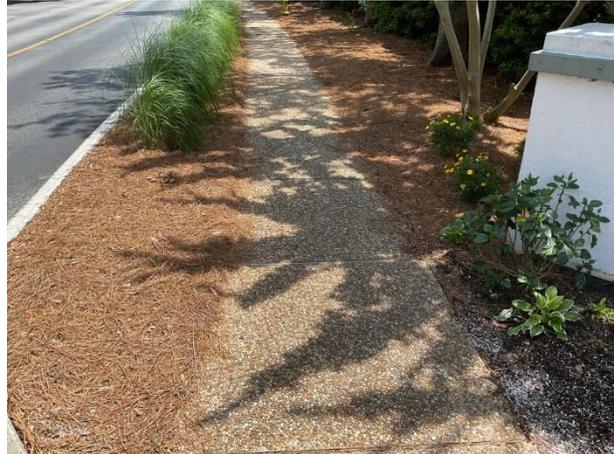
Condition: Fair overall with cracks, trip hazards and settlement evident.

Concrete sidewalk

- Annually:
 - Inspect and repair major cracks, spalls and trip hazards
 - Mark with orange safety paint prior to replacement or repair
 - Repair or perform concrete leveling in areas in immediate need of repair or possible safety hazard

Expenditure Detail Notes: Expenditure timing and costs are depicted in the **Reserve Expenditures** table in Section 3. We estimate that up to 36,464 square feet of concrete sidewalks, or thirty percent (30%) of the total, will require replacement during the next 30 years. Our cost estimate and timing for replacement is based on information provided to us by the Association.

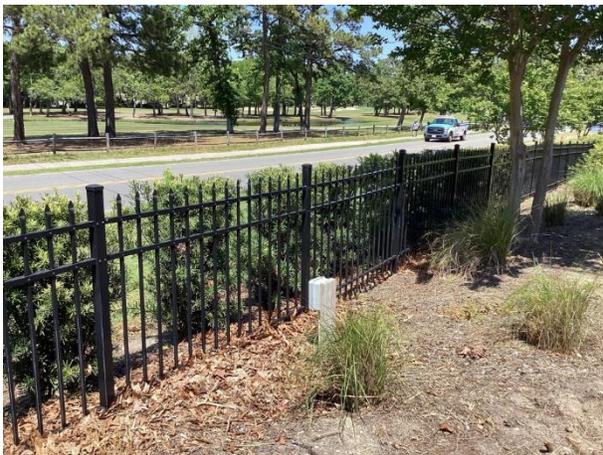
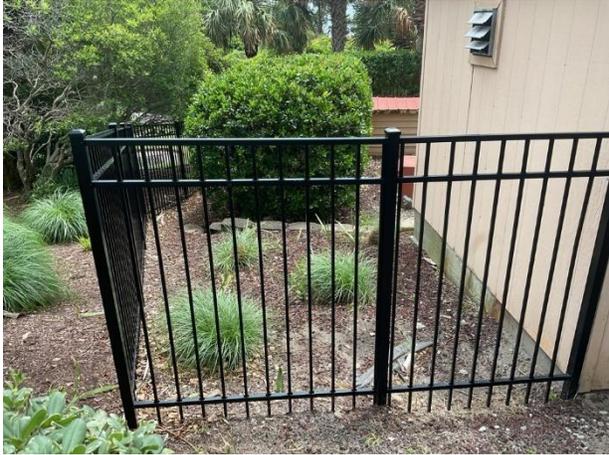
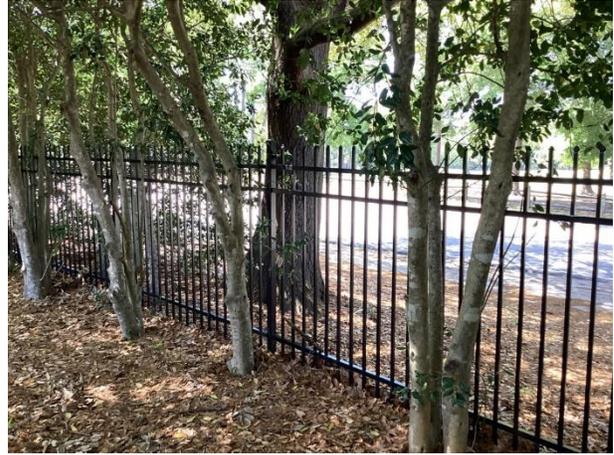
Condition: Good to fair overall

Aluminum fence at Castle Ford Circle

- Annually:
 - Inspect and repair loose fasteners or sections, and damage
 - Repair leaning sections and clear vegetation from fence areas which could cause damage

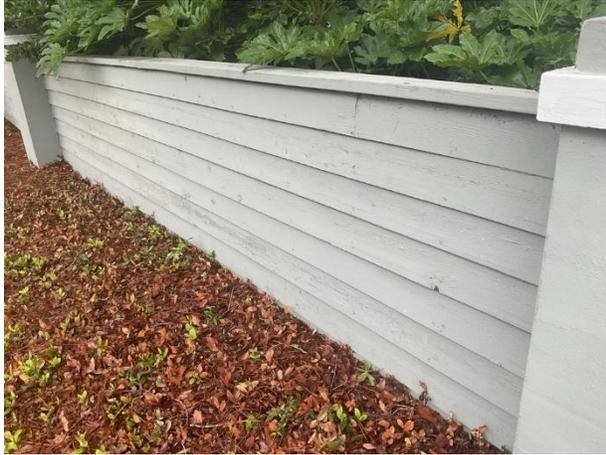
Condition: Fair to poor overall condition with areas of deteriorated wood siding

Wood fence

- Annually:
 - Inspect and repair loose sections, finish deterioration and damage
 - Repair leaning sections and clear vegetation from fence areas which could cause damage

Expenditure Detail Notes: Expenditure timing and costs are depicted in the **Reserve Expenditures** table in Section 3. The Association should anticipate periodic partial replacements due to the non-uniform nature of wood deterioration. Along with these partial replacements, the Association should apply periodic paint applications as needed and fund these activities through the operating budget.

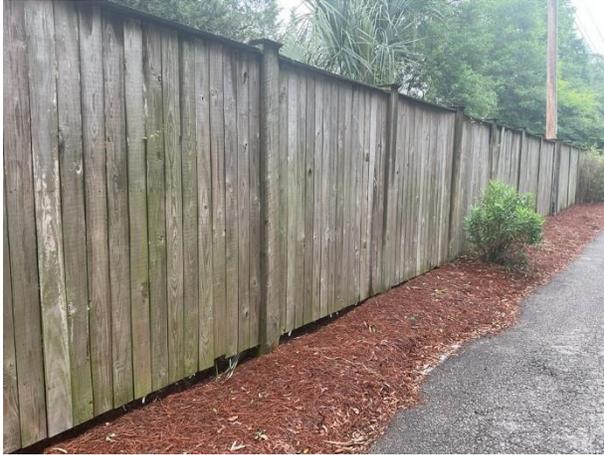
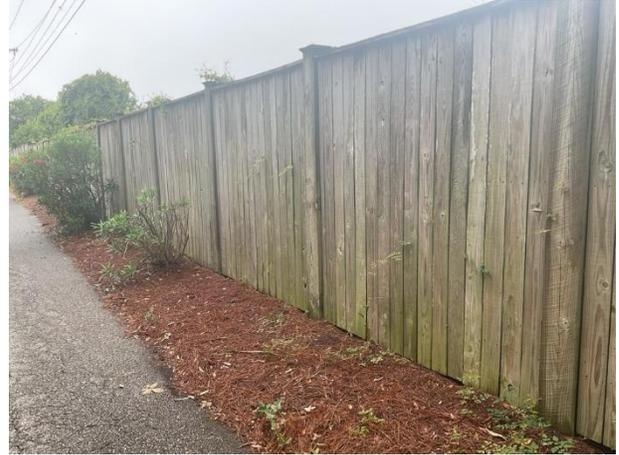
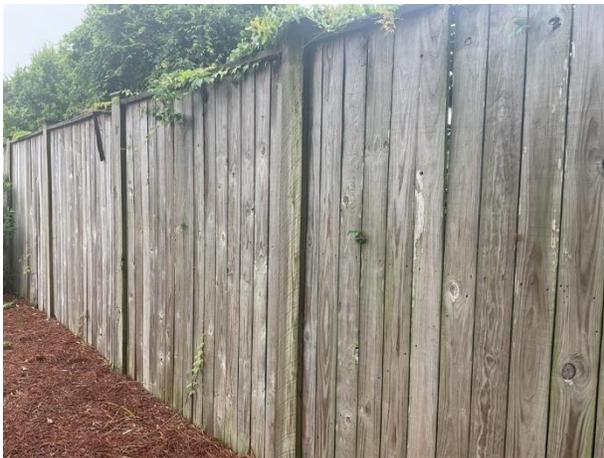
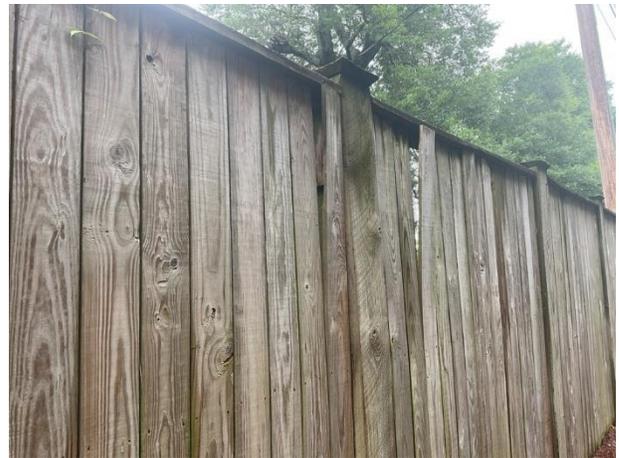
North perimeter fence

Condition: Good to fair overall

Expenditure Detail Notes: Expenditure timing and costs are depicted in the **Reserve Expenditures** table in Section 3. The Association should anticipate periodic partial replacements funded through the operating budget due to the non-uniform nature of wood deterioration. Our cost estimate for replacement is based on information provided to us by the Association.

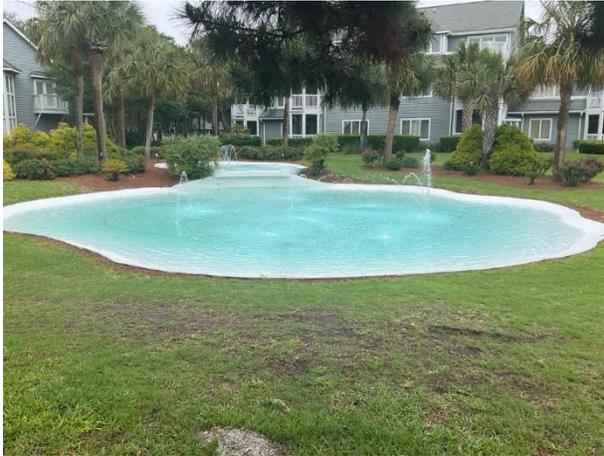
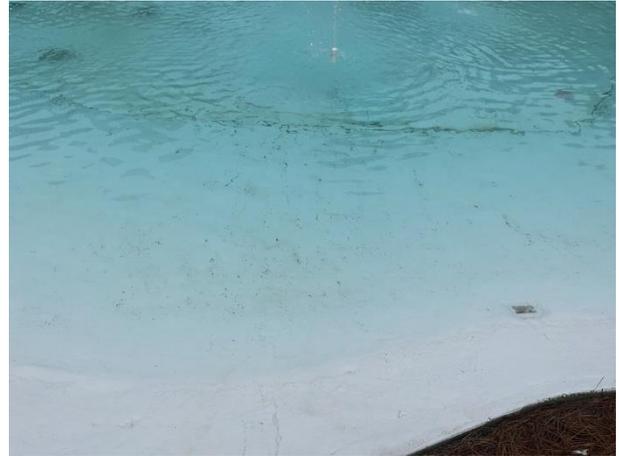
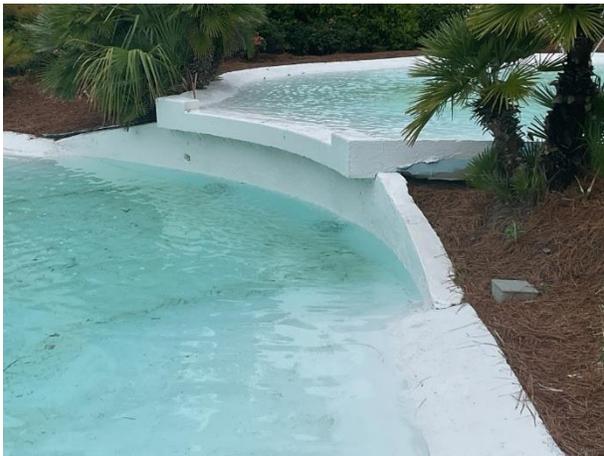
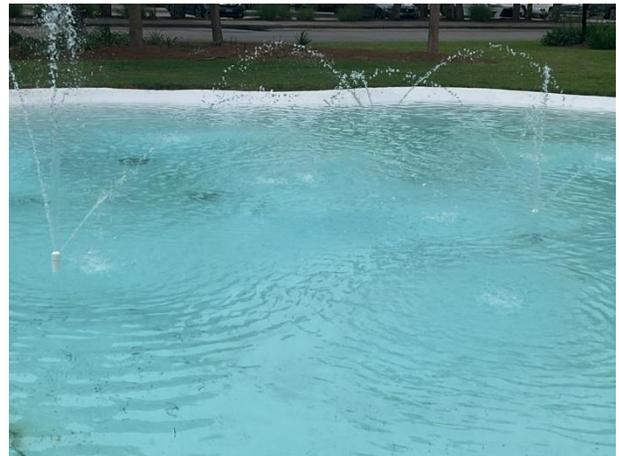
Condition: Good to fair overall

Fountain overview

History: Representatives of the Association inform us that the Association applies a paint finish to the fountain on an as-needed basis. The date of the last paint finish is unknown at this time. We recommend the Association install a plaster finish at the fountain.

Component Detail Notes: Finish replacement provides the opportunity to inspect the fountain structure and to allow for partial repairs of the underlying concrete surfaces as needed. To maintain the integrity of the fountain structure, we recommend the Association budget for the following:

- Removal and replacement of the finish
- Replacement of fountains as needed
- Concrete structure repairs as needed

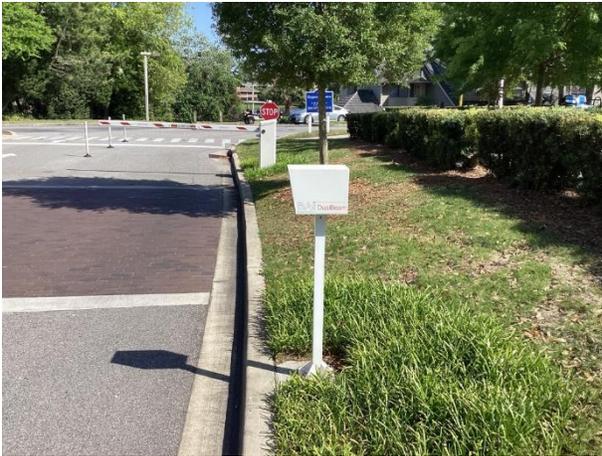
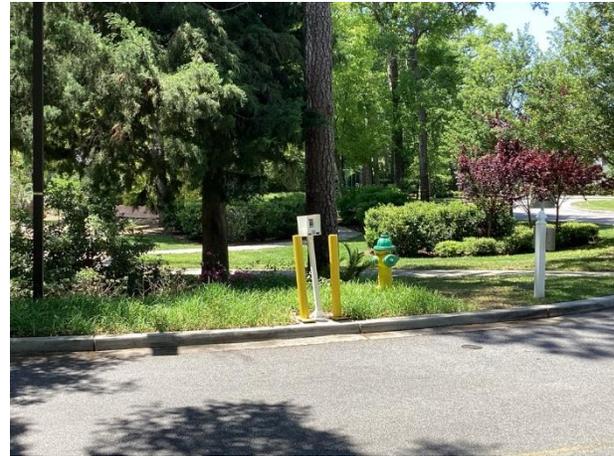
Condition: Reported satisfactory

Gate entry barcode scanner

Preventative Maintenance Notes: We recommend the Association obtain and adhere to the manufacturer's recommended maintenance plan. The required preventative maintenance may vary in frequency and scope based on the unit's age, operational condition, or changes in technology. We note the following select recommended preventative maintenance activities to maximize the remaining useful life:

- Monthly:
 - Inspect panel for damage and ensure the panel is mounted securely, tighten or replace any loose or damaged fasteners.
 - Inspect panel for proper operation of buttons, displays, microphone and speaker.
- Annually:
 - Check power connections, and if applicable, functionality of battery power supply systems

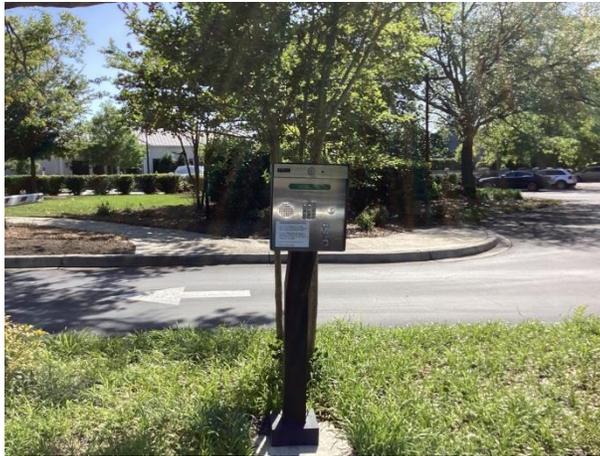
Condition: Reported satisfactory

Canterbury gate entry system

Preventative Maintenance Notes: We recommend the Association obtain and adhere to the manufacturer's recommended maintenance plan. The required preventative maintenance may vary in frequency and scope based on the unit's age, operational condition, or changes in technology. We note the following select recommended preventative maintenance activities to maximize the remaining useful life:

- Monthly:
 - Inspect panel for damage and ensure the panel is mounted securely, tighten or replace any loose or damaged fasteners.
 - Inspect panel for proper operation of buttons, displays, microphone and speaker.
- Annually:
 - Check power connections, and if applicable, functionality of battery power supply systems
