Kingston Plantation Master Association, Inc.

Inspected: May 28, 2025 • Revised on: September 15, 2025
Myrtle Beach, SC

RESERVE STUDY

Kingston Plantation

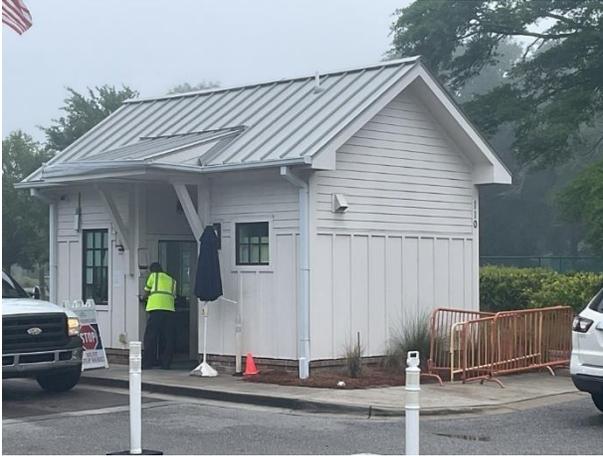
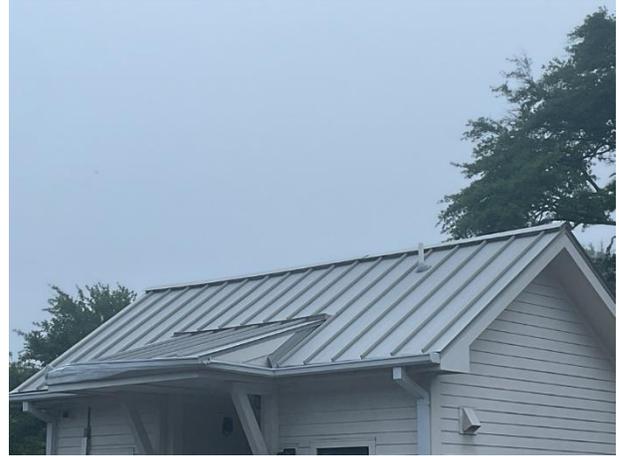
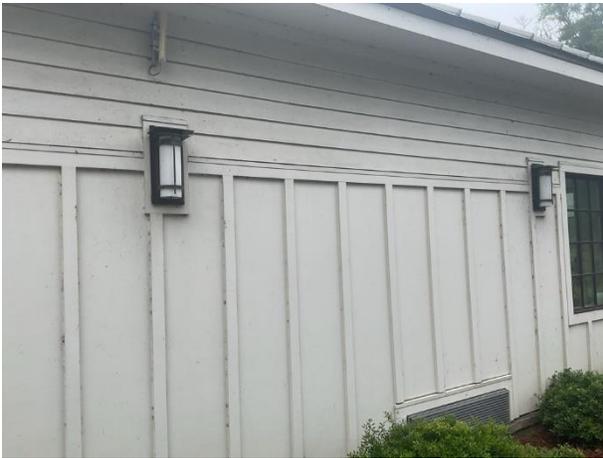
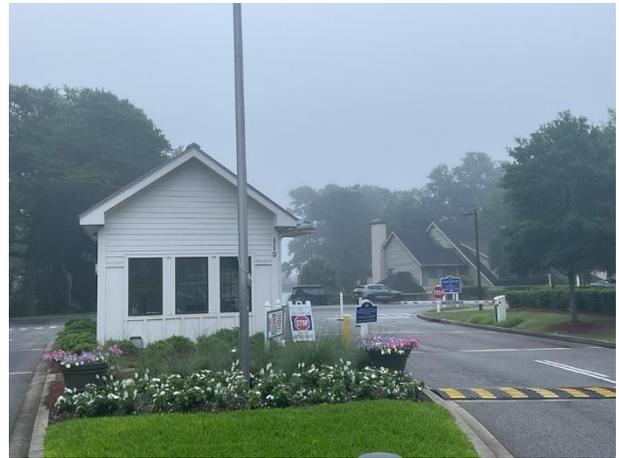
Condition: The gate house elements are in good overall condition.

Gatehouse exterior overview

Gate house metal roof

Gate house exterior light fixtures

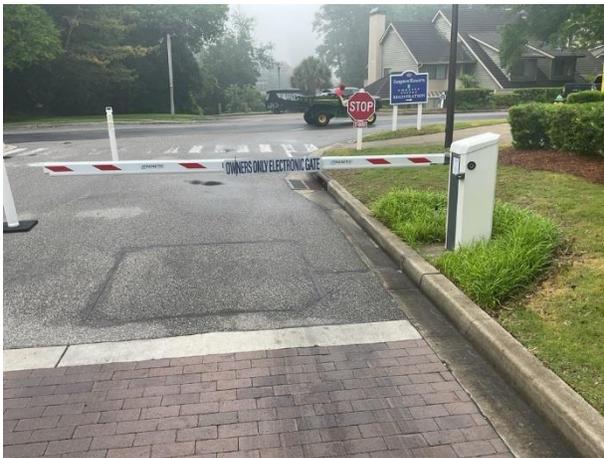
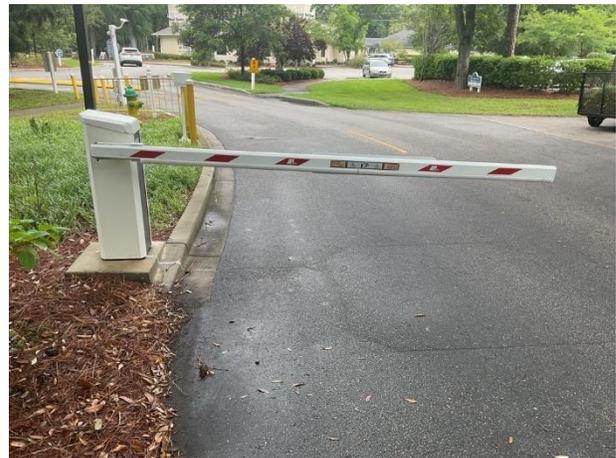
Condition: Reported in satisfactory operational conditions

Lift arm operator

Preventative Maintenance Notes: The status of preventative maintenance was unavailable to us during our inspection. We recommend the Association obtain and adhere to the manufacturer's recommended maintenance plan. We also recommend the Association maintain a maintenance contract with a qualified professional. The required

preventative maintenance may vary in frequency and scope based on the unit's age, operational condition, or changes in technology. We note the following select recommended preventative maintenance activities to maximize the remaining useful life:

- Semi-annually:
 - Ensure gates operate freely
 - Inspect for any wear, rust and loose fasteners
 - Inspect and correct tension in belts and chains, and lubricate hinges and chains as necessary
 - Check alignment of pulleys
 - Check for no oil leakage at the gear box
 - Check the control board for water damage. Clean and remove insects and other pests as needed.
 - Check all wiring for insulation damage and loose connections. If applicable, check functionality of battery power supply systems

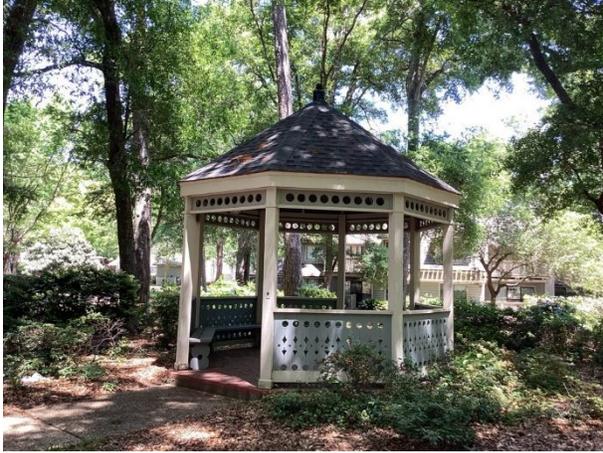
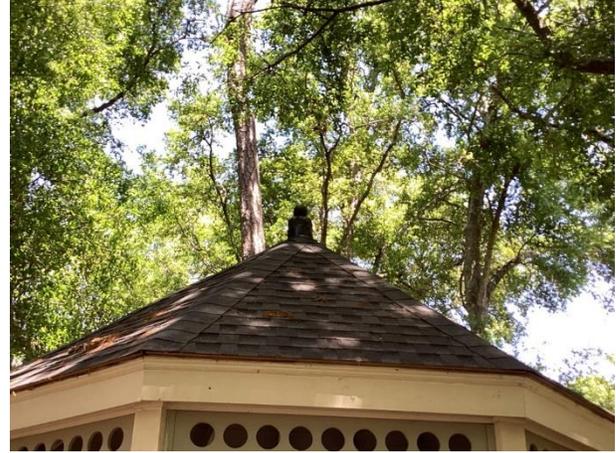
Condition: Good overall

Gazebo overview

Shingle roof

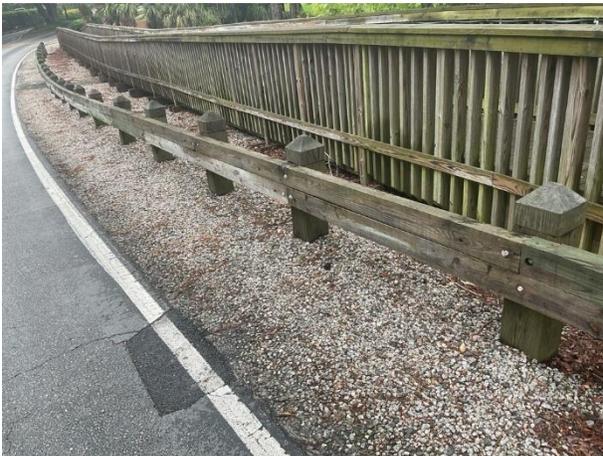
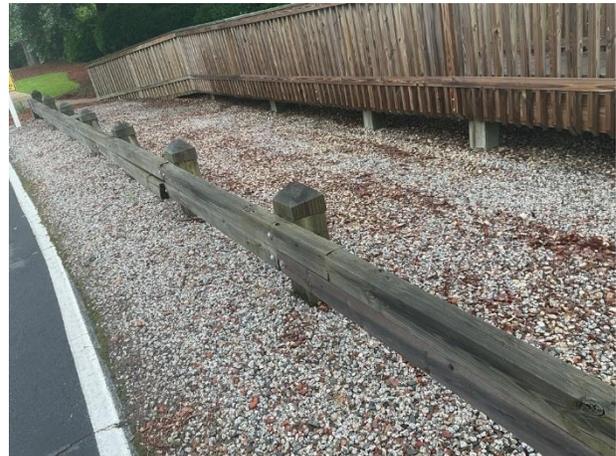
Condition: Good to fair overall

Plantation Lakes Drive guardrail

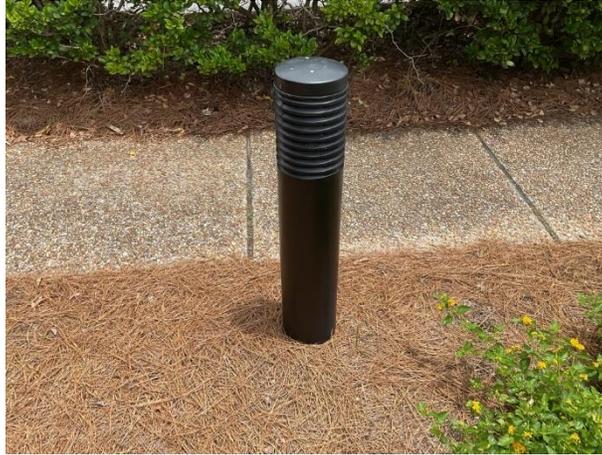
Condition: Fair overall.

Bollard light fixtures

Preventative Maintenance Notes: We note the following select recommended preventative maintenance activities to maximize the remaining useful life:

- As-needed:
 - Inspect and repair broken or dislodged fixtures, and leaning or damaged poles
 - Replaced burned out bulbs as needed

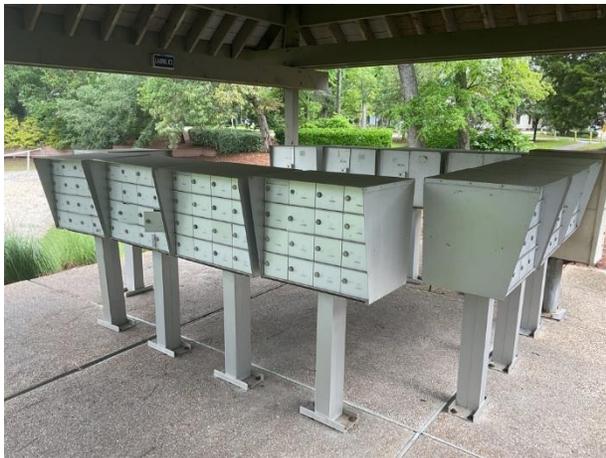
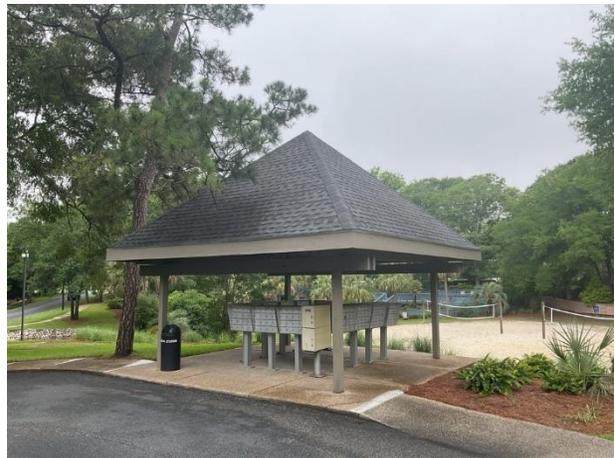
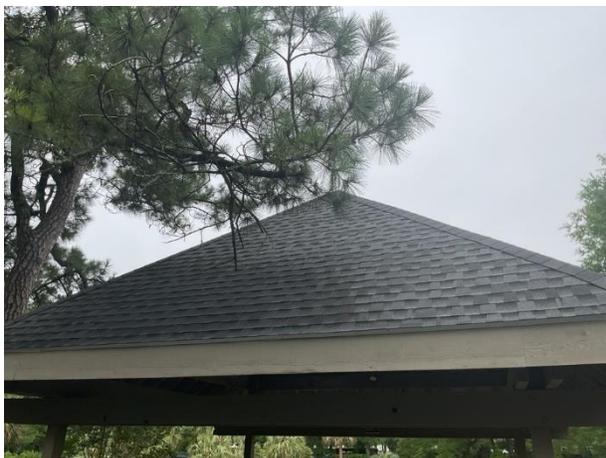
Condition: The roof and paint finishes are in good overall condition. The mailbox stations are in fair to poor condition. We note rust formation and deterioration at the undersides of the mailbox stations.

Mailbox stations

Gazebo overview

Gazebo roof

- Replacement of the asphalt shingle roof assembly
- Paint finishes and structure repairs to the wood structure
- Replacement of the light fixtures
- Partial replacement of the concrete pad

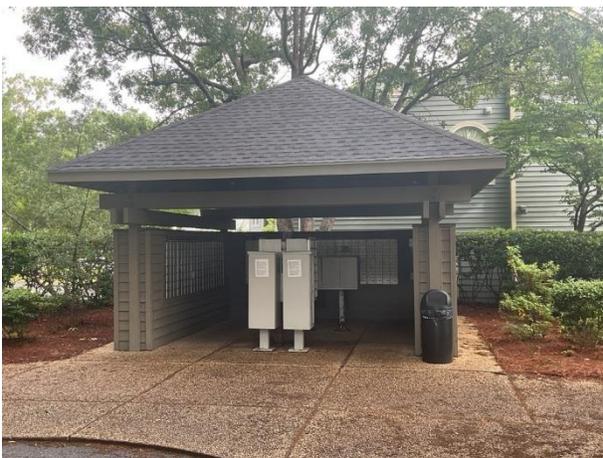
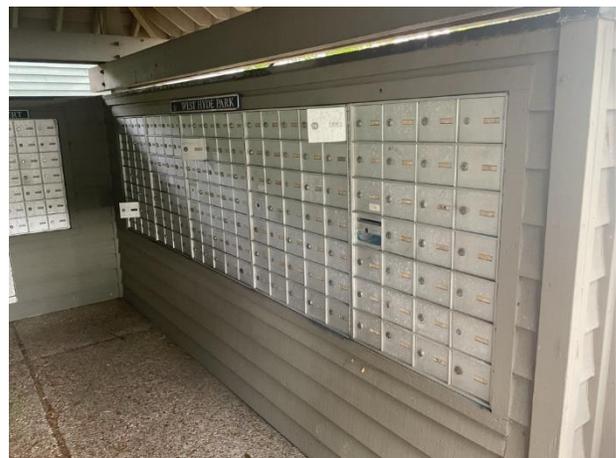
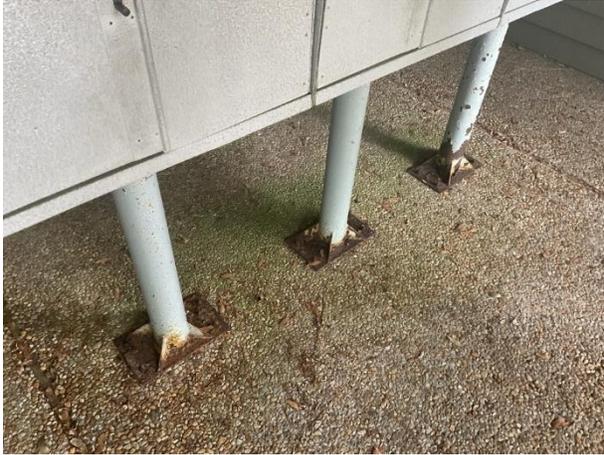
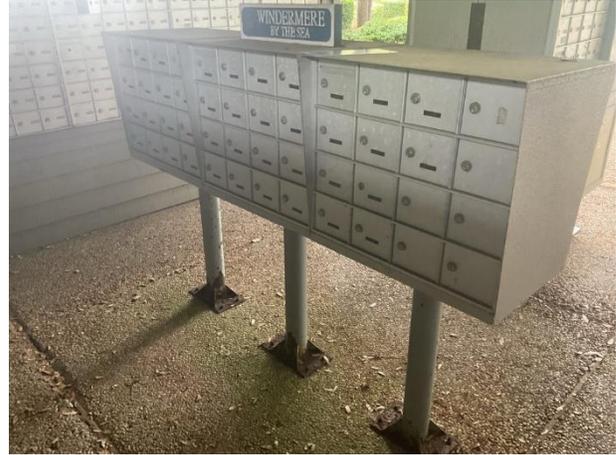
Condition: The roof and paint finishes are in good overall condition. The mailbox stations are in fair to poor condition. We note finish deterioration and rust at the mailbox stations.

West Hyde Park mailbox kiosk

Mailbox stations

Mailbox station rust and finish deterioration

- Replacement of the asphalt shingle roof assembly
- Paint finishes and structure repairs to the wood structure, including partial replacements of wood siding
- Replacement of the light fixtures
- Replacement of the signage
- Partial replacement of the concrete pad

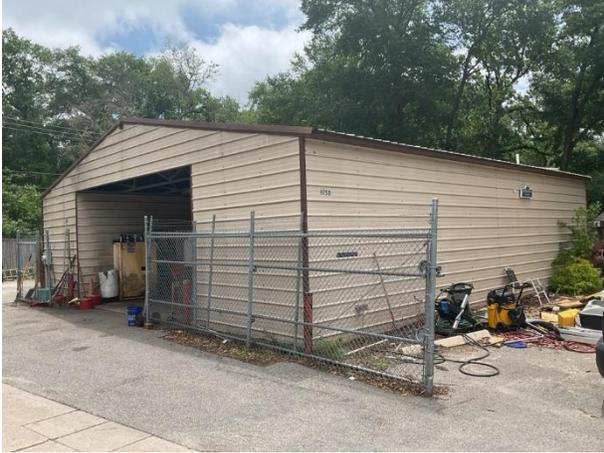
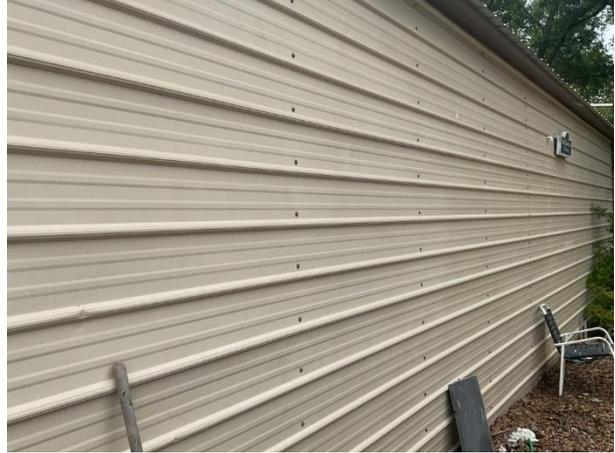
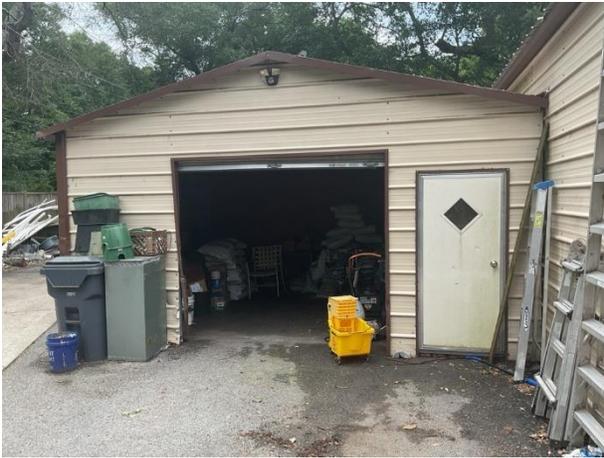
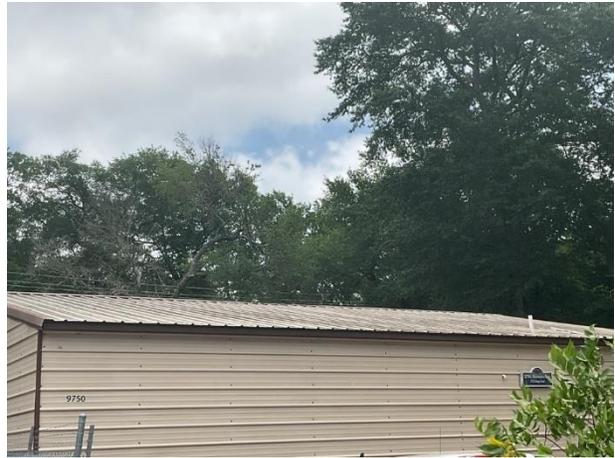
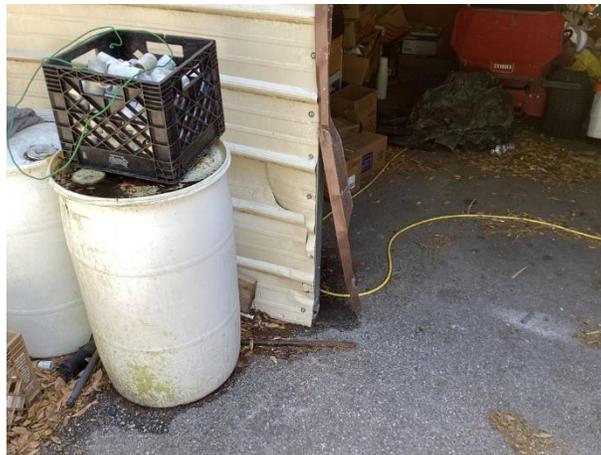
Condition: Fair overall with damaged siding evident

Maintenance building overview

Maintenance building siding overview

Maintenance building roof overview

Damaged siding

- Replacement of the garage doors
- Replacement of the exterior doors

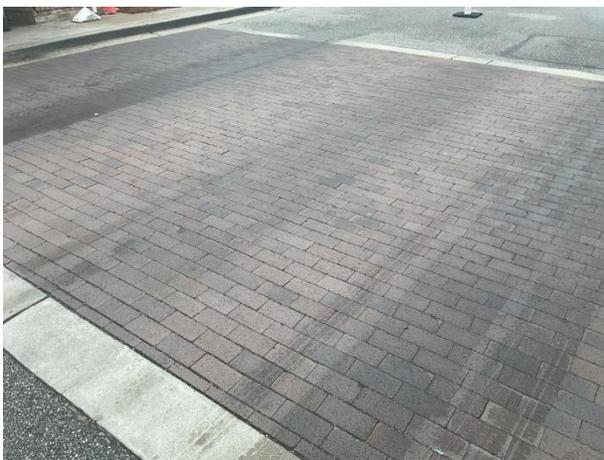
Condition: Good to fair overall with isolated paver spalls evident

Masonry pavers at entrance overview

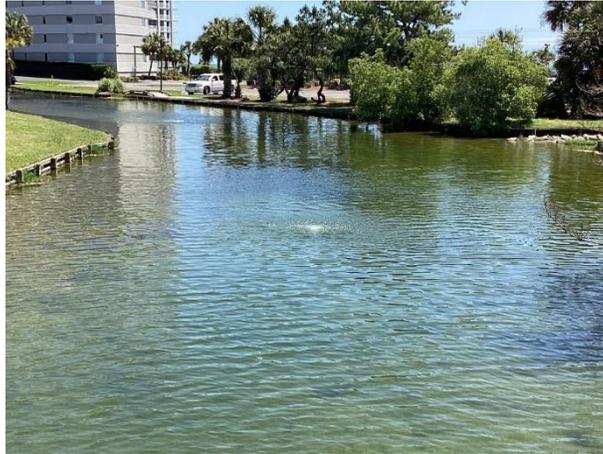
Condition: Reported satisfactory without operational deficiencies

Bubbler aerator

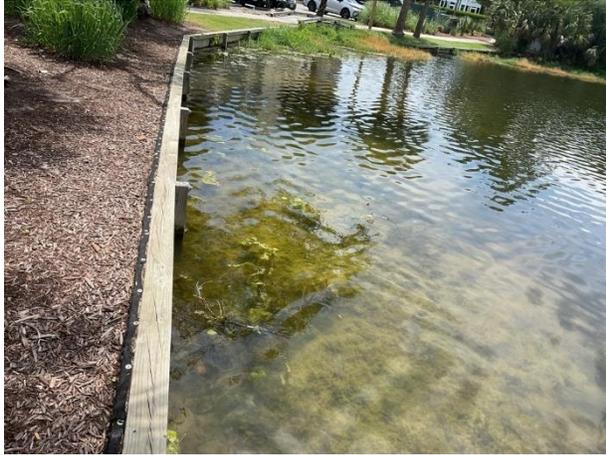
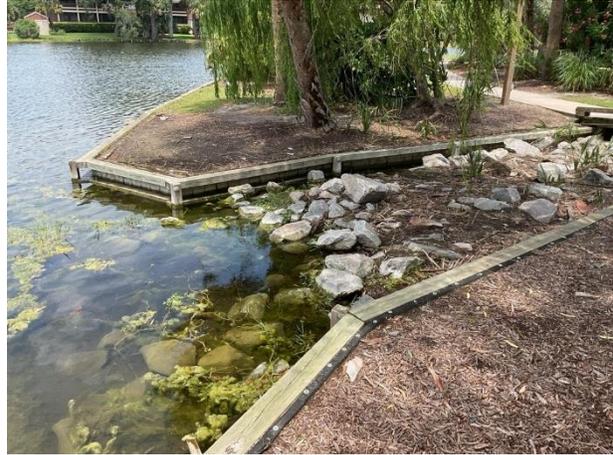
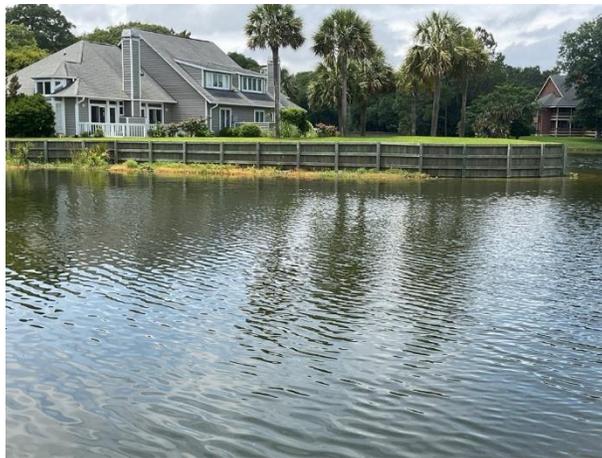
Conditions: Fair overall.

Wood bulkhead

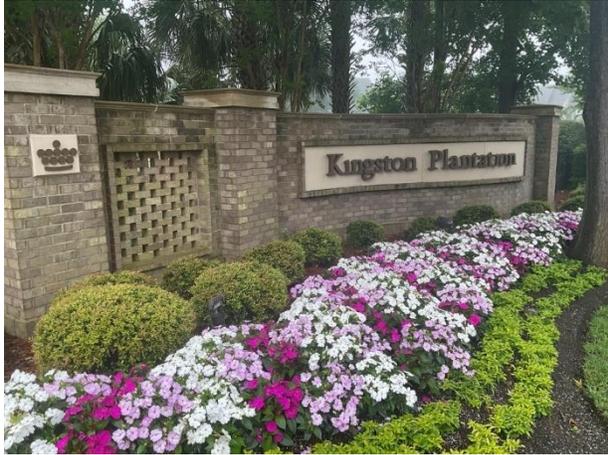
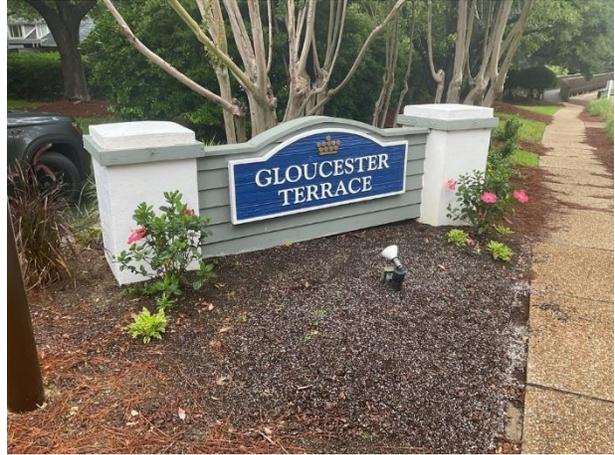
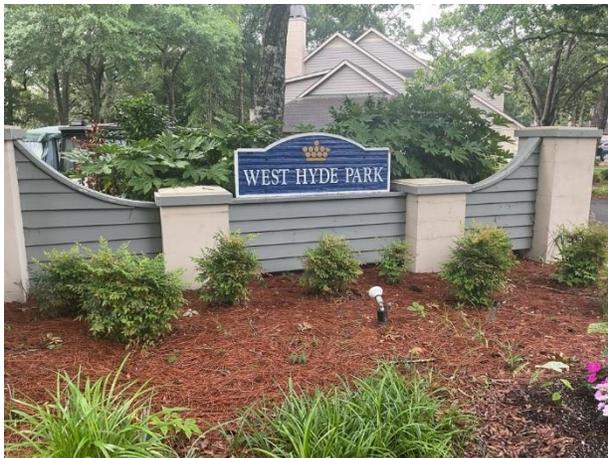
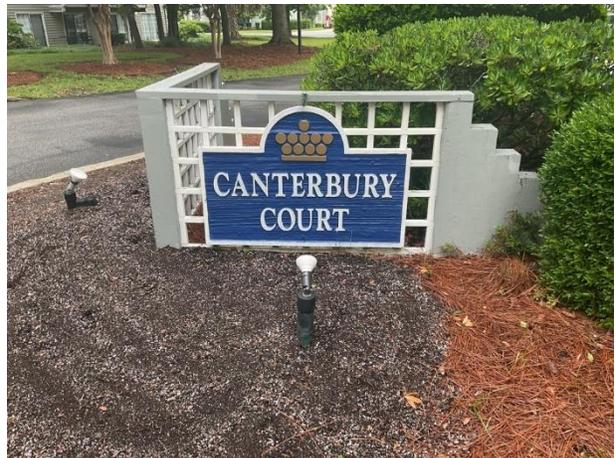
Condition: Fair overall. We note isolated cracks evident.

Entrance monument

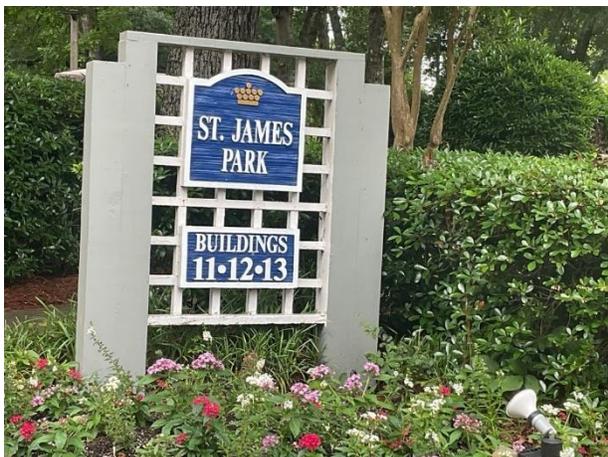
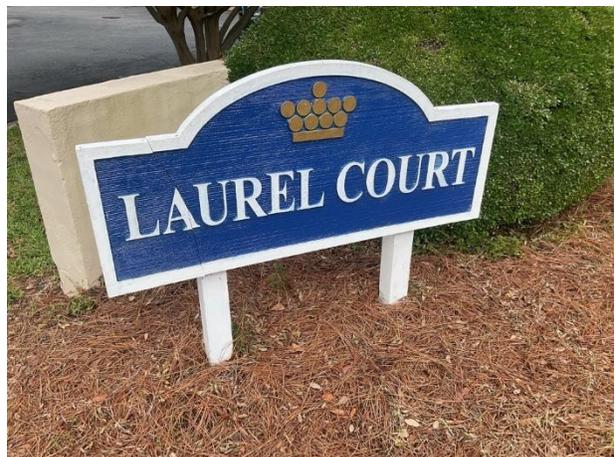
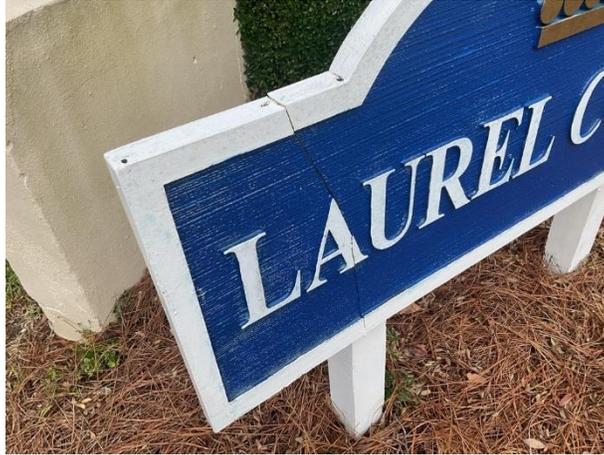
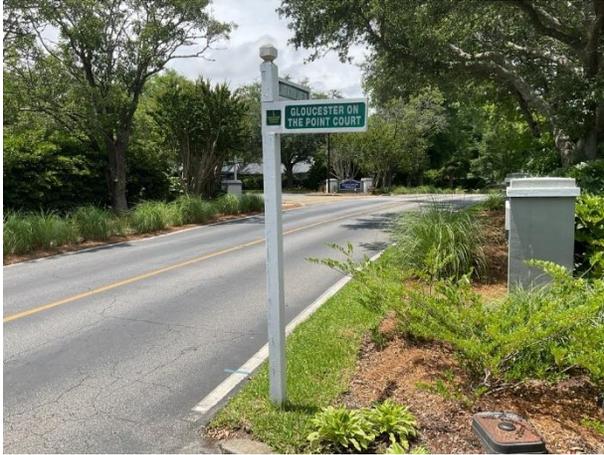
Entrance monument

Sign cracks

Condition: Fair overall

Expenditure Detail Notes: Expenditure timing and costs are depicted in the **Reserve Expenditures** table in Section 3. Our cost for renovation includes repairs to the masonry and replacement of the remaining components listed above.

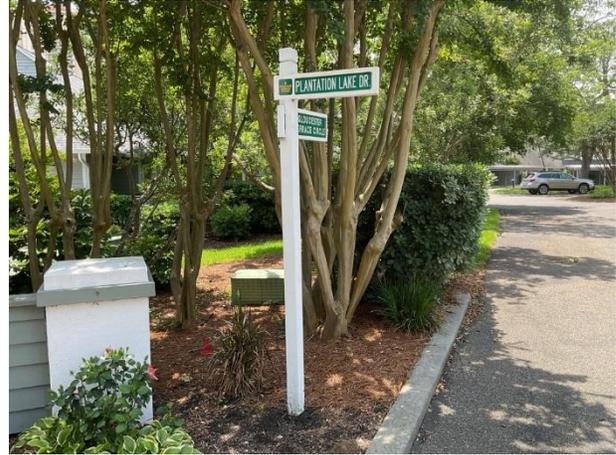
Traffic management signage

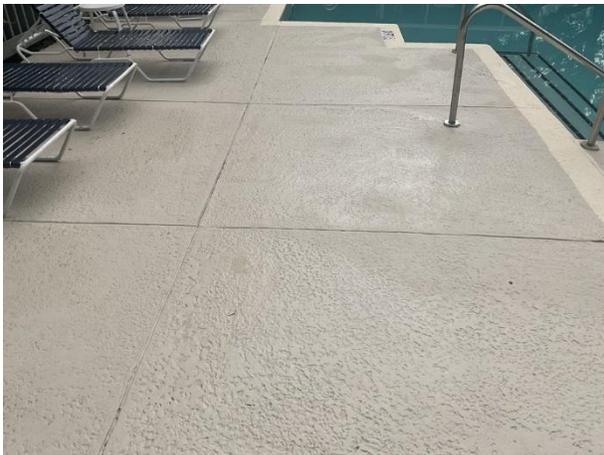
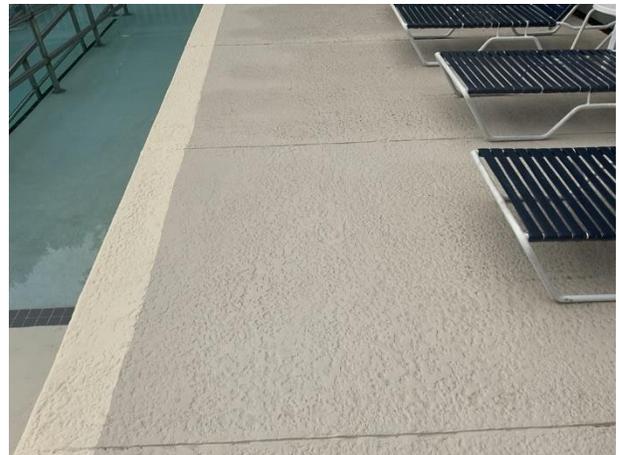
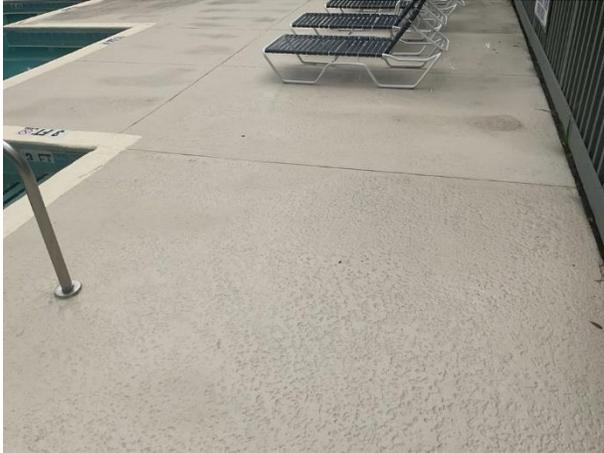
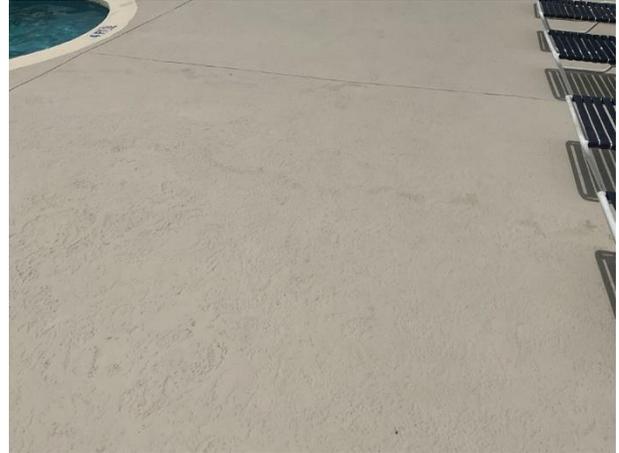
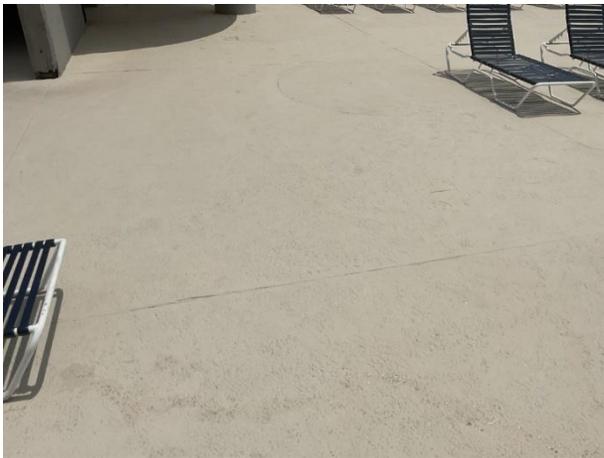
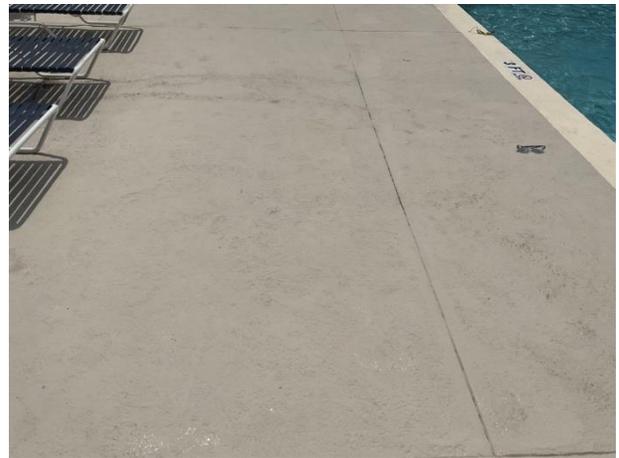
Condition: Good overall with isolated stains evident

Concrete pool deck overview at St. James Park

Concrete pool deck overview at the Beach Pool

Expenditure Detail Notes: Expenditure timing and costs are depicted in the **Reserve Expenditures** table in Section 3. We recommend the Association budget for the following per event:

- Selective cut out and replacements of up to ten percent (10%) of concrete
- Crack repairs as needed
- Mortar joint repairs
- Caulk replacement
- Coating replacement

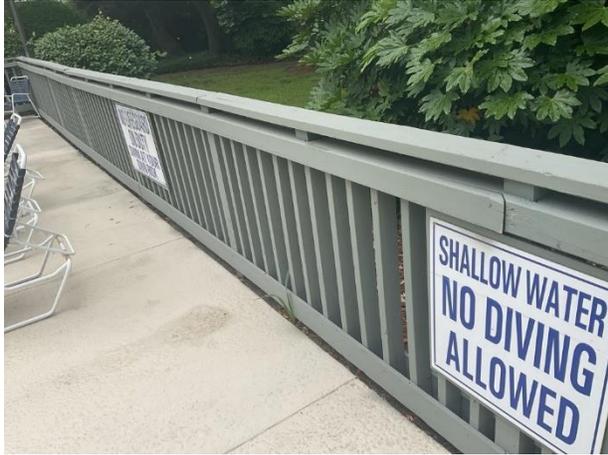
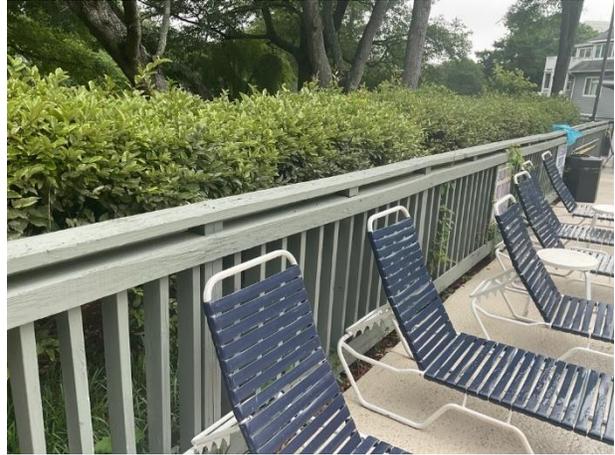
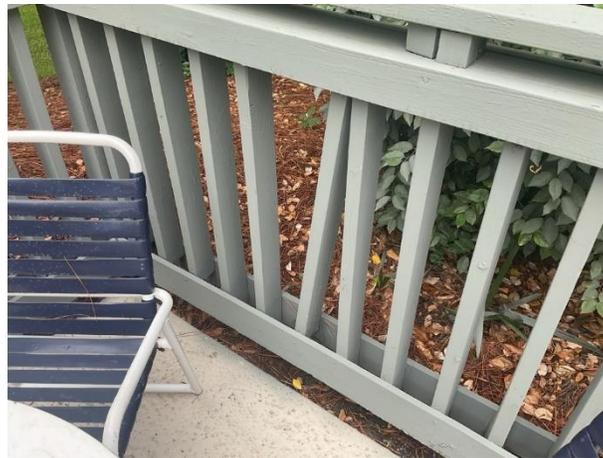
Condition: Fair overall condition with isolated dislodged pickets evident

Wood pool fence

Dislodged picket

Component Detail Notes: The Association should anticipate periodic partial replacements due to the non-uniform nature of wood deterioration. Along with these partial replacements, the Association should apply periodic paint applications as needed and fund these activities through the operating budget.

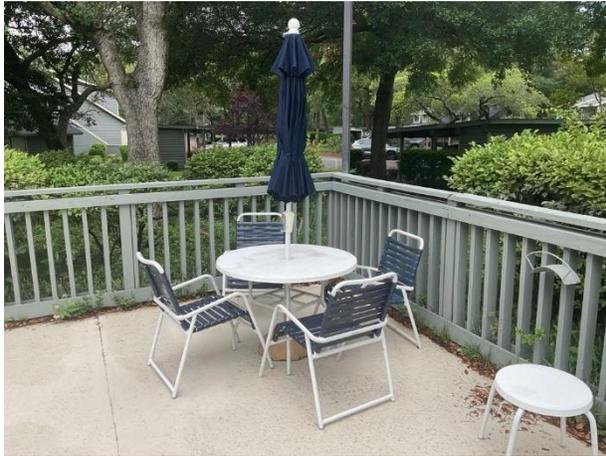
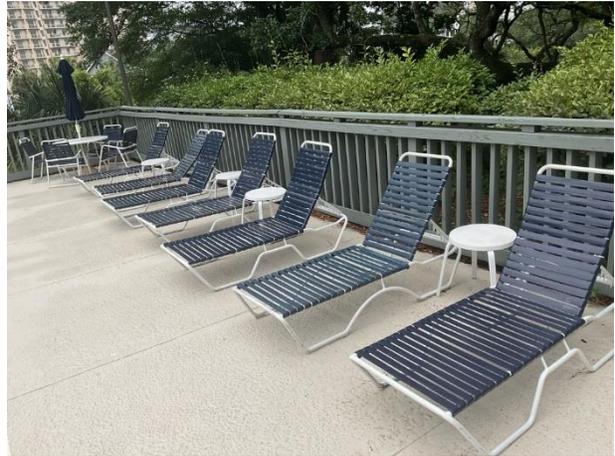
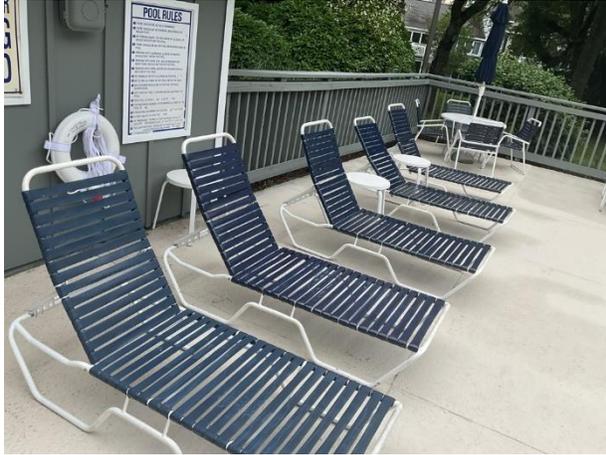
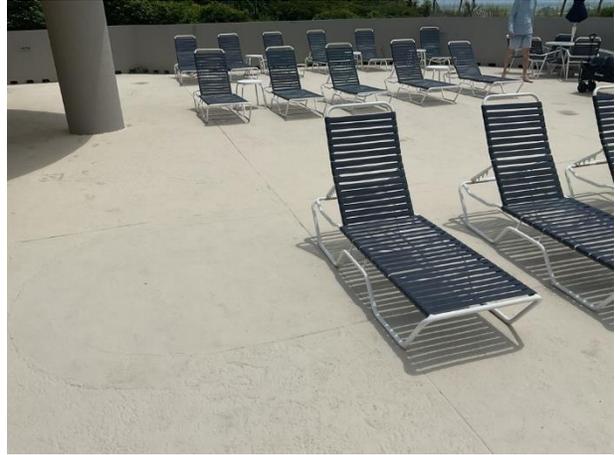
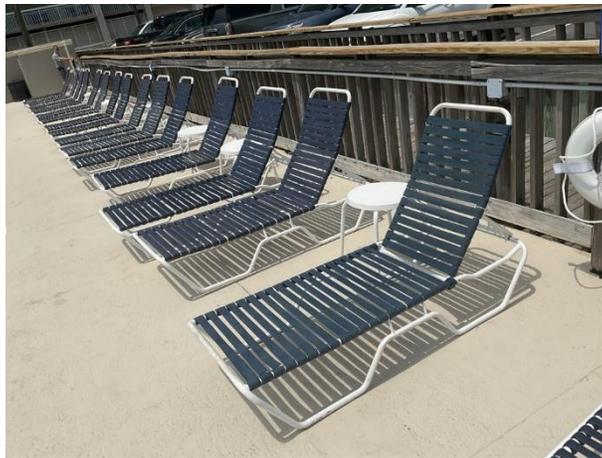
Condition: Good to fair overall

St. James Pool furniture overview

Beach Pool furniture overview

Expenditure Detail Notes: Expenditure timing and costs are depicted in the **Reserve Expenditures** table in Section 3. We recommend interim re-strapping, refinishing, cushion replacements, reupholstering and other repairs to the furniture as normal maintenance to maximize its useful life.

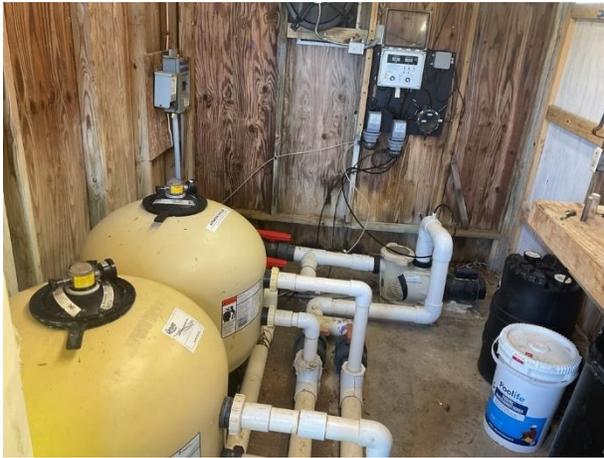
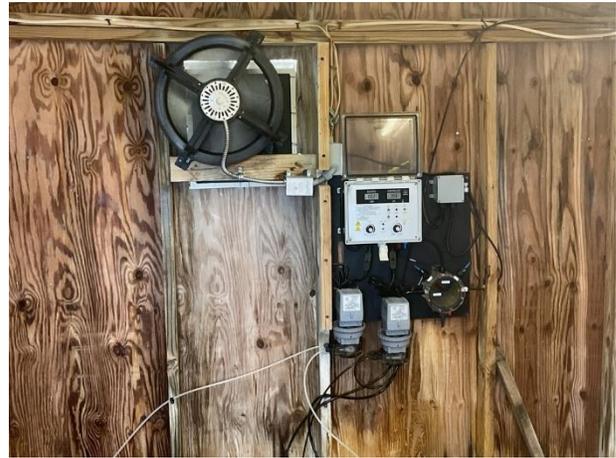
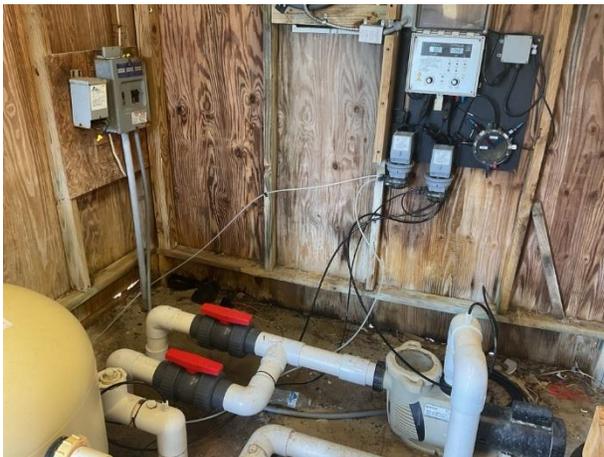
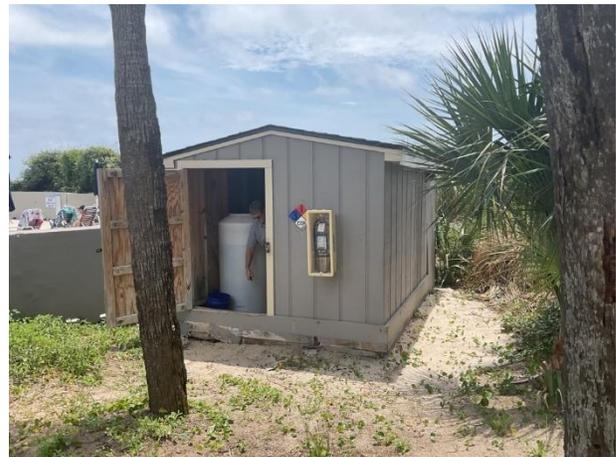
Condition: Reported satisfactory overall

Pool mechanical equipment

Pool mechanical equipment enclosure

Expenditure Detail Notes: Expenditure timing and costs are depicted in the *Reserve Expenditures* table in Section 3. Failure of the pool mechanical equipment as a single event is unlikely. Therefore, we include replacement of up to fifty percent (50%) of the equipment per event. We consider interim replacement of motors and minor repairs as normal maintenance.

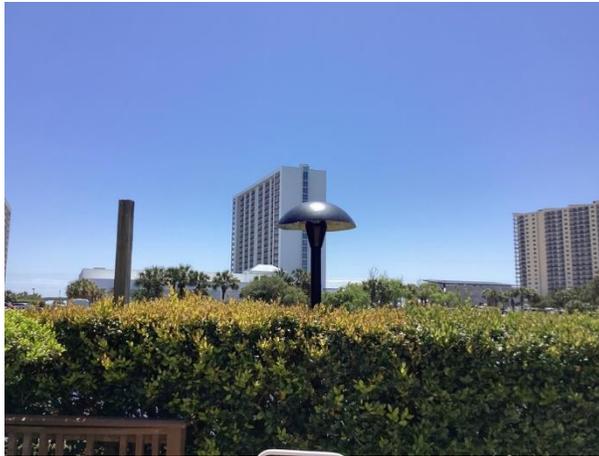
Condition: Fair overall.

Laurel Court pool light poles and fixtures

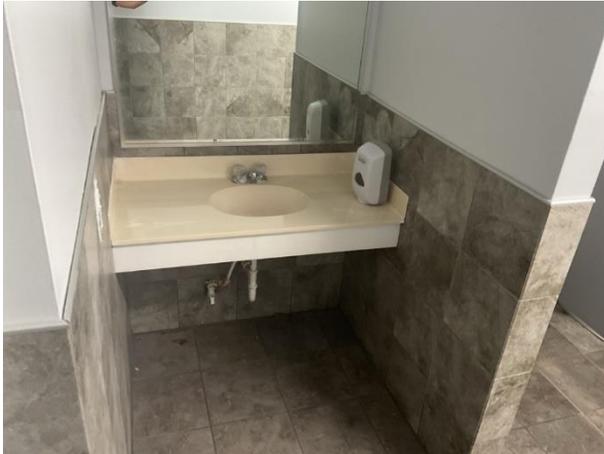
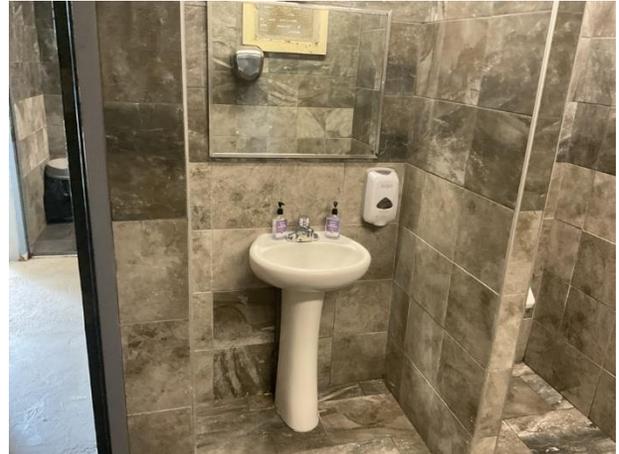
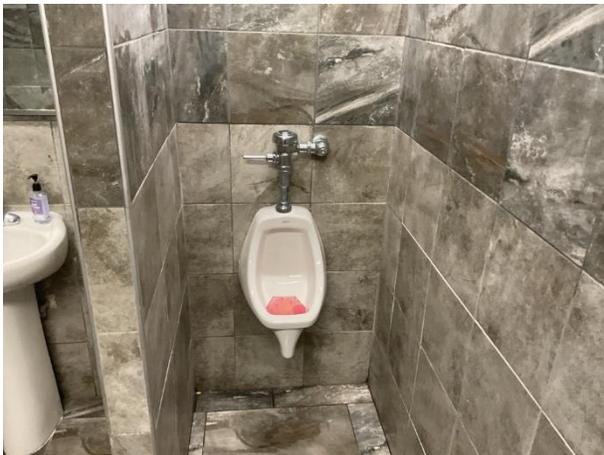
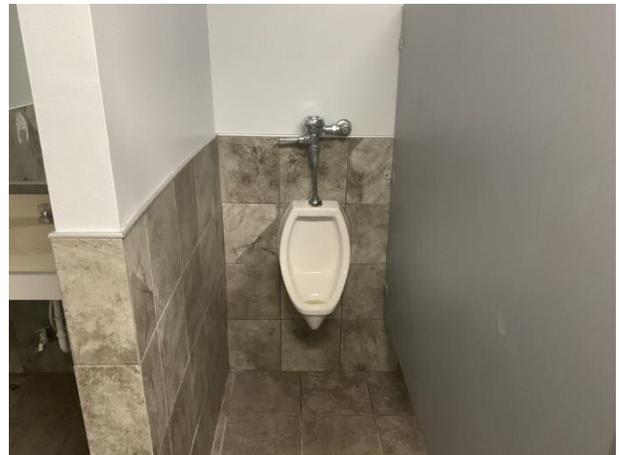
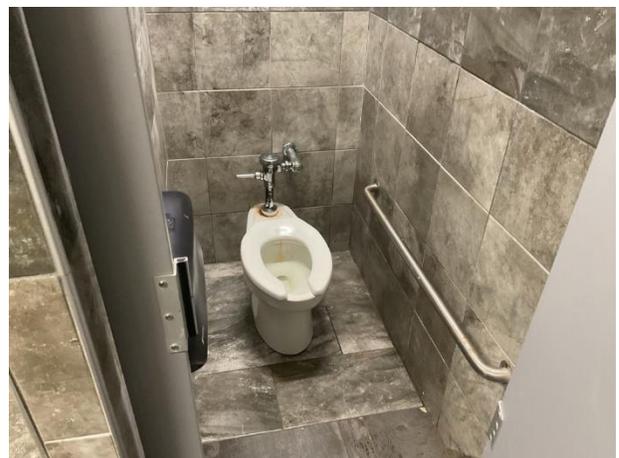
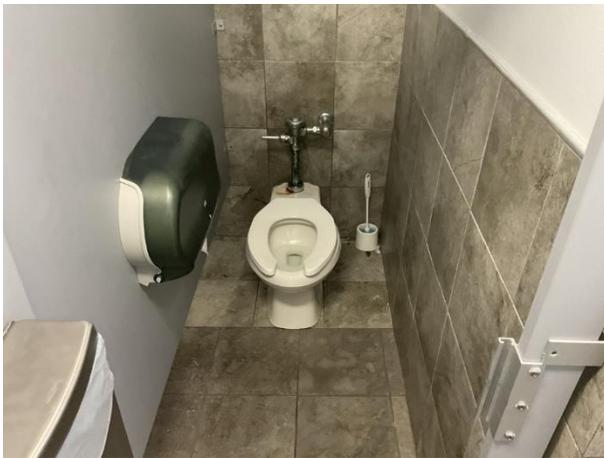
St. James Pool restroom overview

Beach Pool restroom overview

St. James Pool rest room overview

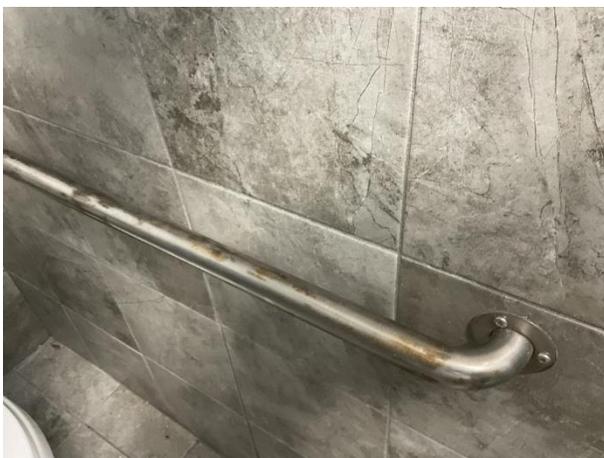
Condition: Good to fair overall with rust evident at the exhaust fan, toiles, and metal bar

St. James Pool restroom rust

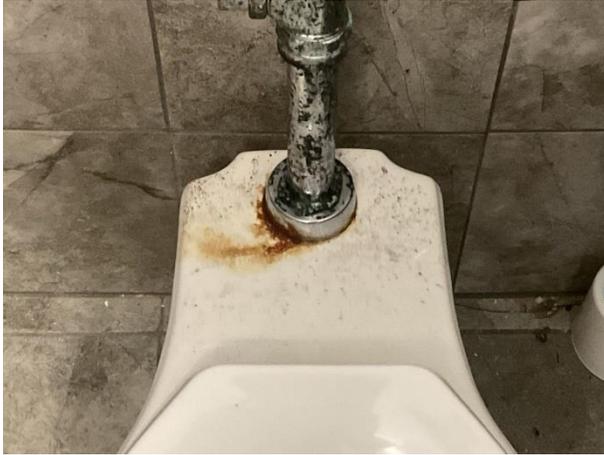
St. James Pool restroom toilet rust

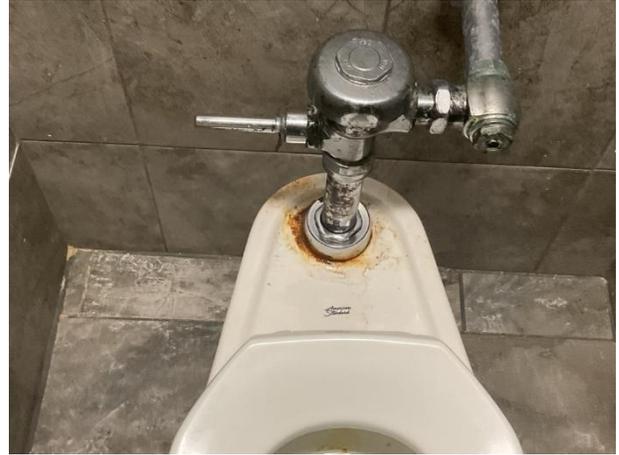
Beach Pool restroom toilet rust

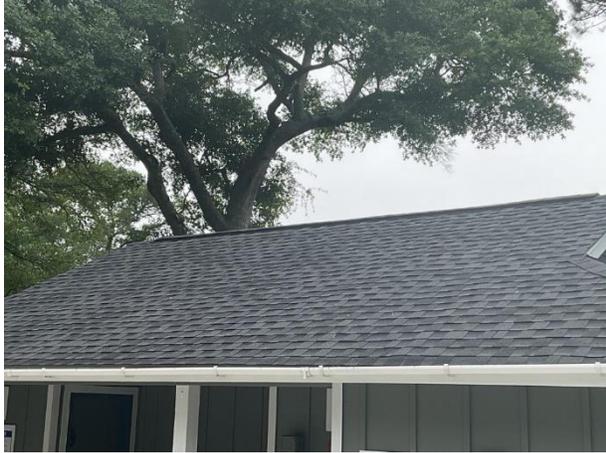
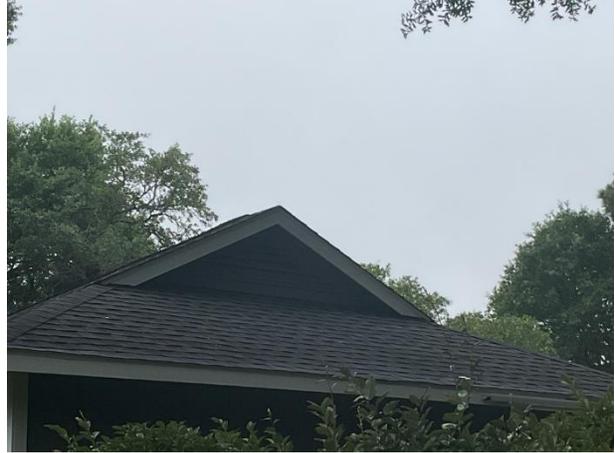
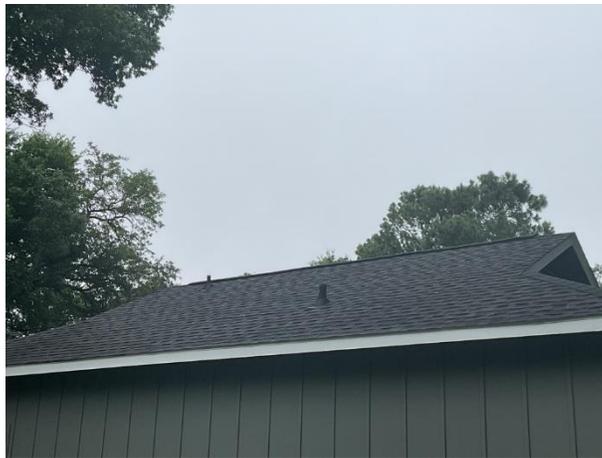
Condition: Good overall with no visible deterioration evident from our visual inspection from the ground. Management do not report a history of leaks.

Roof overview

The Association should plan to coordinate the replacement of gutters and downspouts with the adjacent roofs. This will result in the most economical unit price and minimize the possibility of damage to other roof components as compared to separate replacements.

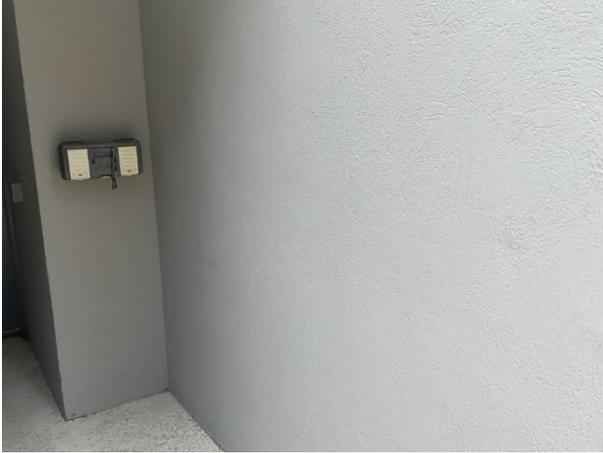
Condition: Fair overall with isolated damage evident

EIFS at pool house overview

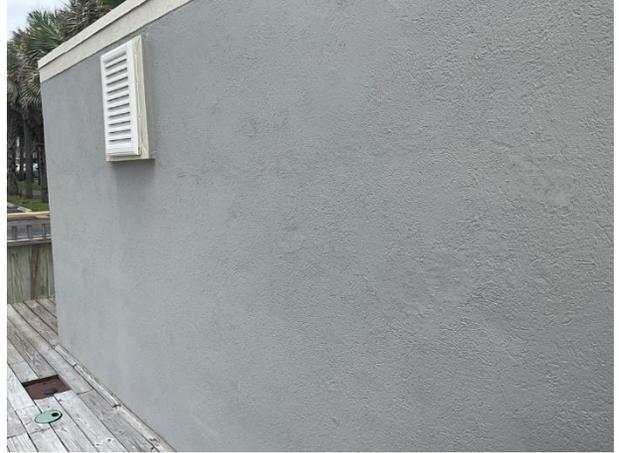
EIFS at pool house overview

Useful Life: EIFS (Exterior Insulation Finish System) wall systems have indefinitely long useful lives with timely repairs and finish applications. We recommend repairs and finish applications every six- to eight-years.

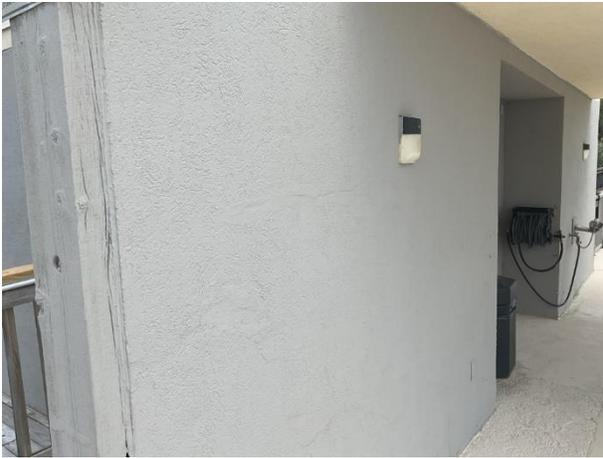
EIFS at pool house overview

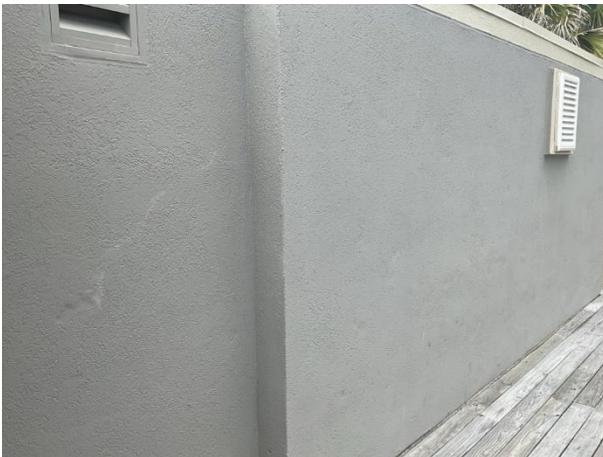
EIFS at pool house overview

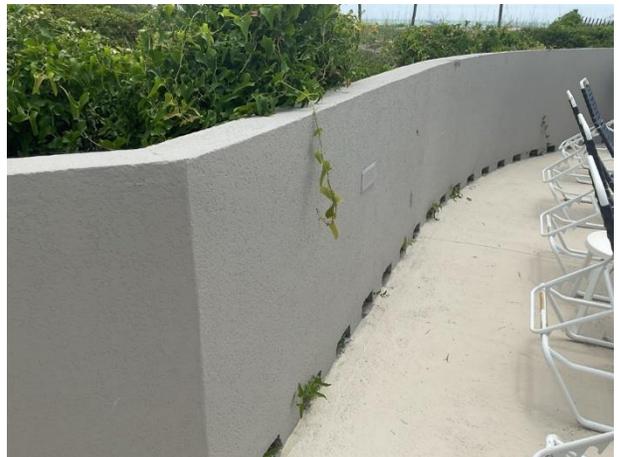
EIFS pool wall overview

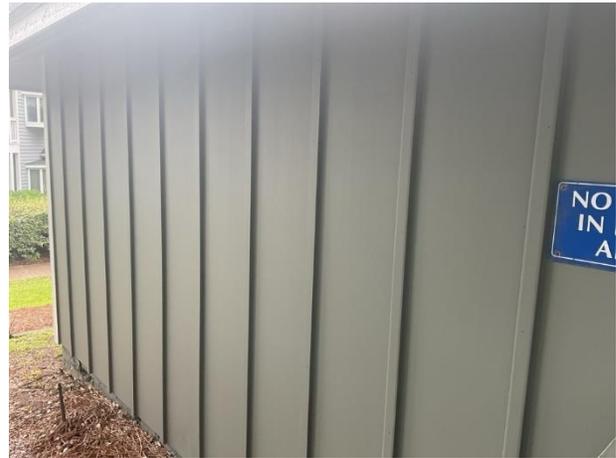
Condition: The siding is in good overall condition and the paint finishes are in good overall condition with no visible deterioration evident.

Fiber cement siding

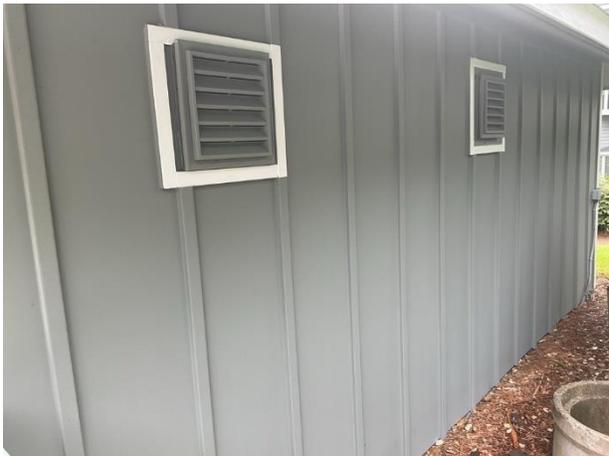
Fiber cement siding

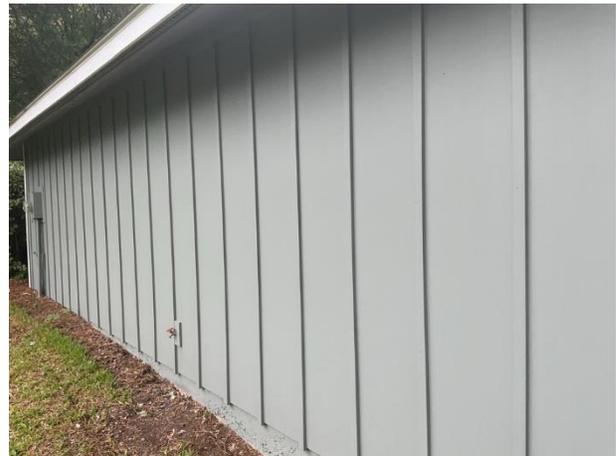
Fiber cement siding
