Kingston Plantation Master Association, Inc.

Inspected: May 28, 2025 • Revised on: September 15, 2025
Myrtle Beach, SC

RESERVE STUDY

Kingston Plantation

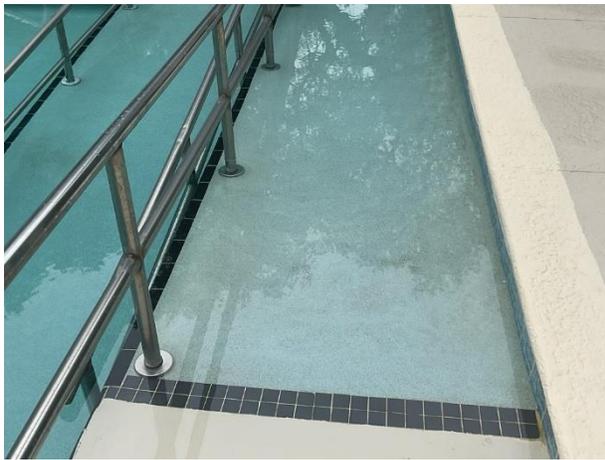
Condition: Good overall

St. James Pool plaster finish with tile perimeter

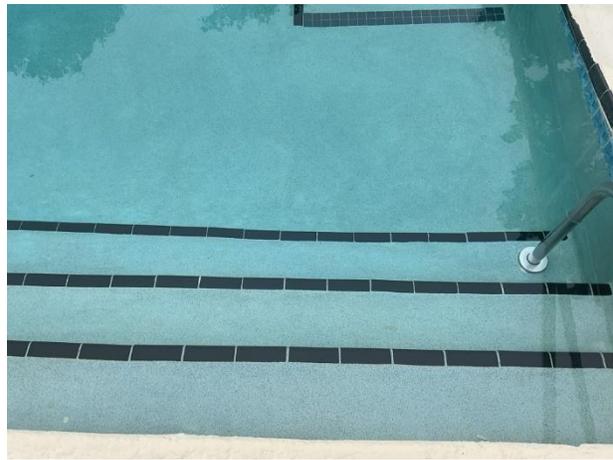
St. James Pool plaster finish with tile perimeter

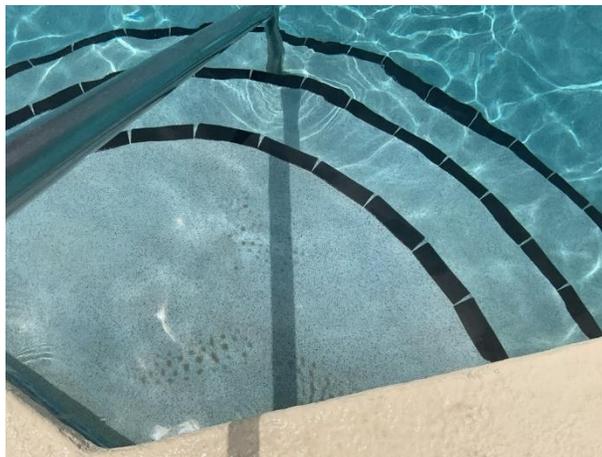
Beach Pool plaster finish with tile perimeter
