# **RESERVE STUDY**

## **Kingston Plantation Master Association, Inc.**

**Myrtle Beach, South Carolina  
February 28, 2020**

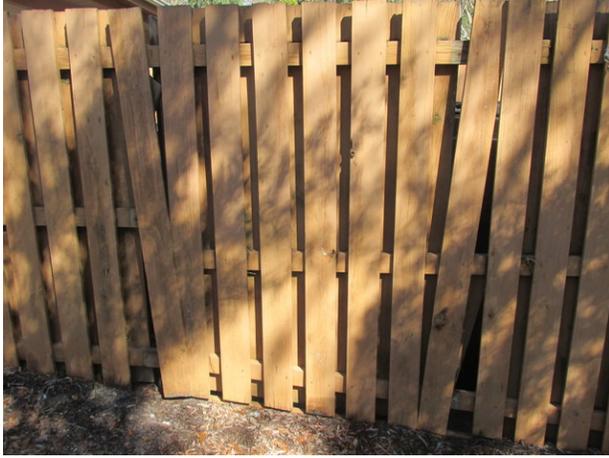
**Condition:** Fair to poor overall condition. We note damaged and detached wood members at the wood fence and damage to the chain link gates.

**Damaged sections of wood fence at trash enclosure**

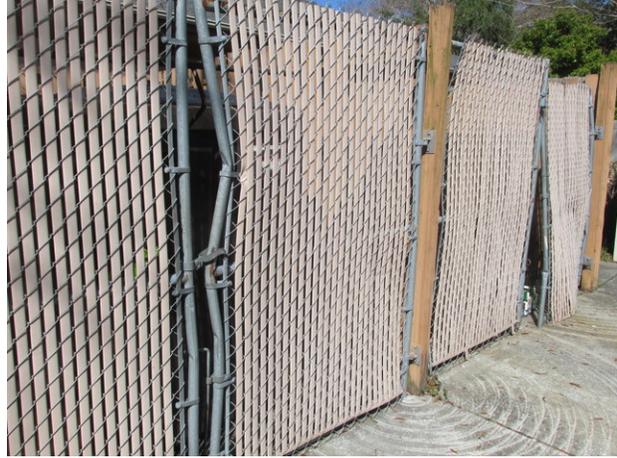
**Damaged chain link gates at trash enclosure**

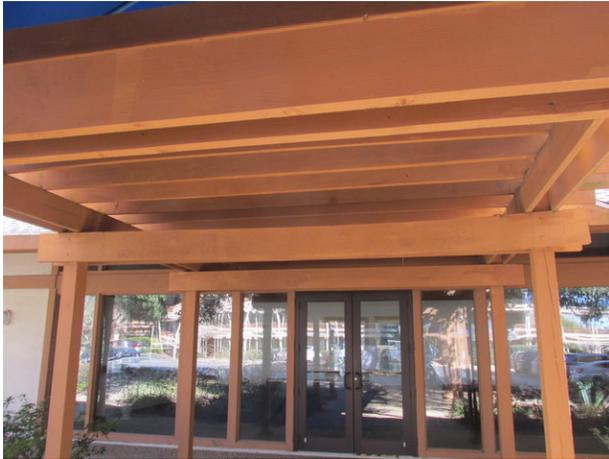
**Condition:** Good to fair overall. We note displaced, deteriorated and deflected wood members. Management informs us that the Association plans to make repairs to the damaged wood components in 2020.

**Deflected wood member at pergola**

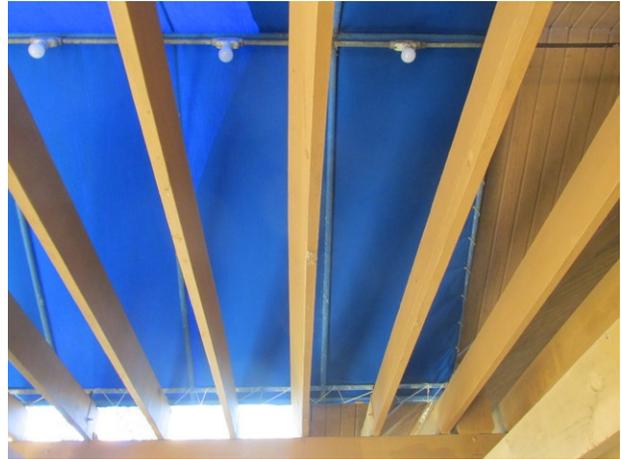
**Displaced wood member at pergola**

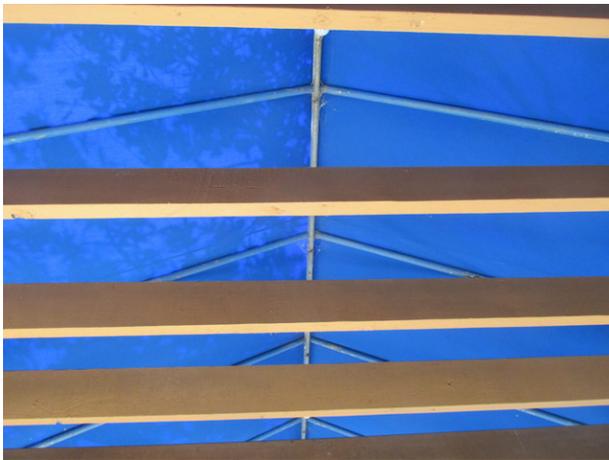
**Displaced wood member at pergola**

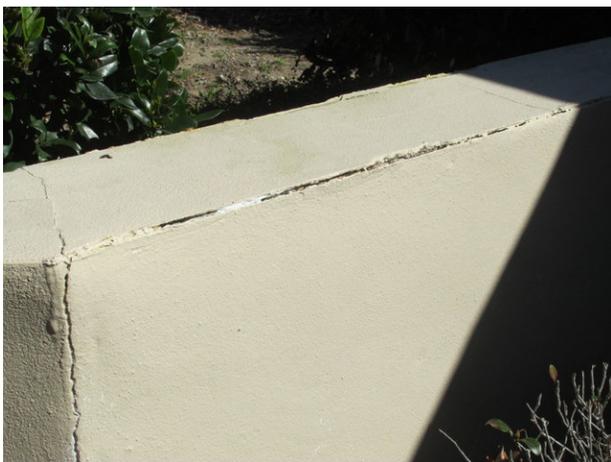
**Condition:** Good overall with the exception of the adjacent stand-alone walls, which are in poor overall condition. We note multiple areas of cracks and poor finishes.

**Cracks at adjacent wall**

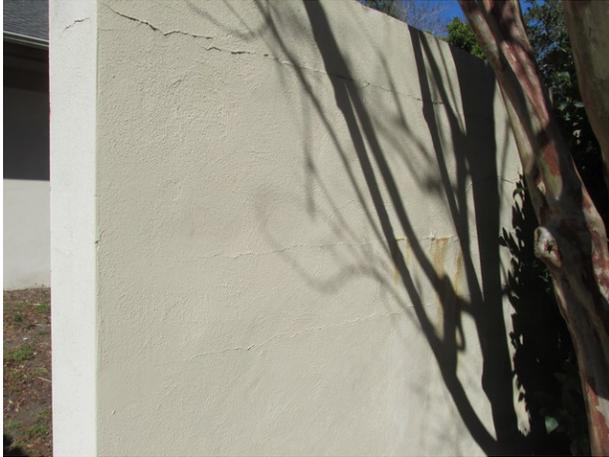
**Cracks and stained paint finishes at adjacent wall**

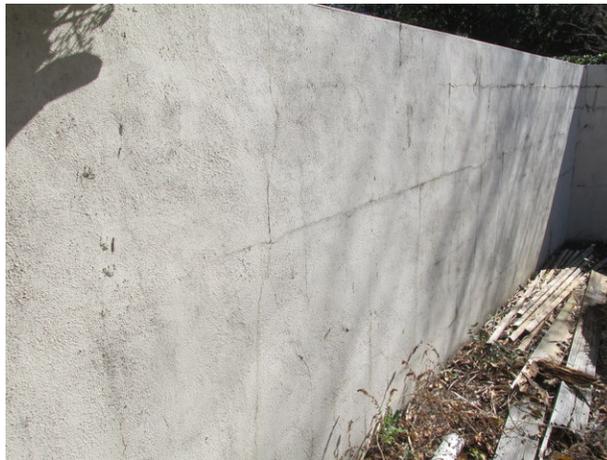
**Cracks and poor finishes at adjacent wall**

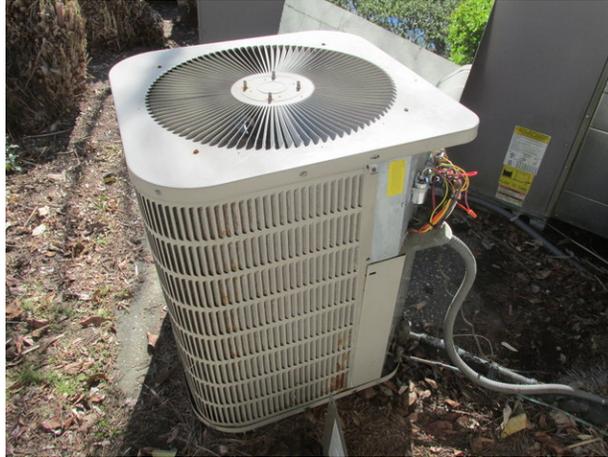
**Condition:** The Association recently replaced the compressor in the condensing unit. The system is reported in satisfactory operational condition.

**Split system condenser**

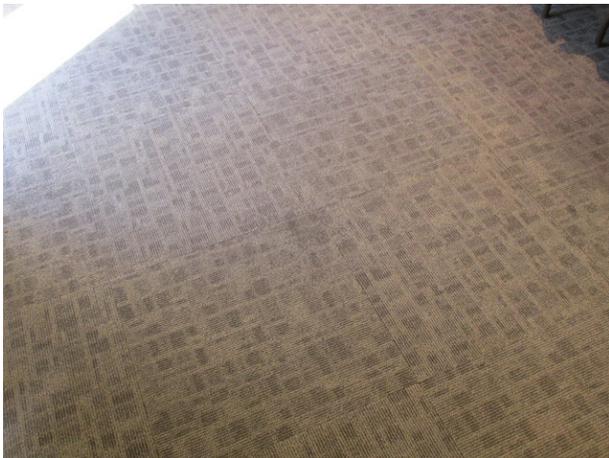
**Condition:** Good to fair overall

**Stained carpet floor coverings**

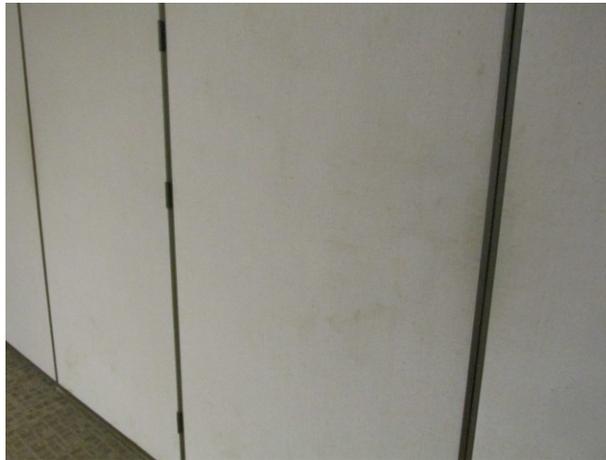
**Condition:** Fair overall. We note stains at the divider.

Stains at acoustical room divider

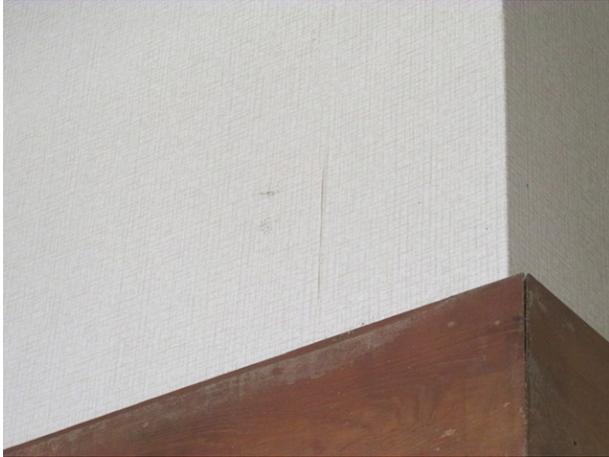
**Condition:** Good to fair overall. We note peeled and rippled areas.

**Stains and ripple at wall coverings**

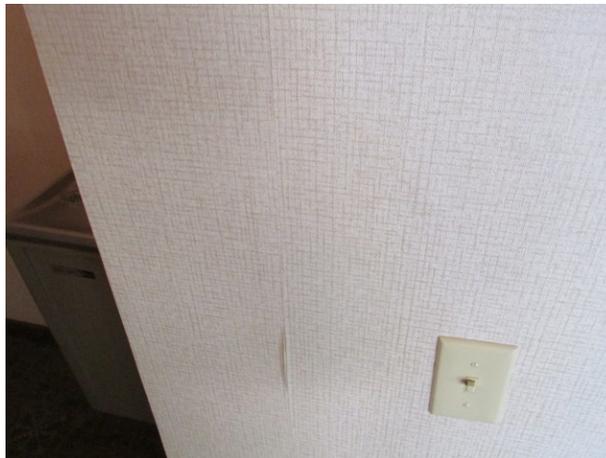
**Ripple at wall coverings**

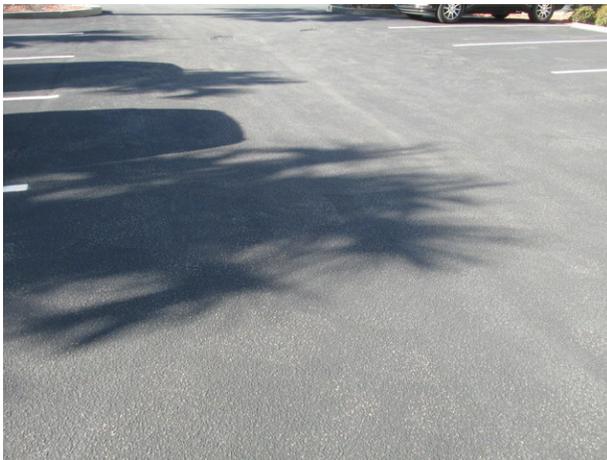
**Condition:** Good to fair overall. We note surface cracks, transverse cracks, isolated alligator cracks and isolated areas of pavement deterioration.

**Typical condition of asphalt pavement**

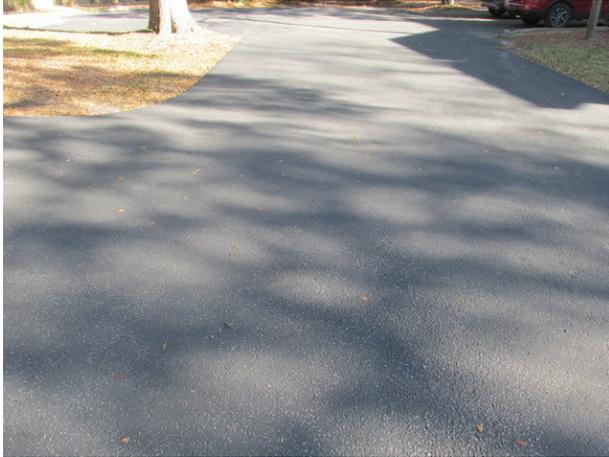
**Typical condition of asphalt pavement**

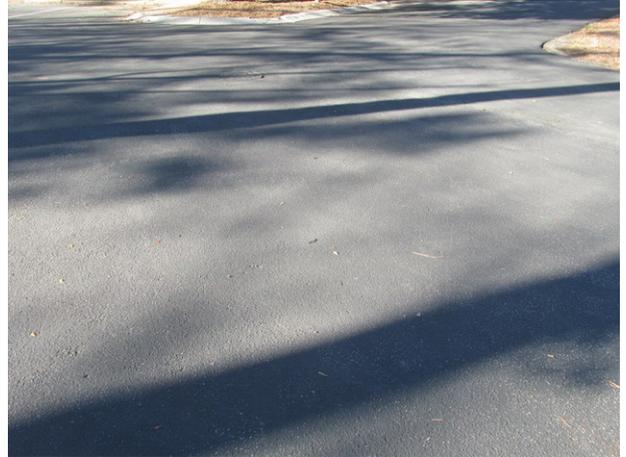
**Typical condition of asphalt pavement**

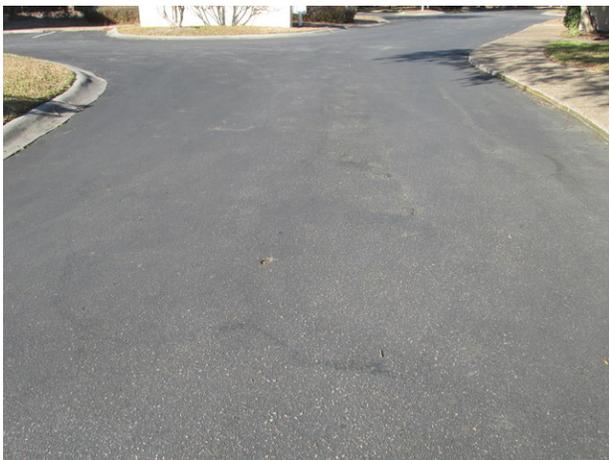
**Typical condition of asphalt pavement**

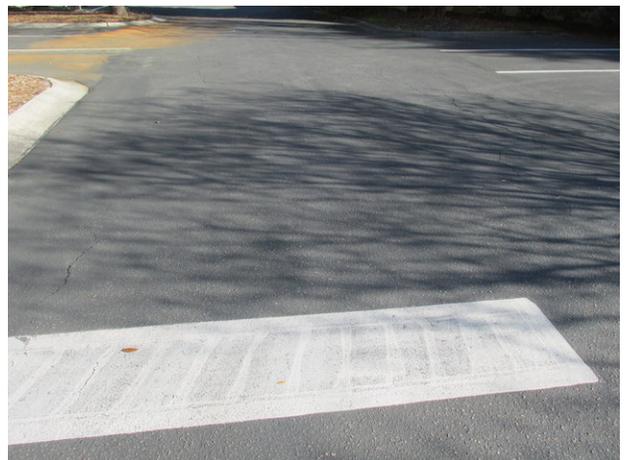
**Typical condition of asphalt pavement**

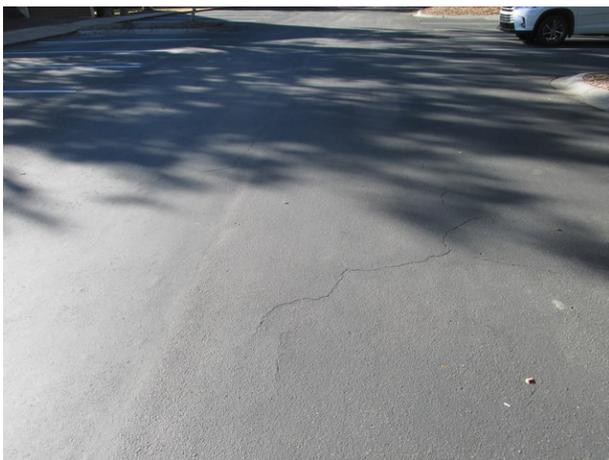
**Typical condition of asphalt pavement**

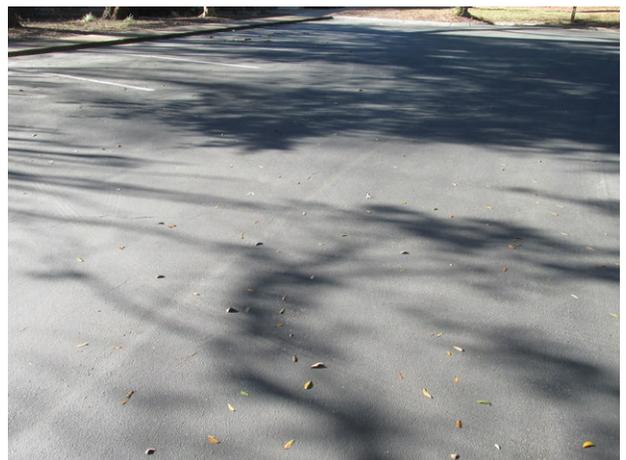
**Typical condition of asphalt pavement**

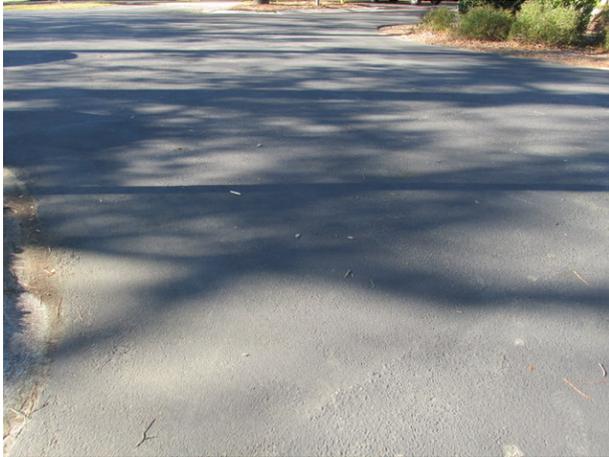
**Typical condition of asphalt pavement**

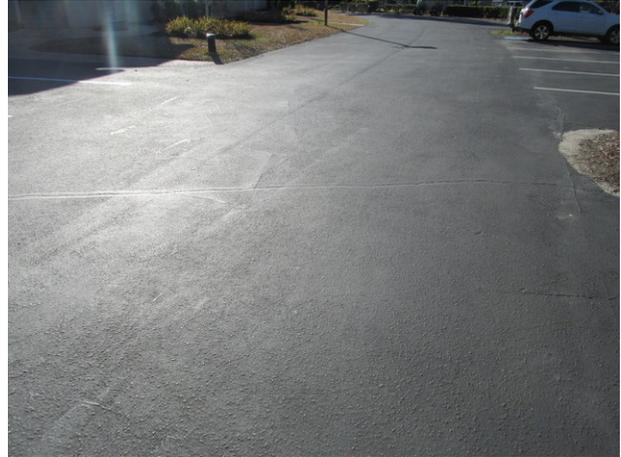
**Typical condition of asphalt pavement**

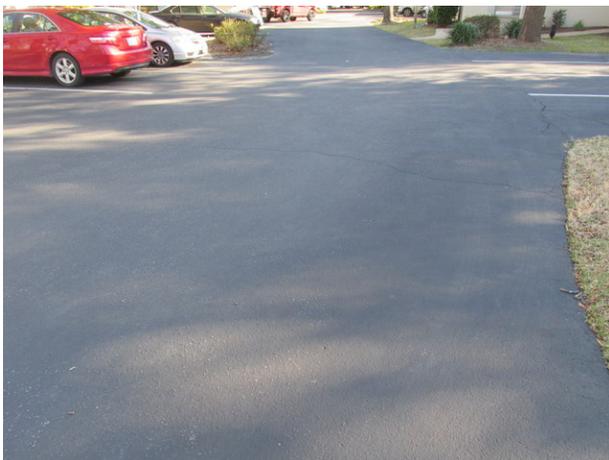
**Typical condition of asphalt pavement**

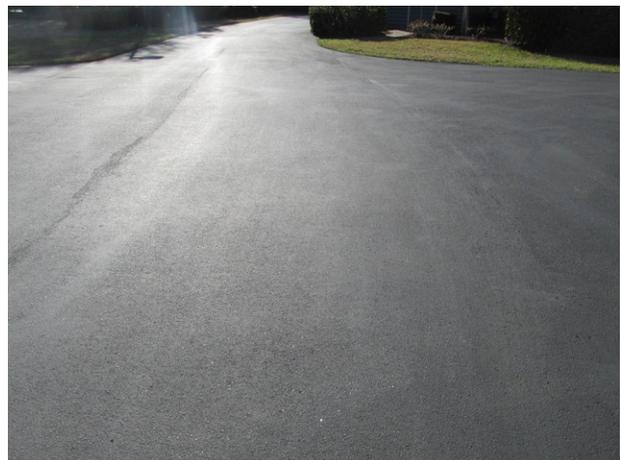
**Typical condition of asphalt pavement**

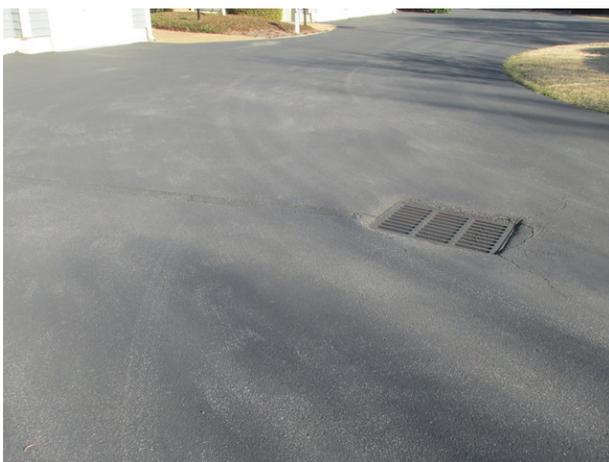
**Typical condition of asphalt pavement**

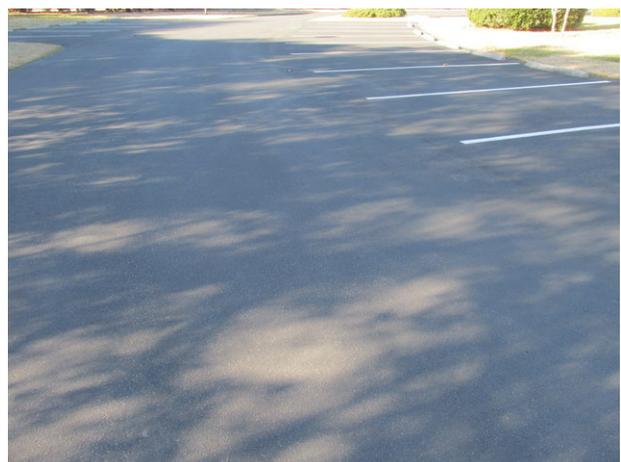
**Typical condition of asphalt pavement**

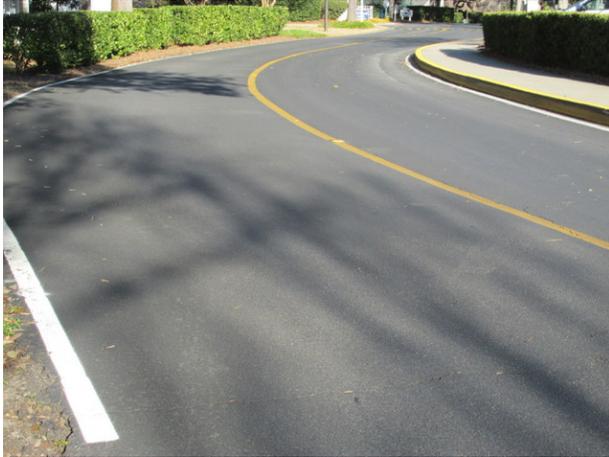
**Typical condition of asphalt pavement**

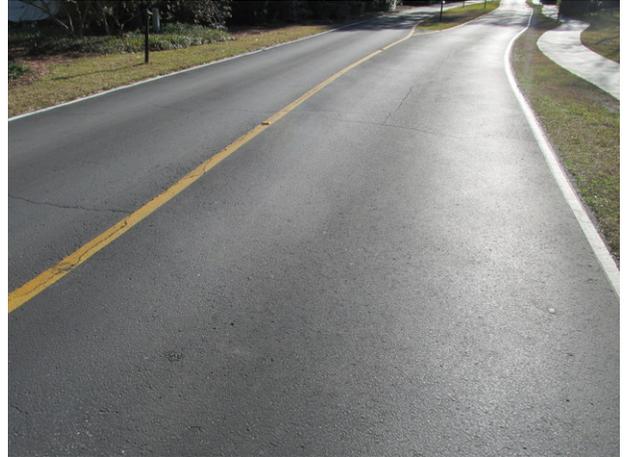
**Typical condition of asphalt pavement**

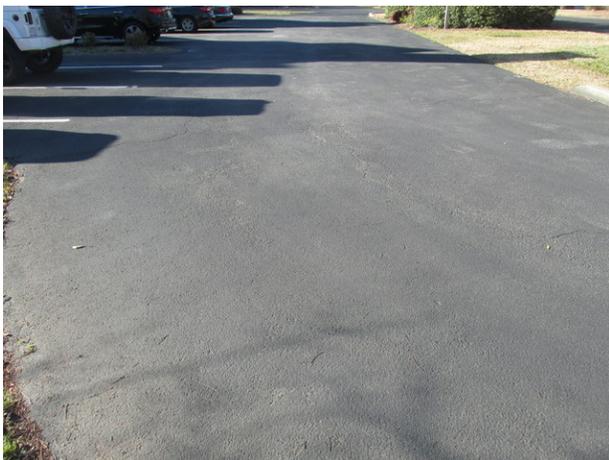
**Typical condition of asphalt pavement**

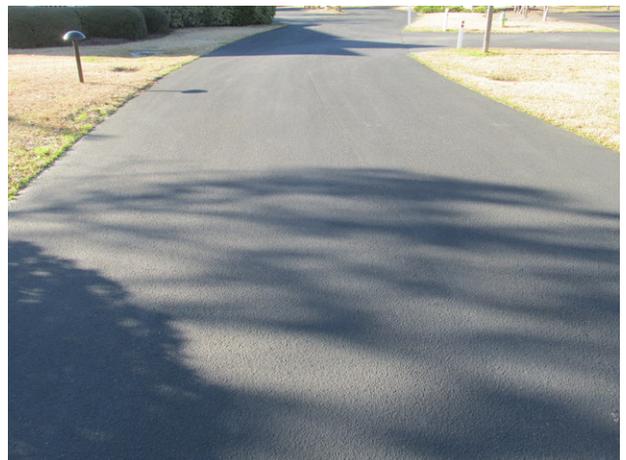
**Typical condition of asphalt pavement**

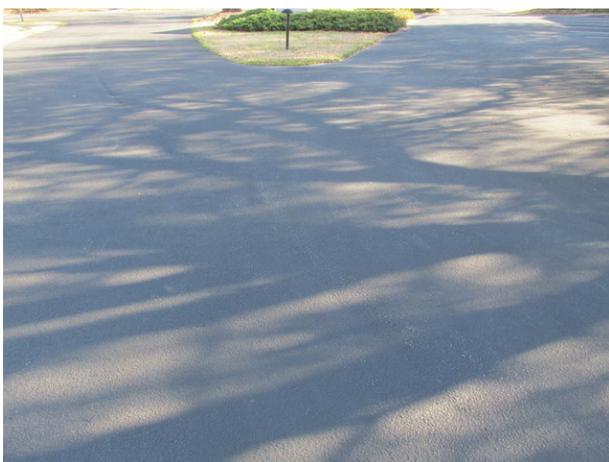
**Typical condition of asphalt pavement**

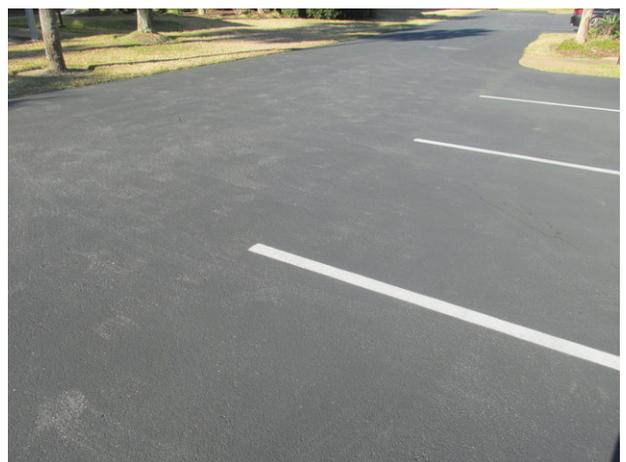
**Typical condition of asphalt pavement**

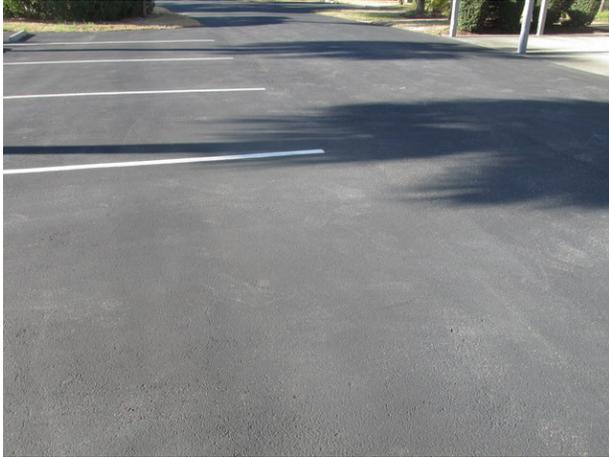
**Typical condition of asphalt pavement**

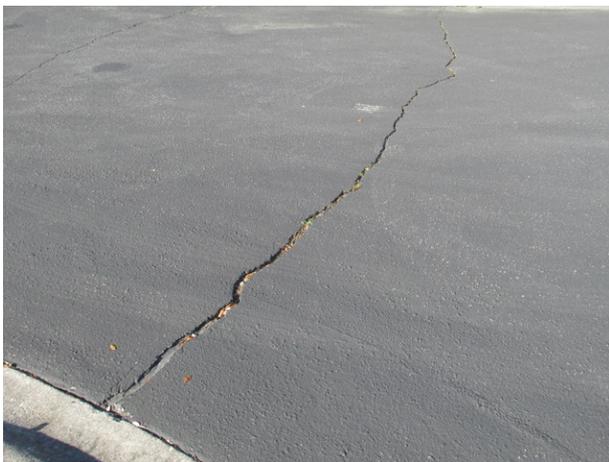
**Example of transverse crack at asphalt pavement**

**Component Detail Notes:** Proposals for seal coat applications should include crack repairs and patching. The contractor should only apply seal coat applications after repairs are completed. A seal coat does not bridge or close cracks, therefore, unrepaired cracks render the seal coat applications useless.

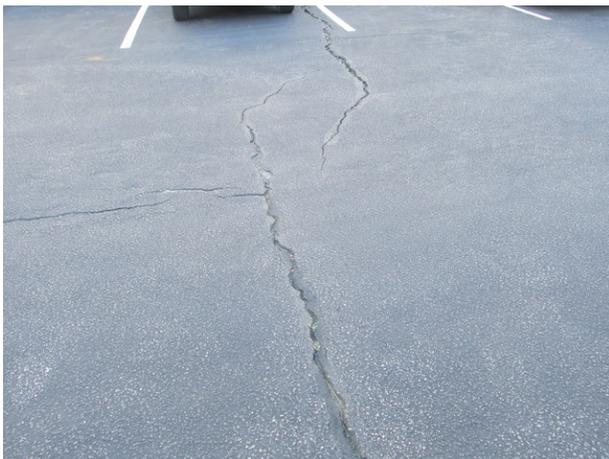
**Example of transverse cracks at asphalt pavement**

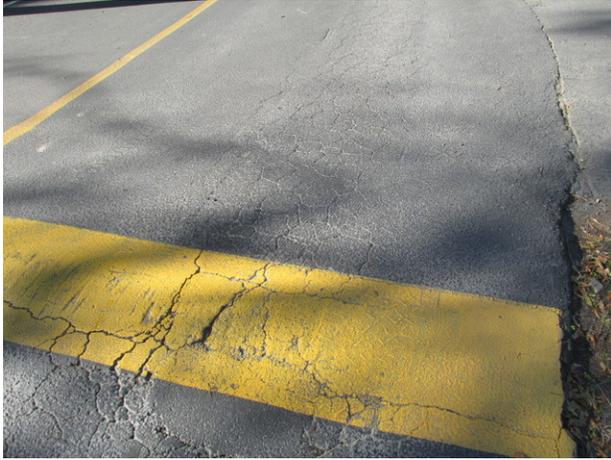
**Isolated example of alligator cracks and pavement deterioration at speedbump**

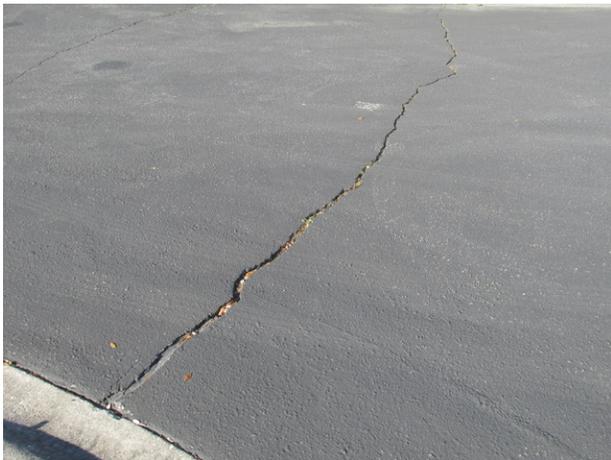
**Example of transverse crack at asphalt pavement**

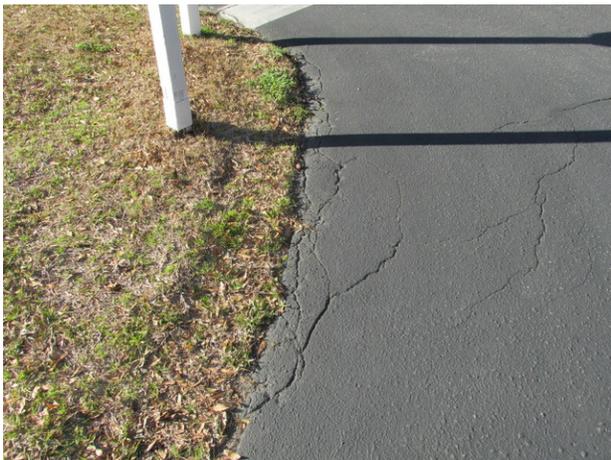
**Edge cracking at asphalt pavement**

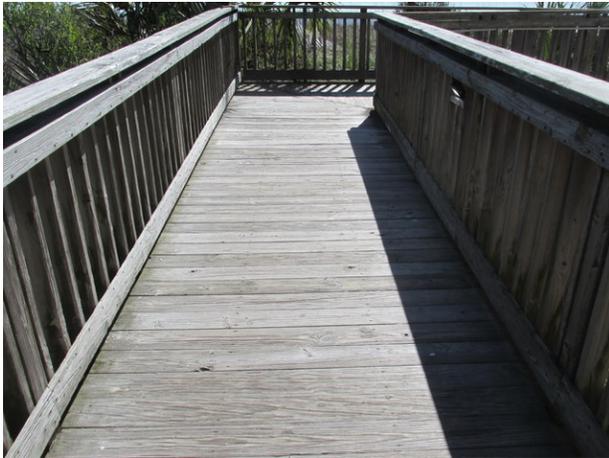
Wood decking and railings at main boardwalk

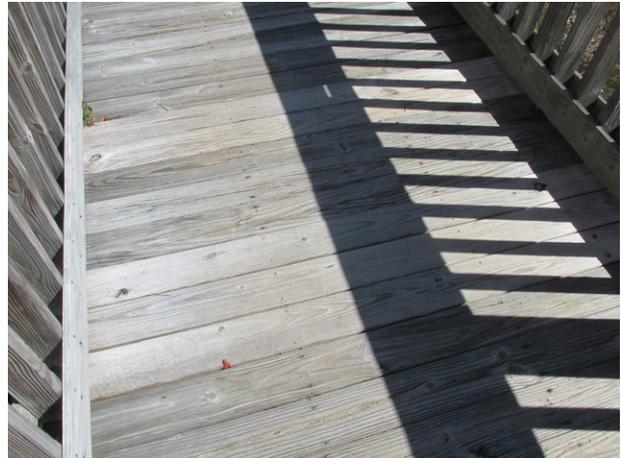
Wood decking at main boardwalk

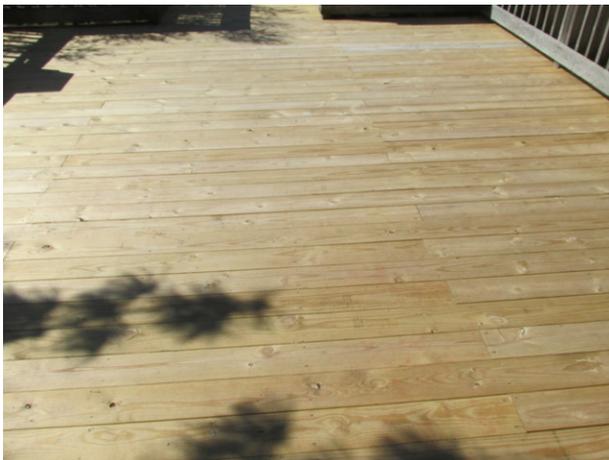
Replaced wood decking at main boardwalk

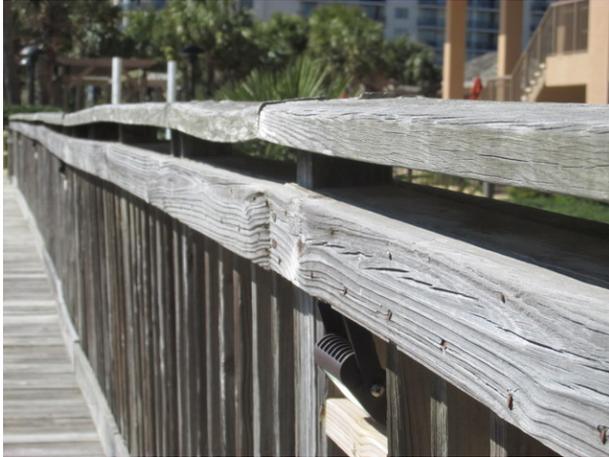
**Warped wood members at railing at main boardwalk**

- Annual inspections to identify and correct any unsafe conditions
- Securing of loose fasteners and replacement of deteriorated fasteners
- Replacement of deteriorated wood components
- Power washing with an algaecide and application of a sealer/stain

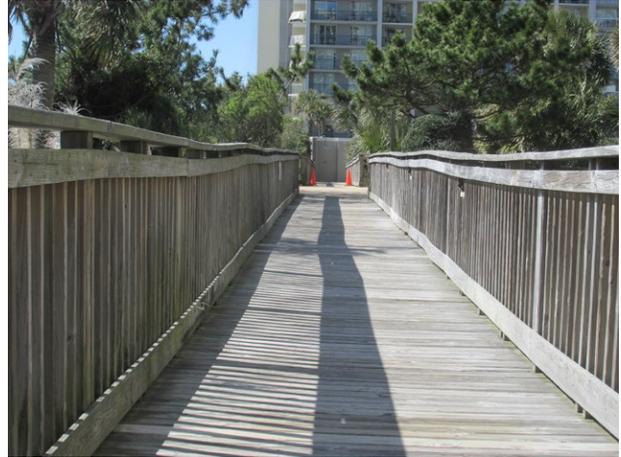
**Warped wood members at railing at main boardwalk**

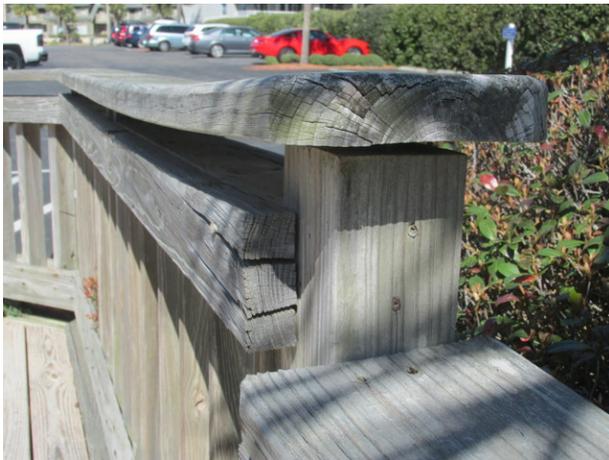
**Warped, cracked and detached wood members at railing at main boardwalk**

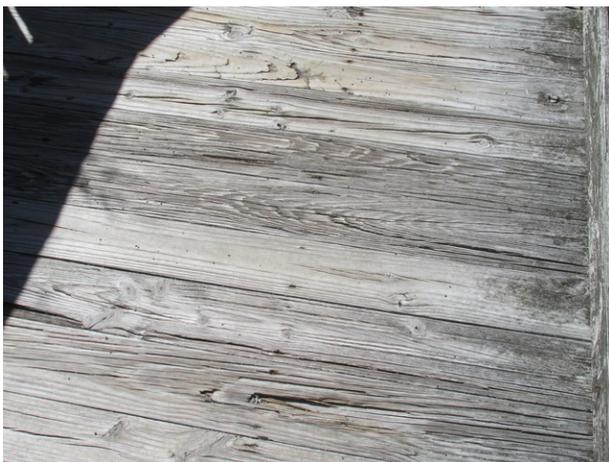
**Deteriorated wood decking at main boardwalk**

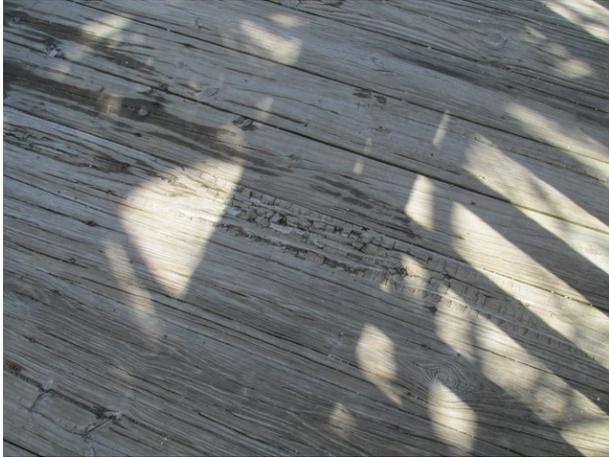
**Deteriorated wood decking at main boardwalk**

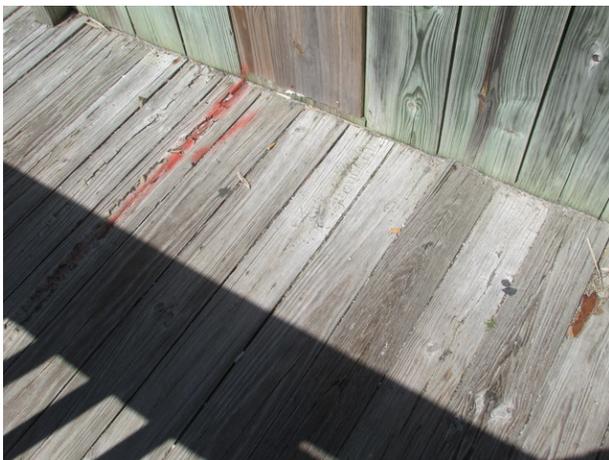
**Deteriorated wood decking at main boardwalk**

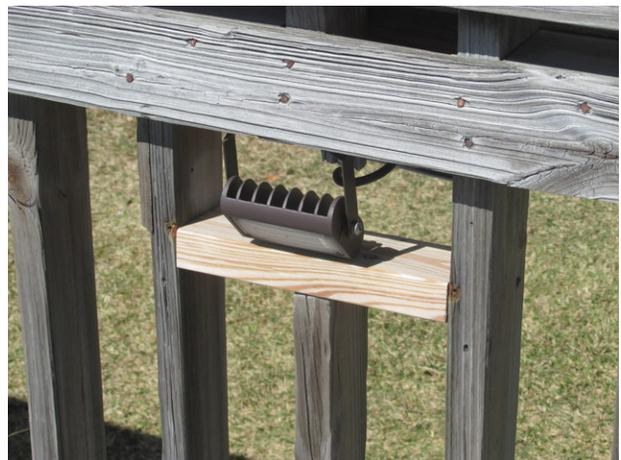
**Newly installed light fixture at railing at main boardwalk**

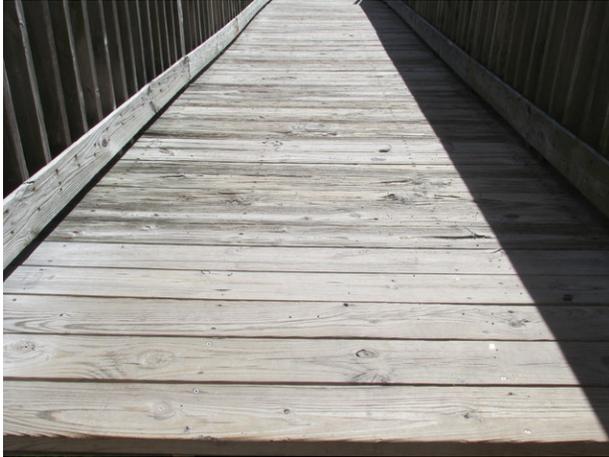
**Wood decking at Brighton beach access**

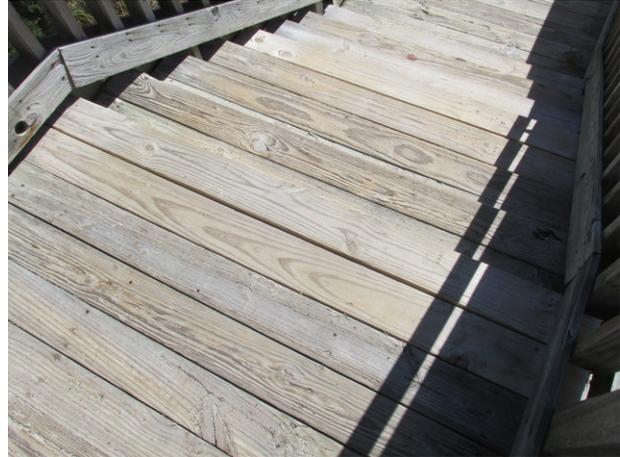
**Replaced sections of wood decking at Brighton beach access**

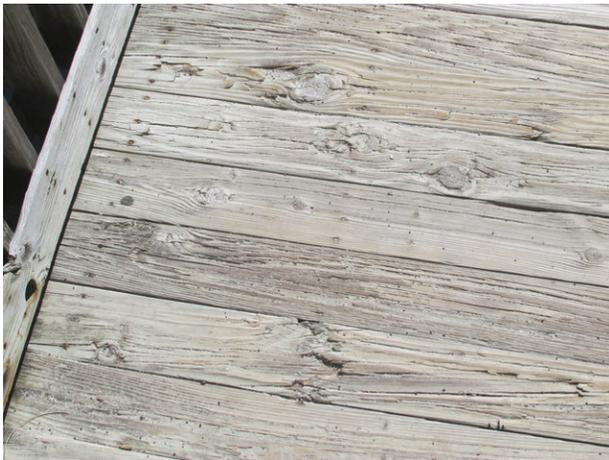
**Example of deteriorated wood decking at Brighton beach access**

Our estimates of unit cost include replacement of the light fixtures and showers. For near-term 2021 replacements, we include the replacement of the decking and railing at Brighton; replacement of the railing only at Embassy Suites North and South; replacement of the decking only at Margate; and replacement of the railings only at North Hampton and South Hampton.

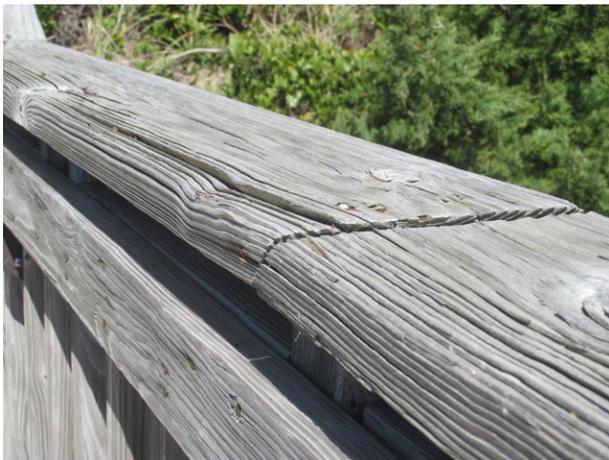
**Example of deteriorated wood railing at Brighton beach access**

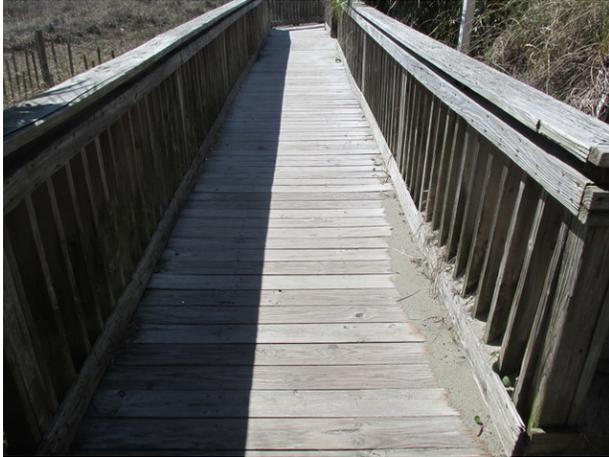
**Wood decking and railings at Embassy Suites South beach access**

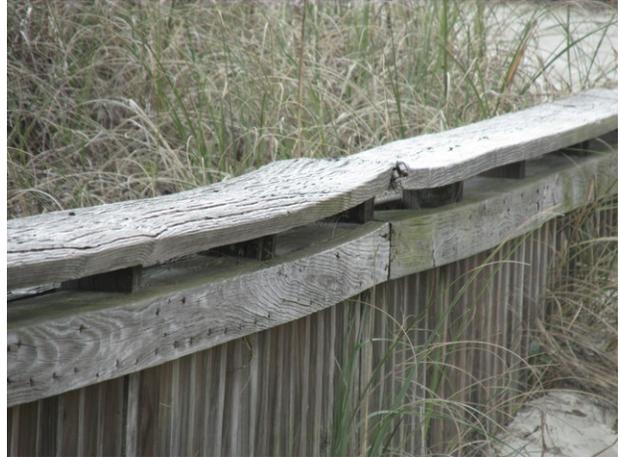
**Warped wood members at railing at Embassy Suites South beach access**

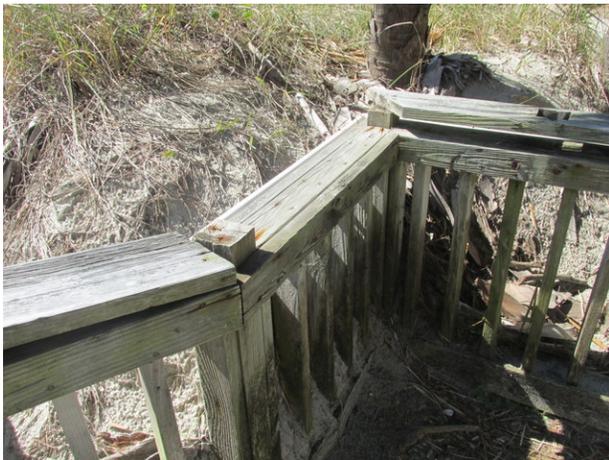
**Damaged and missing wood members at railing at Embassy Suites South beach access**

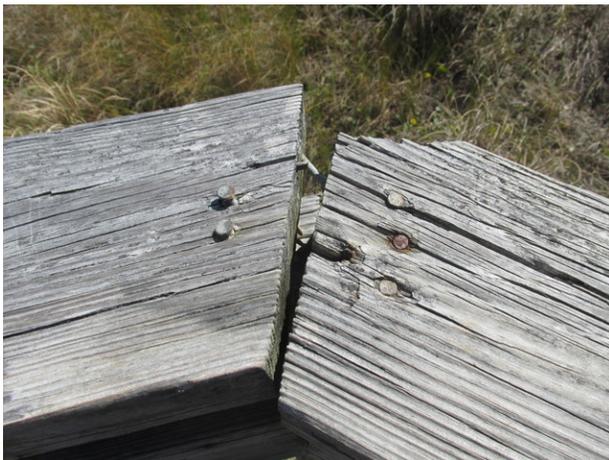
**Separated wood members at railing at Embassy Suites South beach access with toe-nailed connection**

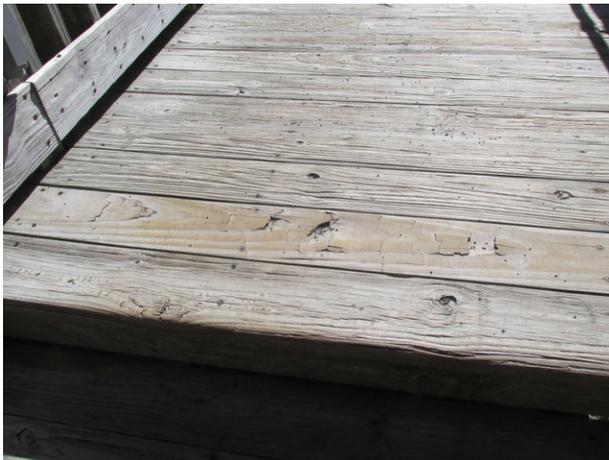
**Deteriorated decking at Margate beach access**

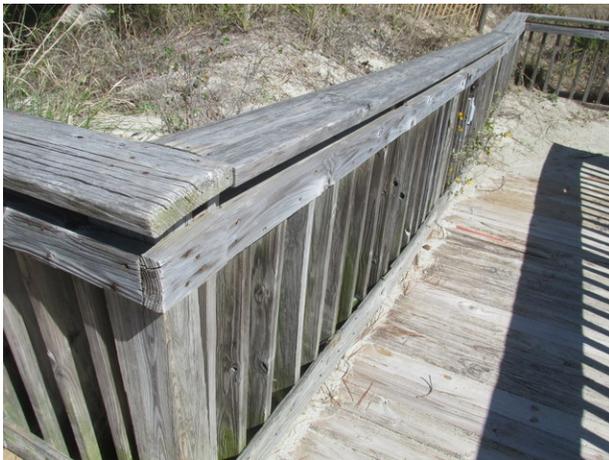
**Wood railing at North Hampton beach access**

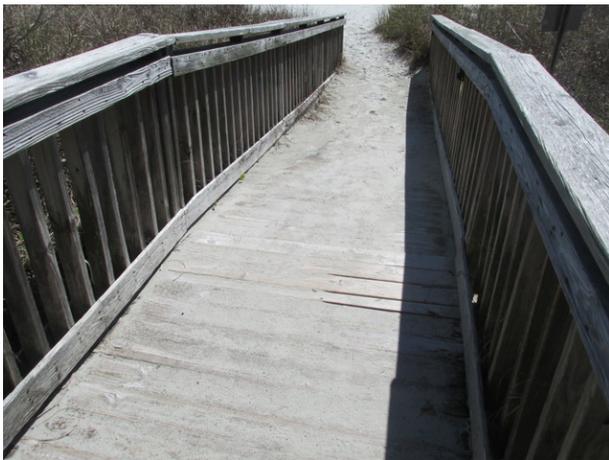
**Wood decking at South Hampton beach access**

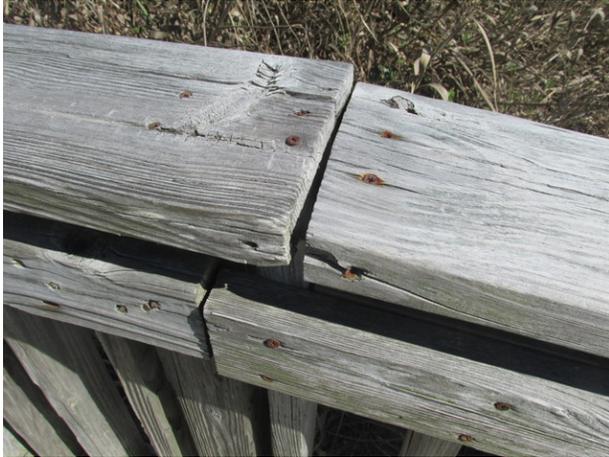
**Detached wood railing at South Hampton beach access**

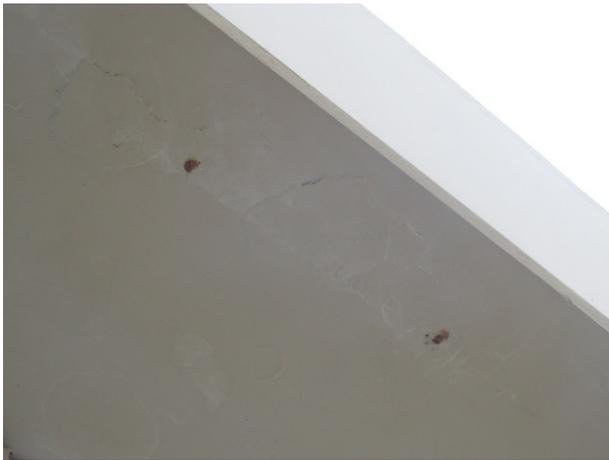
Rust formation and cracked concrete at underside of bridge

**Useful Life:** We estimate a useful life of up to 30 years with the benefit of capital repairs including a close-up visual inspection, patching of delaminated concrete, and routing and filling of cracked concrete. The Association should fund these interim repairs through the operating budget.

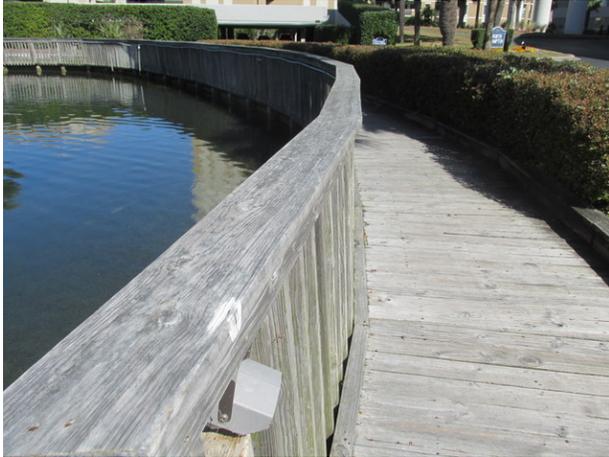
**Leaning railing at bridge at North Hampton**

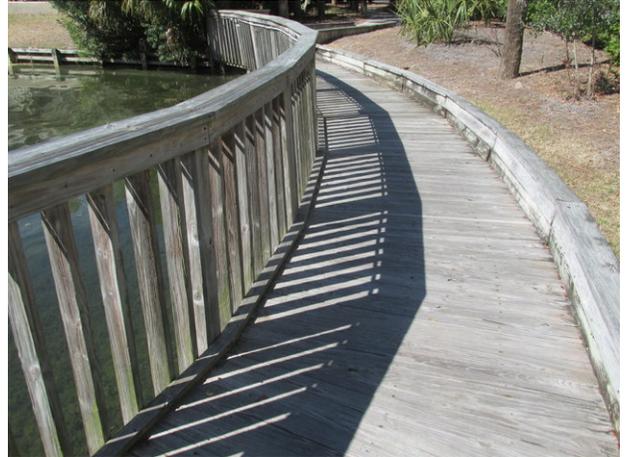
**Leaning railing at bridge at North Hampton**

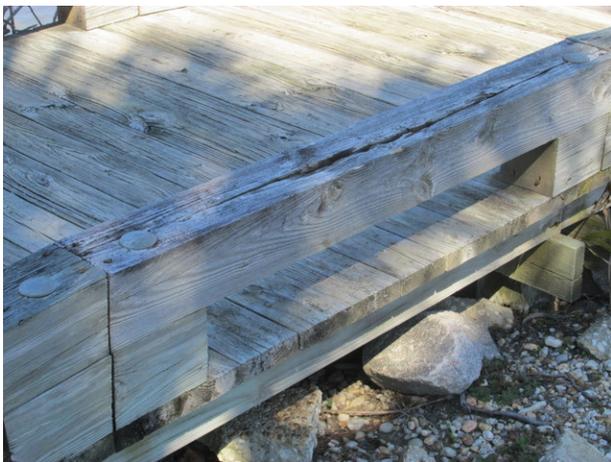
**Deteriorated wood member at sidewalk bridge**

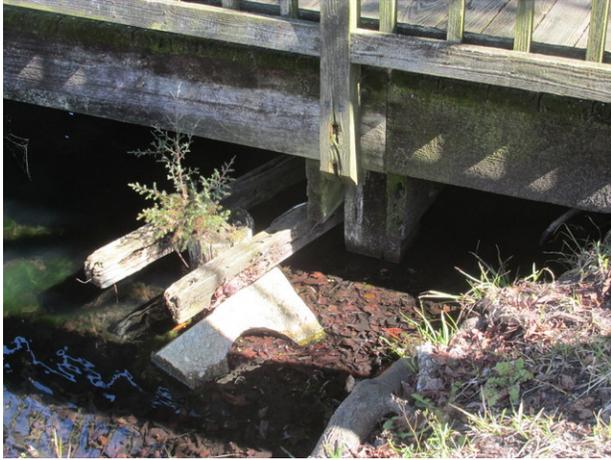
**Detached wood members at St. James bridge frame/foundation**

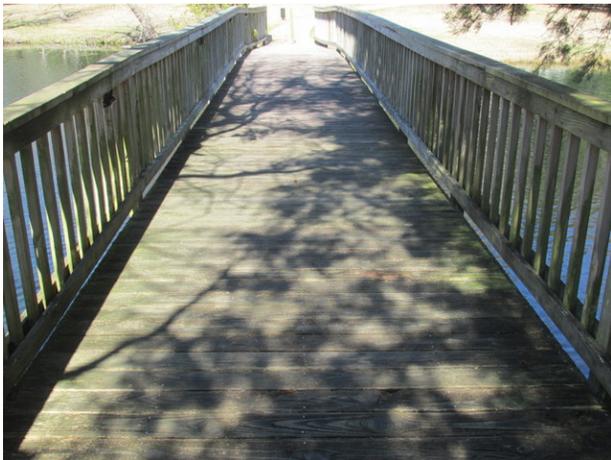
**Wood decking and railings at St. James bridge**

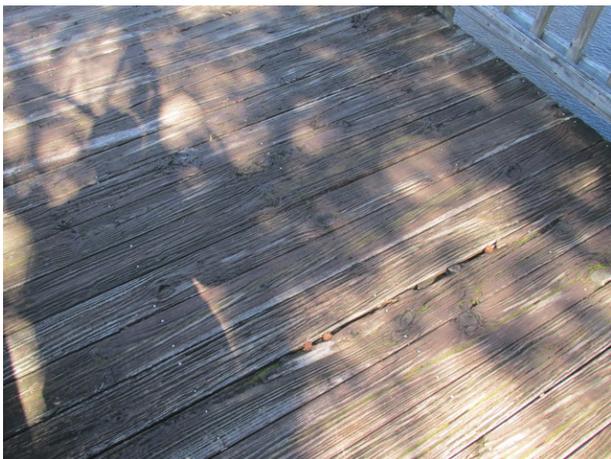
**Deteriorated wood decking at St. James bridge**

**Useful Life:** We include replacement of the decking, railings and light fixtures every 15- to 20-years with complete replacement of the bridges every 35 years.

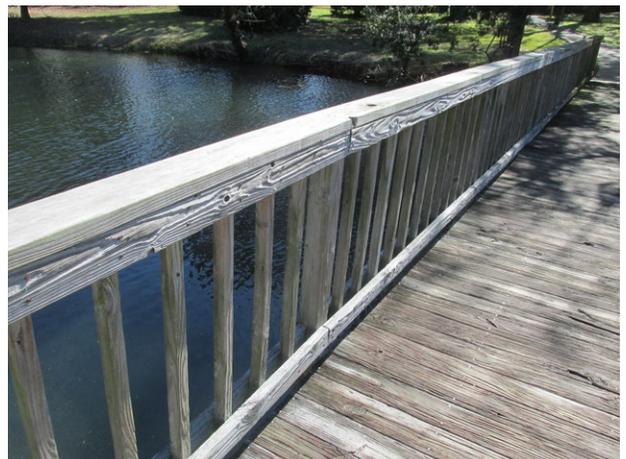
**Wood railing at St. James bridge**

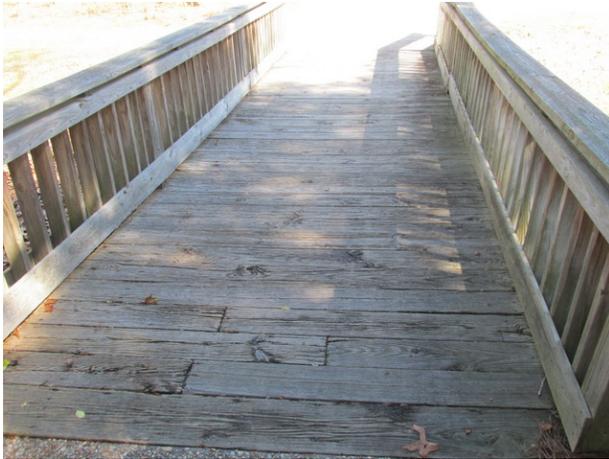
**Wood decking and railings at West Hyde Park mail station bridge**

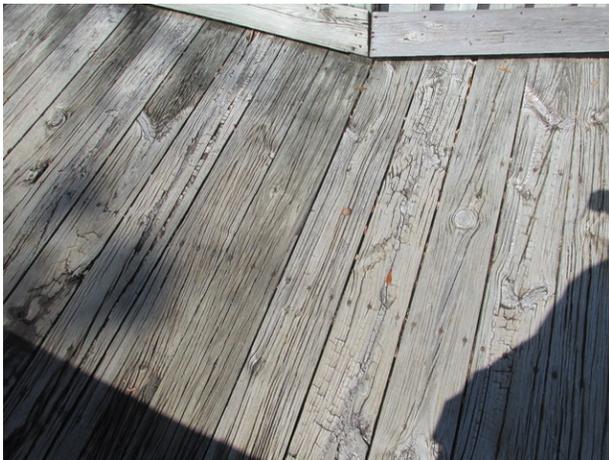
**Deteriorated wood decking at West Hyde Park mail station bridge**

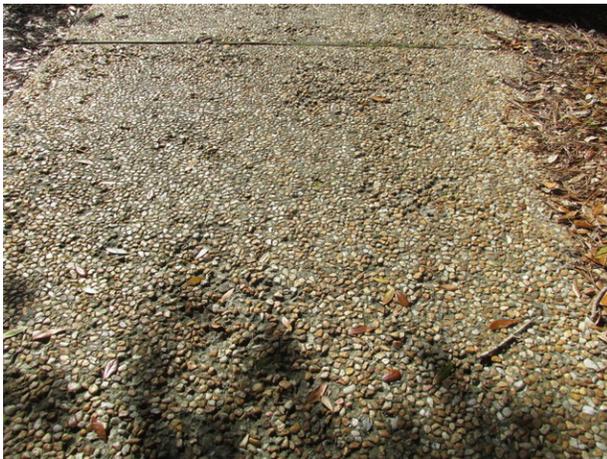
**Loss of pebbles at sidewalk**

**Expenditure Detail Notes:** Expenditure timing and costs are depicted in the **Reserve Expenditures** table in Section 3. We estimate that up to 60,750 square feet of concrete sidewalks, or fifty percent (50%) of the total, will require replacement during the next 30 years. At the request of Management, we include replacement of the sidewalks with concrete with a “salt finish”. We base our estimate of unit cost on information provided by Management.

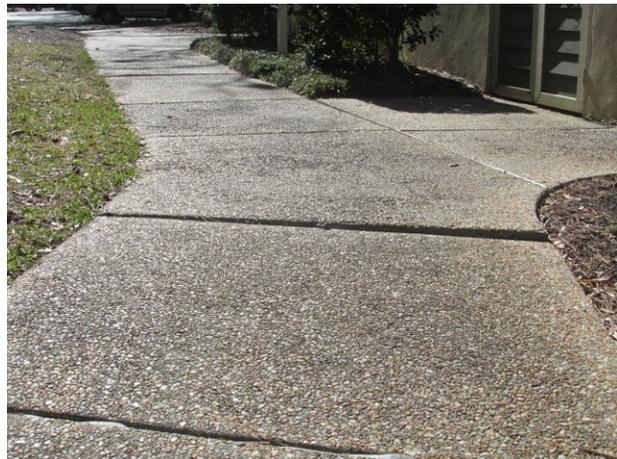
**Example of trip hazard at sidewalk**

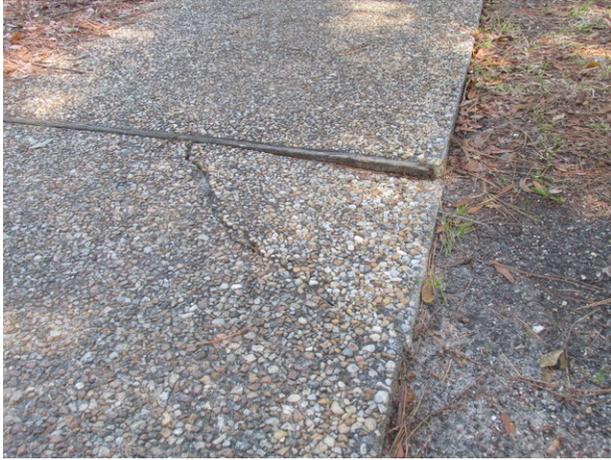
**Cracked section of sidewalk**

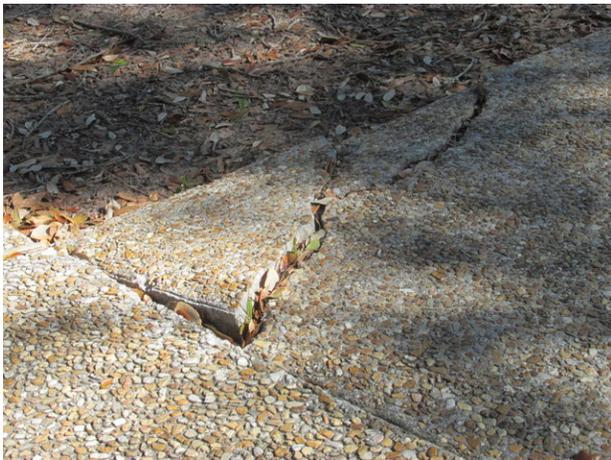
**Cracked and deteriorated section of sidewalk**

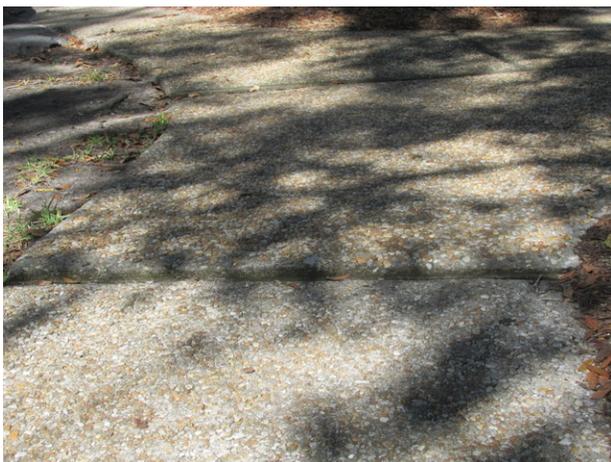
**Example of trip hazard at sidewalk**
