# **RESERVE STUDY**

## **Kingston Plantation Master Association, Inc.**

**Myrtle Beach, South Carolina  
February 28, 2020**

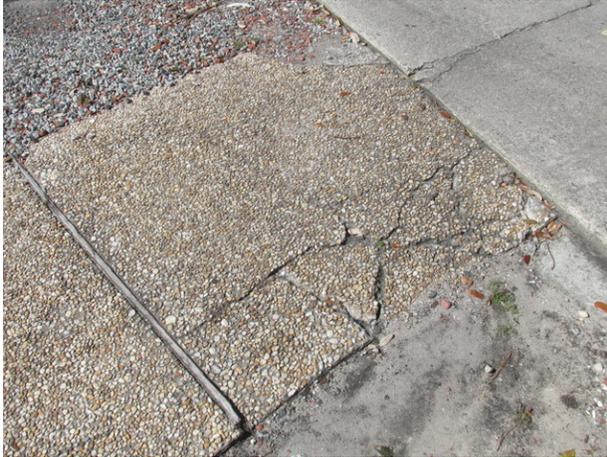
**Cracked and deteriorated section of sidewalk**

**Expenditure Detail Notes:** Expenditure timing and costs are depicted in the **Reserve Expenditures** table in Section 3. We estimate that up to 60,750 square feet of concrete sidewalks, or fifty percent (50%) of the total, will require replacement during the next 30 years. At the request of Management, we include replacement of the sidewalks with concrete with a “salt finish”. We base our estimate of unit cost on information provided by Management.

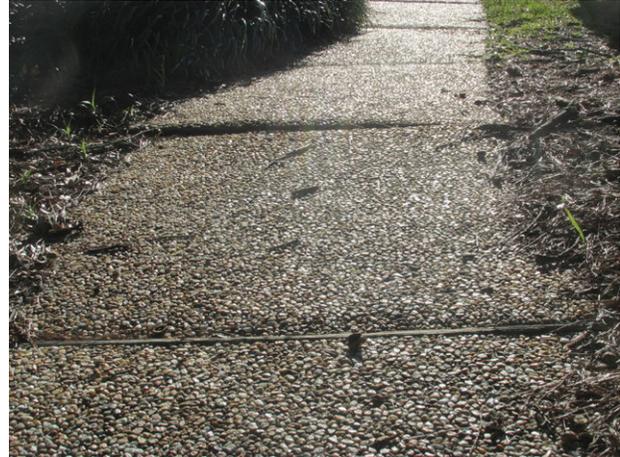
**Example of trip hazard at sidewalk**

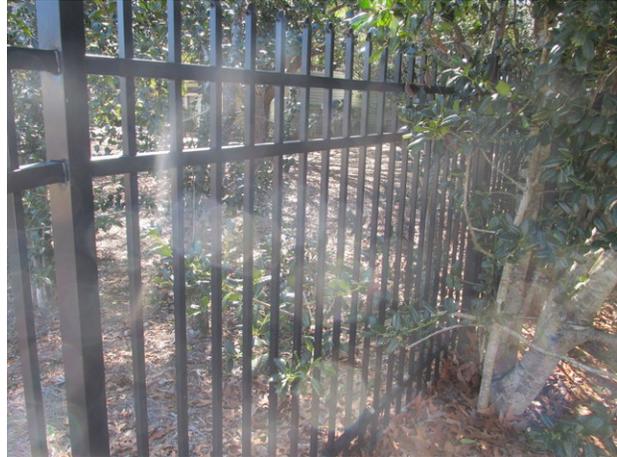
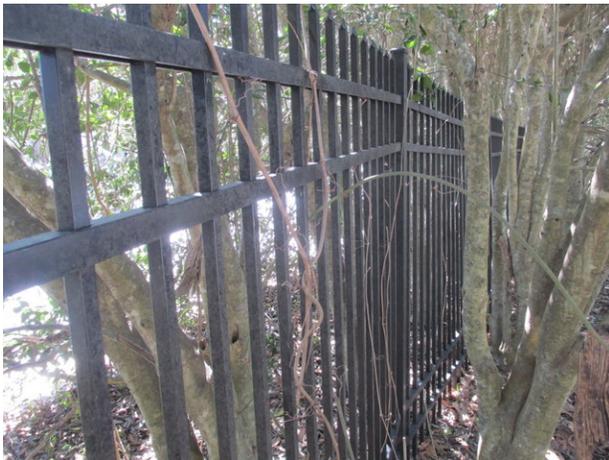
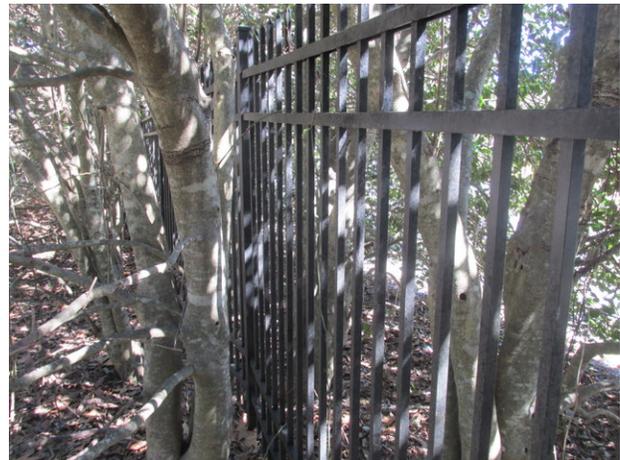
**Aluminum fence at west perimeter installed in 2013 – Note close vegetation growth to fence**

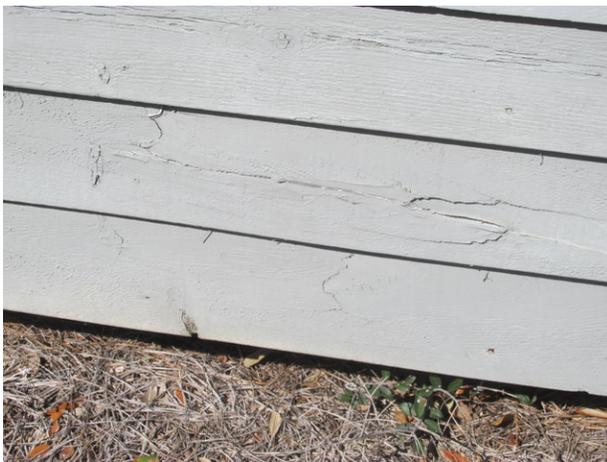
**Condition:** Fair to poor overall condition with areas of deteriorated wood siding

Deteriorated wood siding

**Expenditure Detail Notes:** Expenditure timing and costs are depicted in the **Reserve Expenditures** table in Section 3. Management informs us that the Association plans to replace the fences with aluminum fencing at the time of replacement.

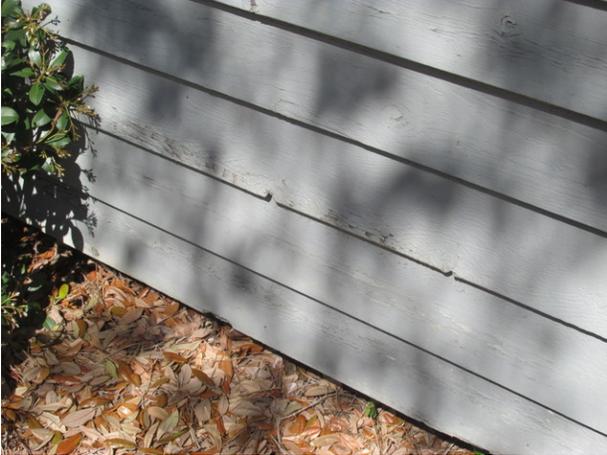
**Deteriorated wood siding**

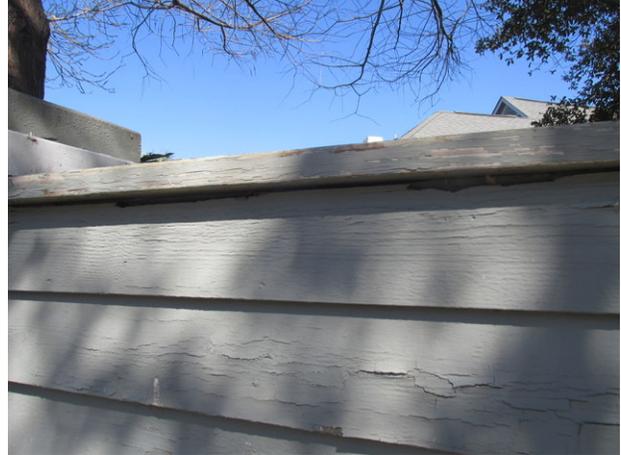
**Deteriorated wood siding**

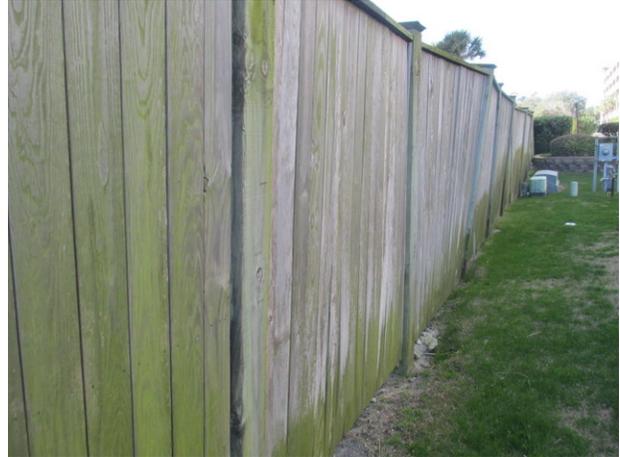
**Condition:** Fair to poor overall condition with multiple leaning sections and warped wood members

**Leaning section of wood fence at north perimeter**

**Expenditure Detail Notes:** Expenditure timing and costs are depicted in the **Reserve Expenditures** table in Section 3. The Association should anticipate periodic partial replacements due to the non-uniform nature of wood deterioration. Along with these partial replacements, the Association should apply periodic paint applications as needed and fund these activities through the operating budget.

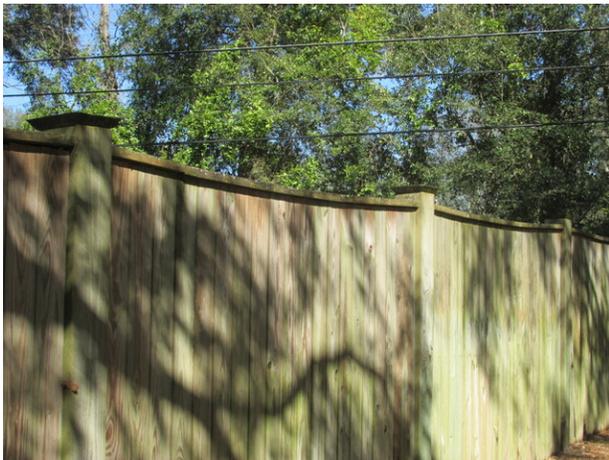
**Deflected members at wood fence at north perimeter**

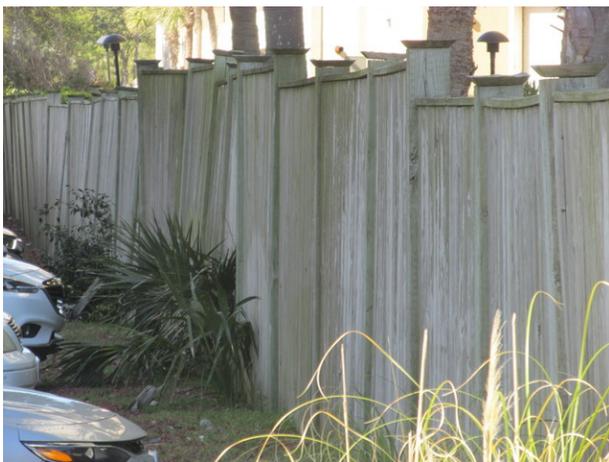
**Leaning sections of wood fence at north perimeter**

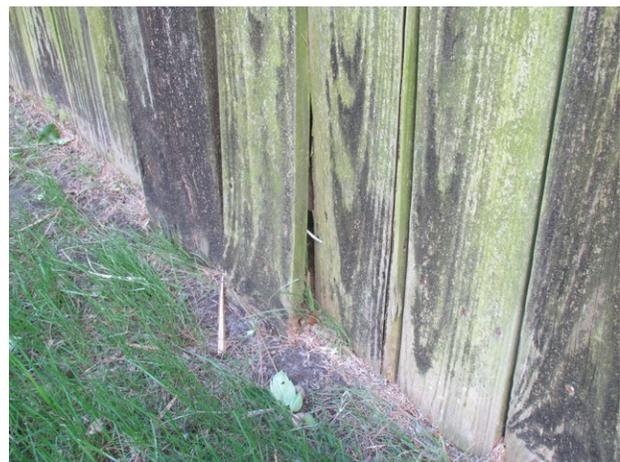
**Detached wood member at fence at north perimeter**

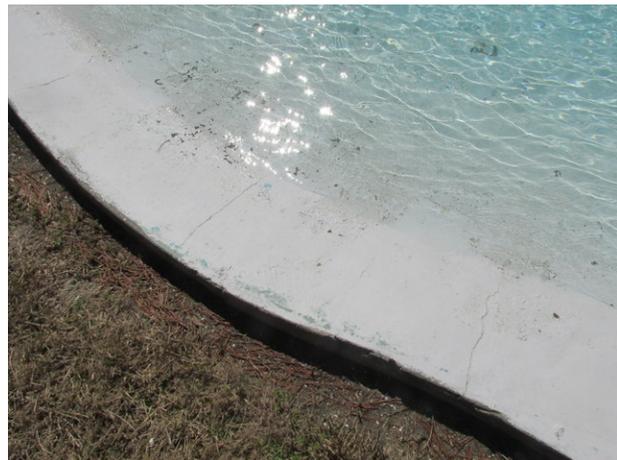
**Condition:** Fair to poor overall condition. We note multiple cracks at the concrete structure. Representatives of the Association inform us of leaks.

Cracked concrete at edge of fountain

**Component Detail Notes:** Finish replacement provides the opportunity to inspect the fountain structure and to allow for partial repairs of the underlying concrete surfaces as needed. To maintain the integrity of the fountain structure, we recommend the Association budget for the following:

- Removal and replacement of the finish
- Replacement of fountains as needed
- Concrete structure repairs as needed

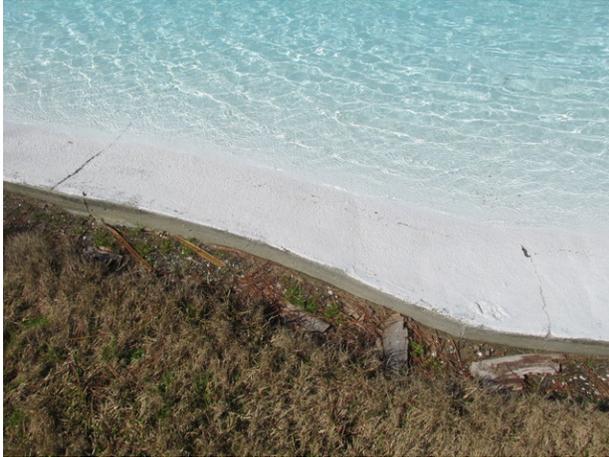
**Cracked concrete at edge of fountain**

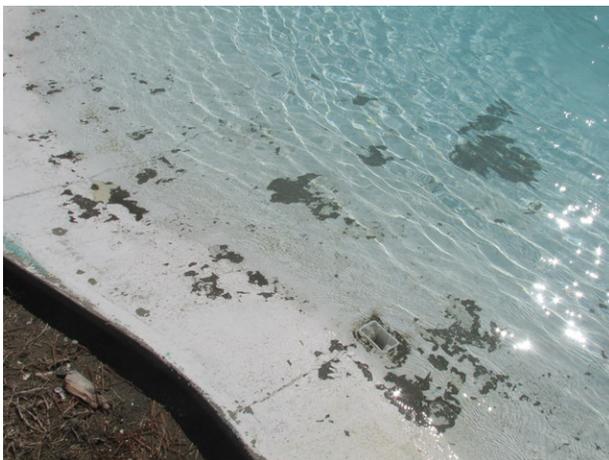
**Deteriorated finish at fountain**

**History:** Representatives of the Association inform us that the Association applies a paint finish to the fountain on an as-needed basis. We recommend the Association install a plaster finish at the fountain.

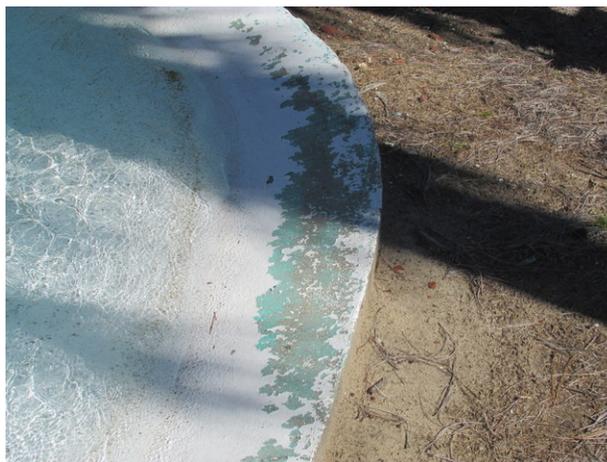
**Deteriorated finish at fountain**

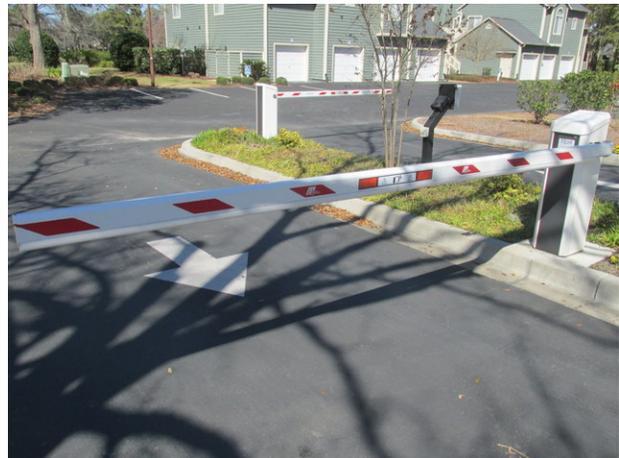
Swing-arm gate operators at entrance to Canterbury III

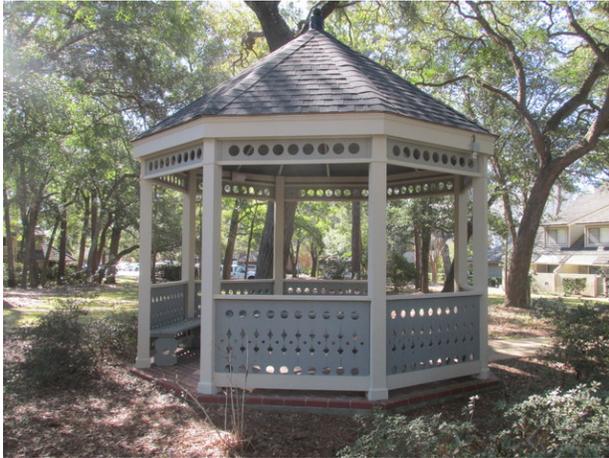
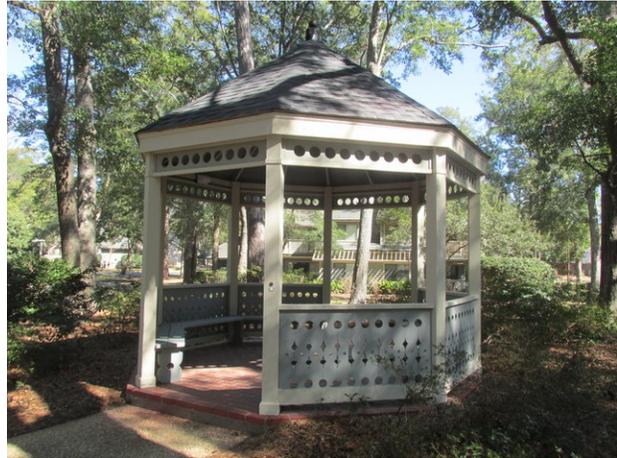
**Condition:** Good overall condition

**Overview of gazebo**

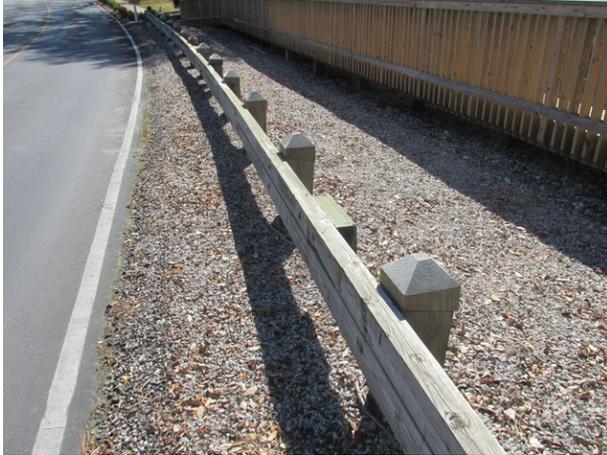
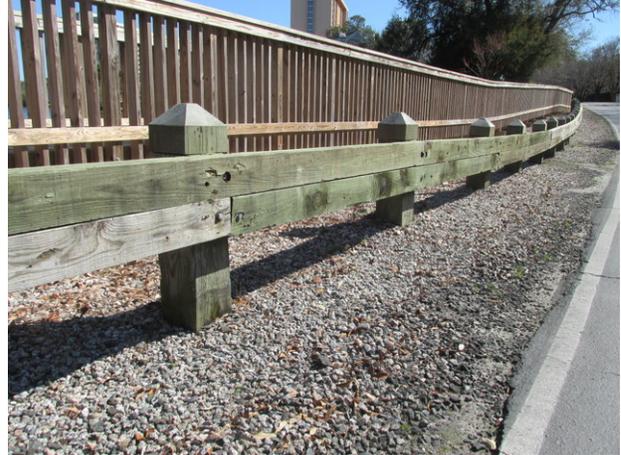
**Condition:** Good to fair overall

Wood guardrail at Plantation Lakes Drive

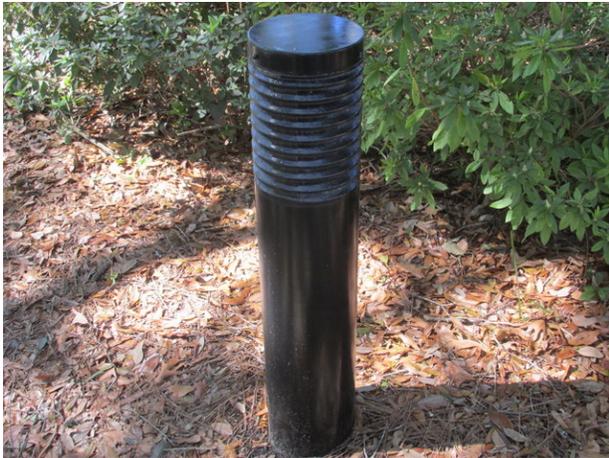
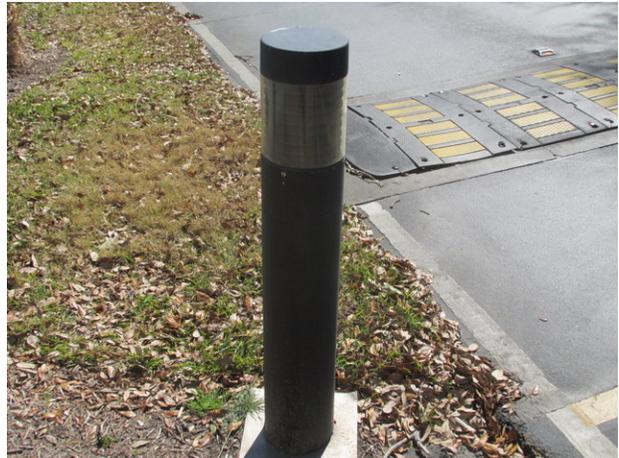
**Condition:** Good to fair overall

**Bollard-type light fixture**

**Expenditure Detail Notes:** Expenditure timing and costs are depicted in the **Reserve Expenditures** table in Section 3. Management informs us that the Association plans a phased replacement of the light fixtures in the near term.

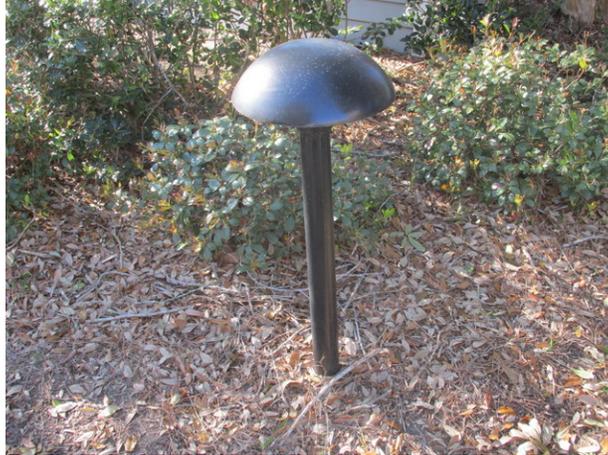
**Condition:** Good to fair overall

**Mushroom-type light fixture**

**Expenditure Detail Notes:** Expenditure timing and costs are depicted in the **Reserve Expenditures** table in Section 3. Management informs us that the Association plans a phased replacement of the light fixtures in the near term.

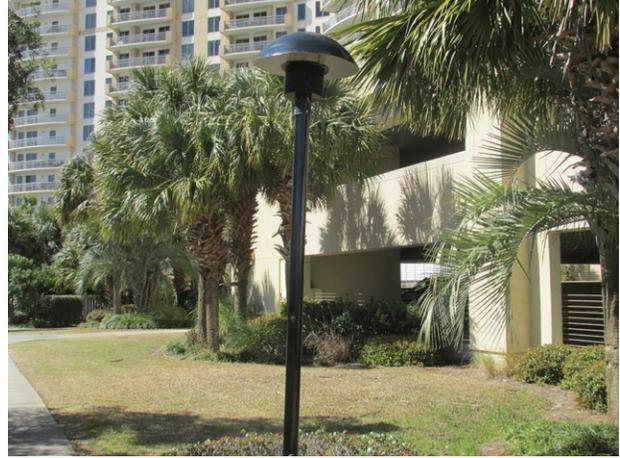
**Leaning light pole and fixture**

**Expenditure Detail Notes:** Expenditure timing and costs are depicted in the **Reserve Expenditures** table in Section 3. Management informs us that the Association plans a phased replacement of the light fixtures in the near term.

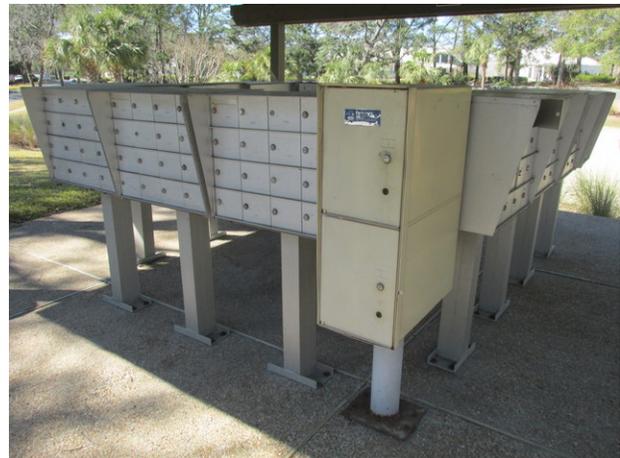
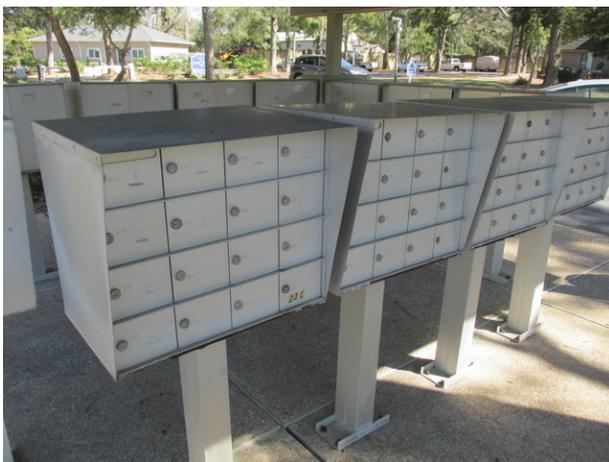
**Condition:** The roof and paint finishes are in good overall condition. The mailbox stations are in fair to poor condition. We note rust formation and deterioration at the undersides of the mailbox stations.

**Mailbox stations at Richmond Park**

- Replacement of the asphalt shingle roof assembly
- Paint finishes and structure repairs to the wood structure
- Replacement of the light fixtures
- Partial replacement of the concrete pad

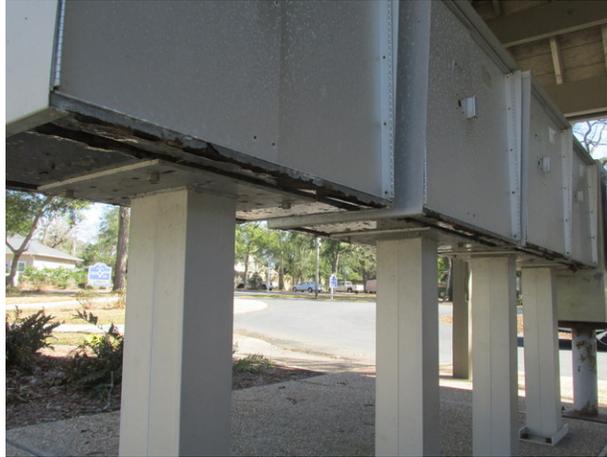
**Rust formation and deterioration at mailbox stations at Richmond Park**

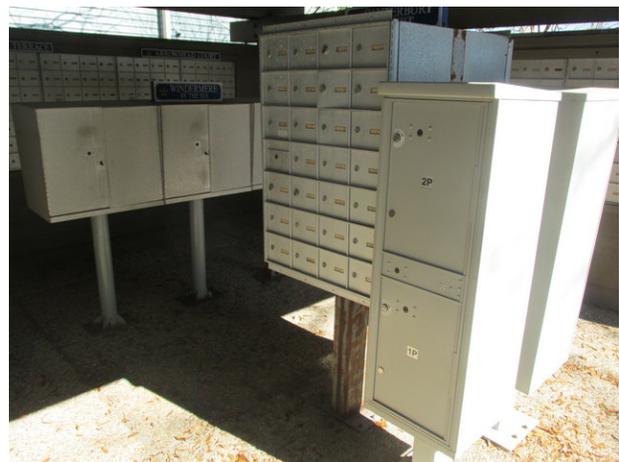
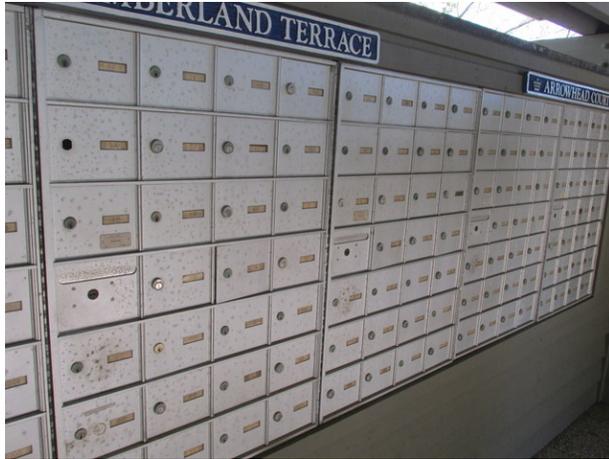
**Condition:** The roof and paint finishes are in good overall condition. The mailbox stations are in fair to poor condition. We note finish deterioration at the mailbox stations.

**Mailbox stations at West Hyde Park**

- Replacement of the asphalt shingle roof assembly
- Paint finishes and structure repairs to the wood structure, including partial replacements of wood siding
- Replacement of the light fixtures
- Replacement of the signage
- Partial replacement of the concrete pad

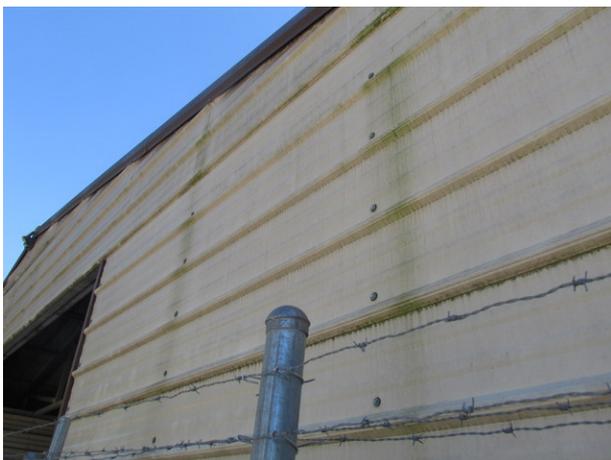
**Isolated stained siding at maintenance building**

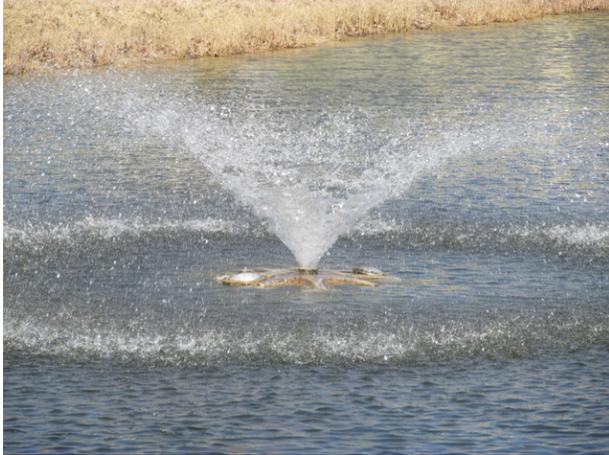
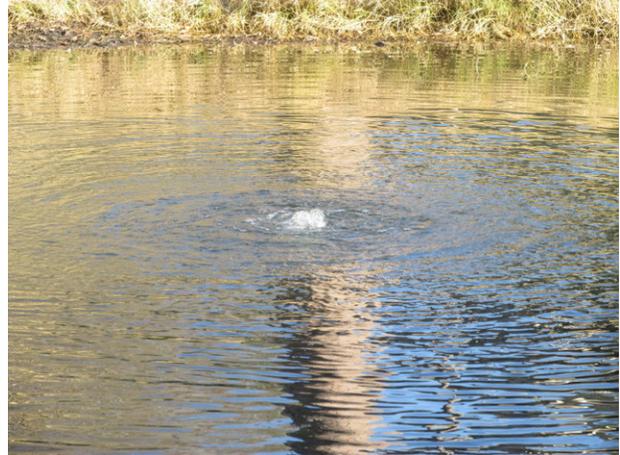
**Condition:** Management informs us that some bubblers are not operational and the Association plans to make near-term replacements.

**Fountain aerator**

**Bubbler aerator**

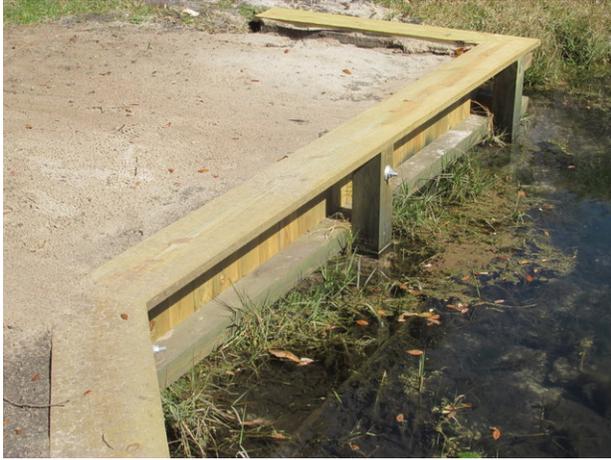
**Recently replaced section of timber bulkhead east of Westleton Drive**

**Expenditure Detail Notes:** Expenditure timing and costs are depicted in the **Reserve Expenditures** table in Section 3. Management informs us that the Association plans to spend approximately \$40,000 in 2020 on replacements to the bulkheads. We include the phased replacement of the remaining bulkheads from 2022 through 2026.

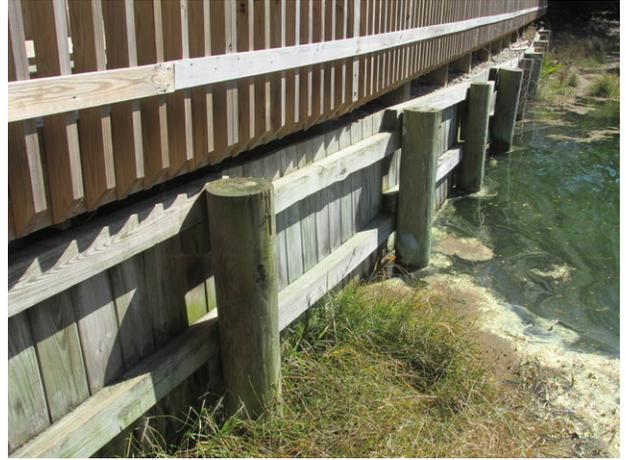
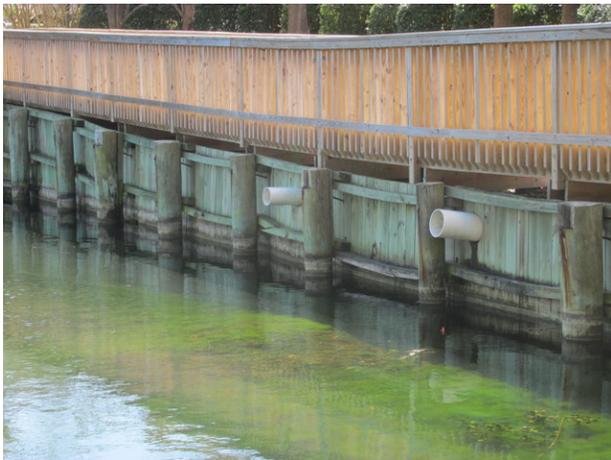
**Conditions:** Fair overall condition with areas of deteriorated wood members, leaning sections and settlement behind the bulkheads.

**Timber bulkhead at Lake Drive**

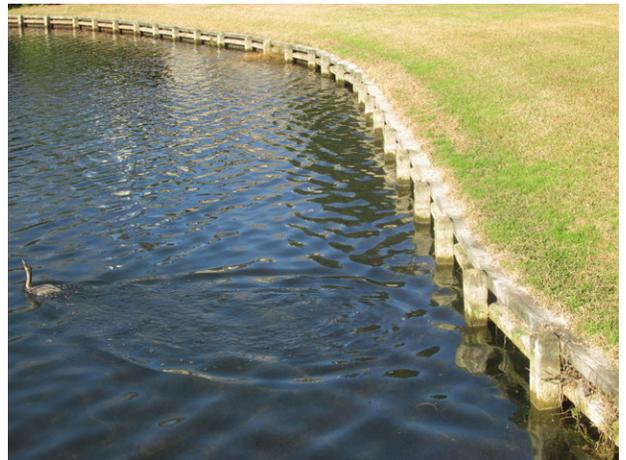
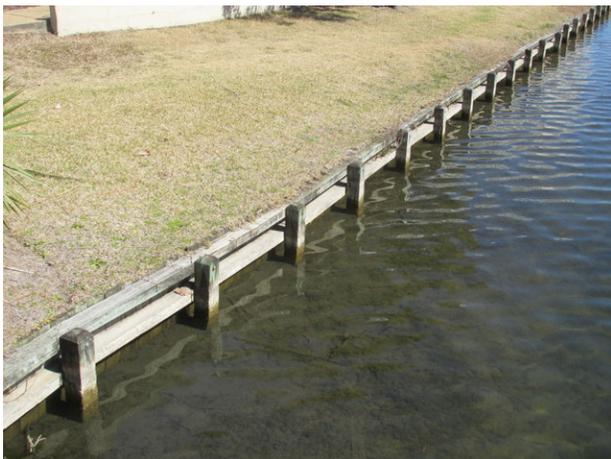
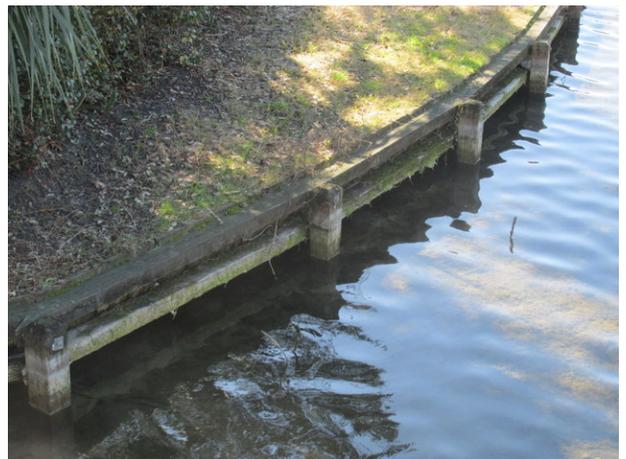
**Timber bulkhead at Lake Arrowhead**

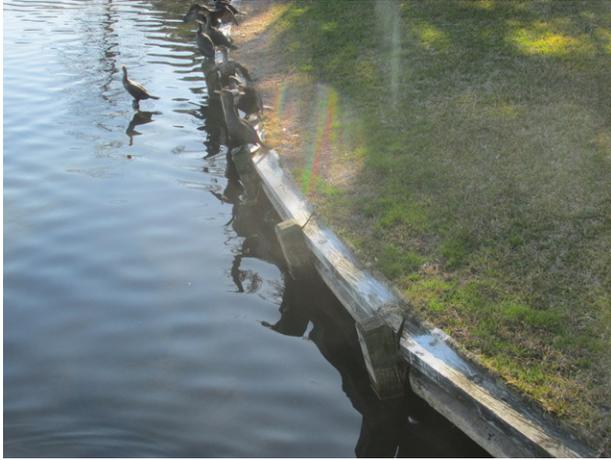
**Leaning section of timber bulkhead at Lake Arrowhead**

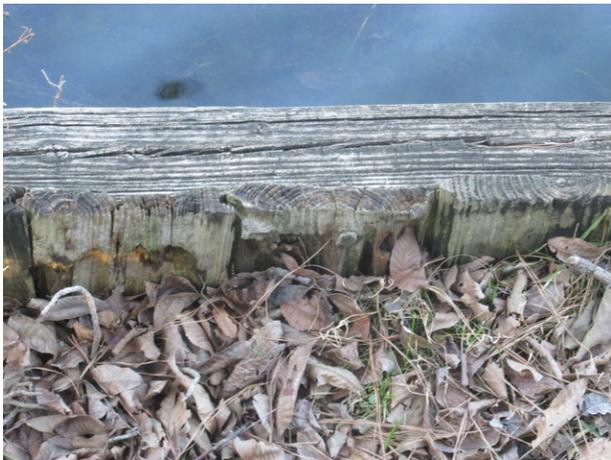
**Wood deterioration at bulkhead at Lake Arrowhead**

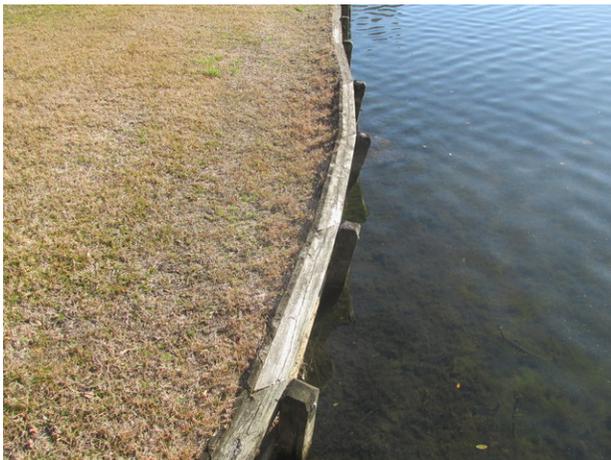
**Leaning section of timber bulkhead at Lake Arrowhead**

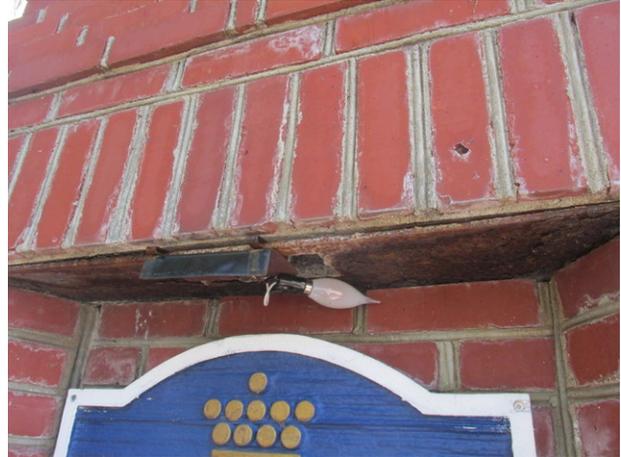
**Condition:** Fair to poor overall condition. We note efflorescence at the masonry, deteriorated wood siding and cracks at the signage.

**Poor finishes at shelf angle at Richmond Park monument**

**Expenditure Detail Notes:** Expenditure timing and costs are depicted in the **Reserve Expenditures** table in Section 3. Our cost for renovation includes repointing and repairs to the masonry and replacement of the remaining components listed above.

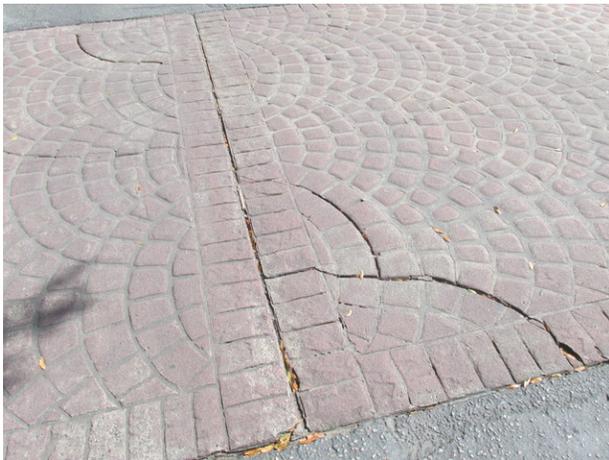
**Cracked stamped concrete at entrance to Richmond Park**

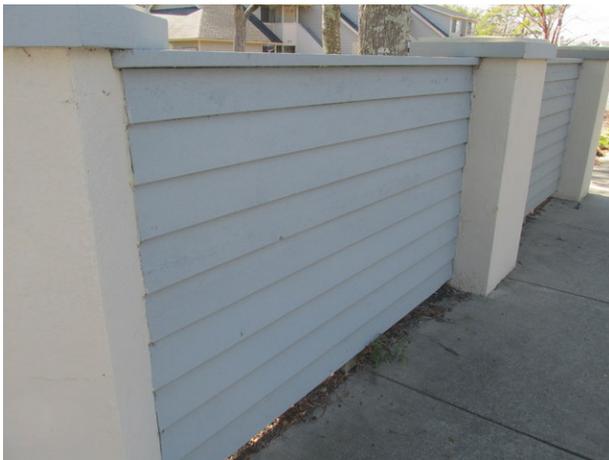
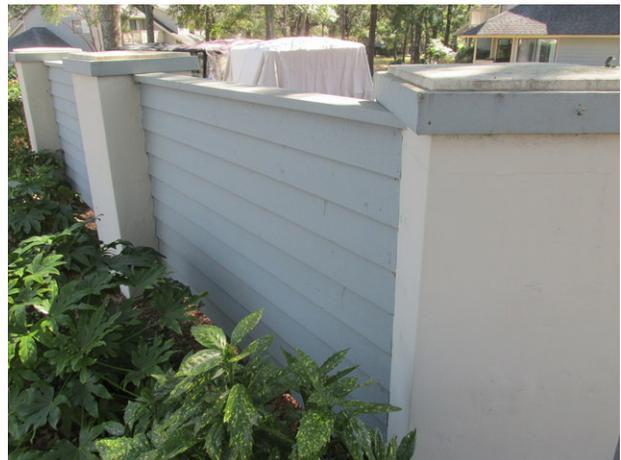
**Wood siding at monument at West Hyde Park**

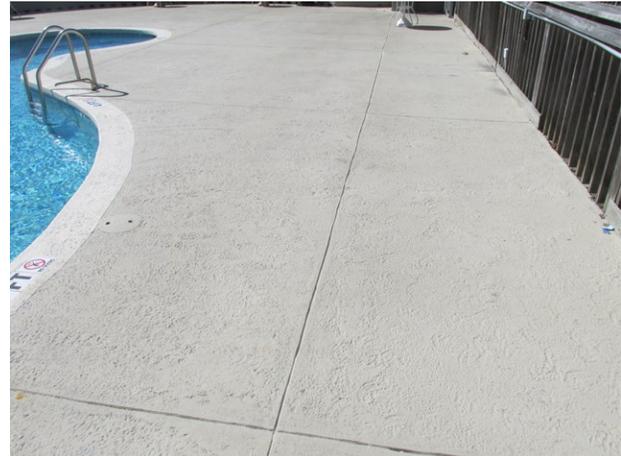
Crack at concrete deck

- Selective cut out and replacements of up to ten percent (10%) of concrete
- Crack repairs as needed
- Mortar joint repairs
- Caulk replacement
- Coating replacement

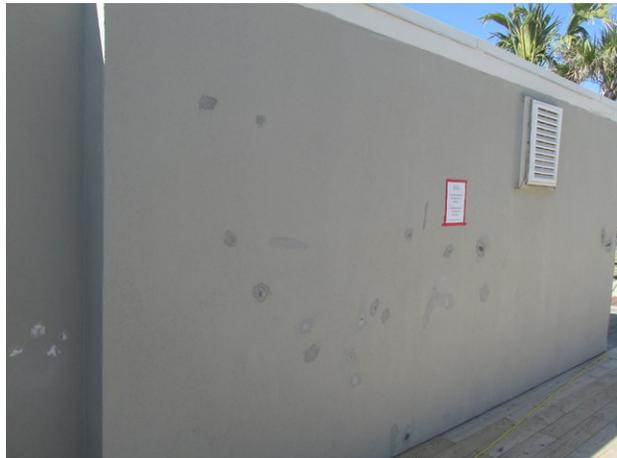
On-going concrete repair at exterior of pool house during inspection

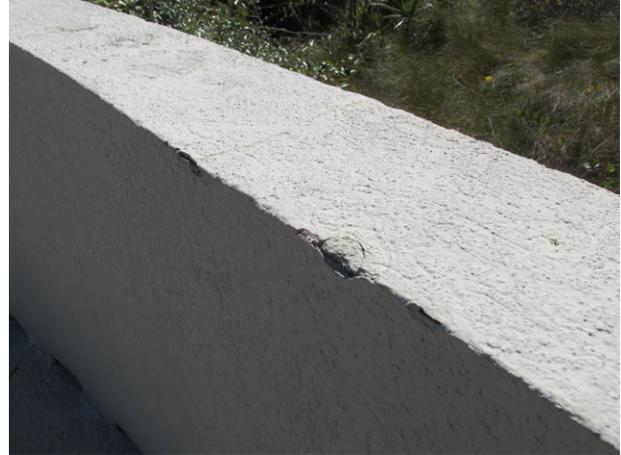
**Isolated damaged EIFS at stand-alone wall**

- Crack repairs as needed (Each paint product has the limited ability to cover and seal cracks but we recommend repair of all cracks which exceed the ability of the paint product to bridge.)
- Replacement of the EIFS walls (The exact amount of area in need of repair will be discretionary based on the actual future conditions and the desired appearance.)
- Replacement of up to fifty percent (50%) of the sealants in coordination with each paint finish application.

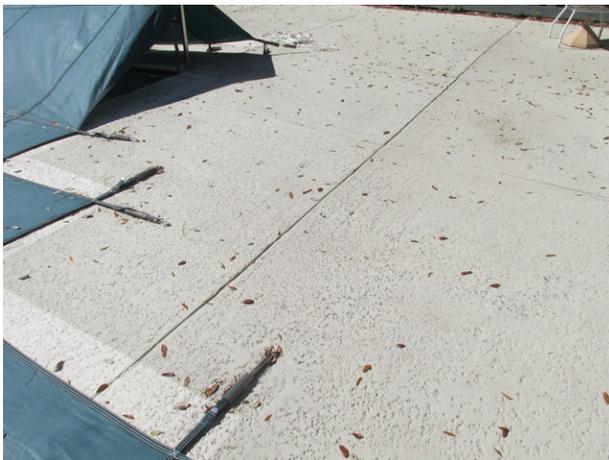
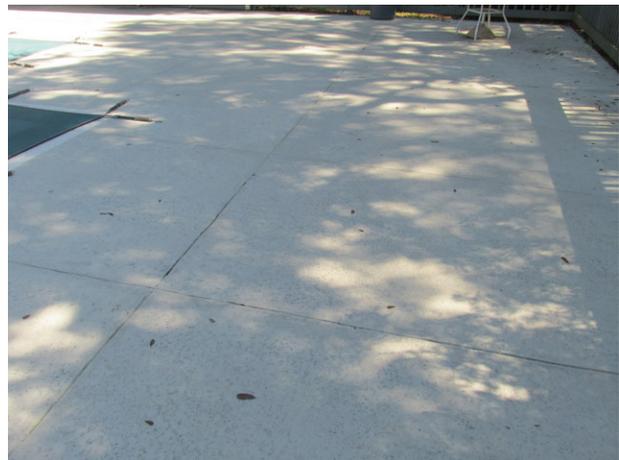
**Condition:** Good overall

Coated concrete deck

**Useful Life:** The useful life of a concrete pool deck is up to 60 years or more with timely repairs. We recommend the Association conduct inspections, partial replacements and repairs to the deck every 8- to 12-years in conjunction with coating replacements.

- Selective cut out and replacements of up to ten percent (10%) of concrete

- Crack repairs as needed
- Mortar joint repairs
- Caulk replacement
- Coating replacement

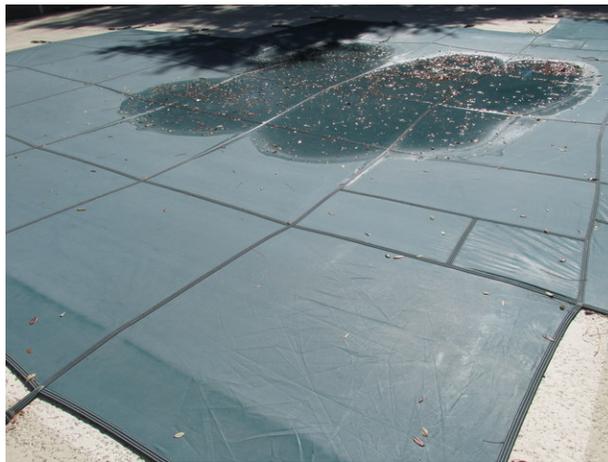
**Condition:** Fair overall

Vinyl pool cover

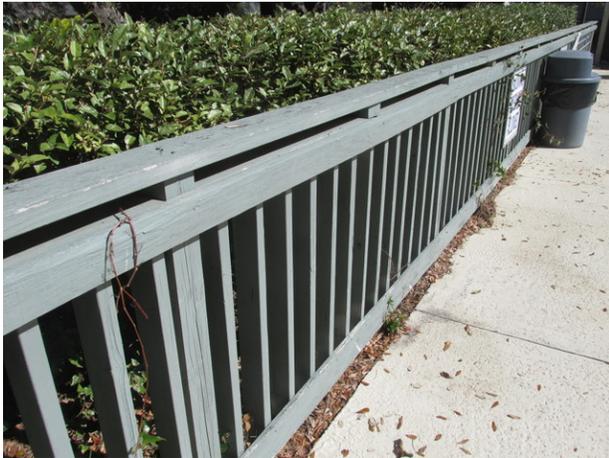
**Condition:** Fair overall condition

**Wood fence at pool area**

**Component Detail Notes:** The Association should anticipate periodic partial replacements due to the non-uniform nature of wood deterioration. Along with these partial replacements, the Association should apply periodic paint applications as needed and fund these activities through the operating budget.

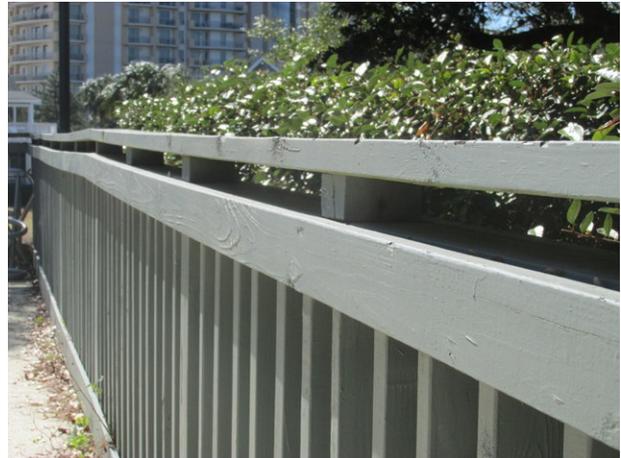
**Minor warping of wood fence at pool area**

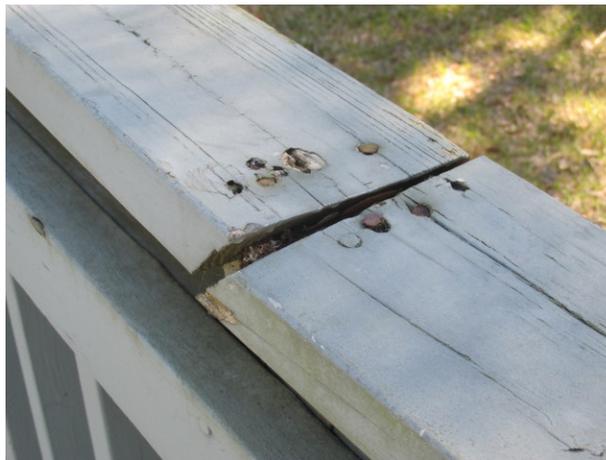
**Separated railing at fence**

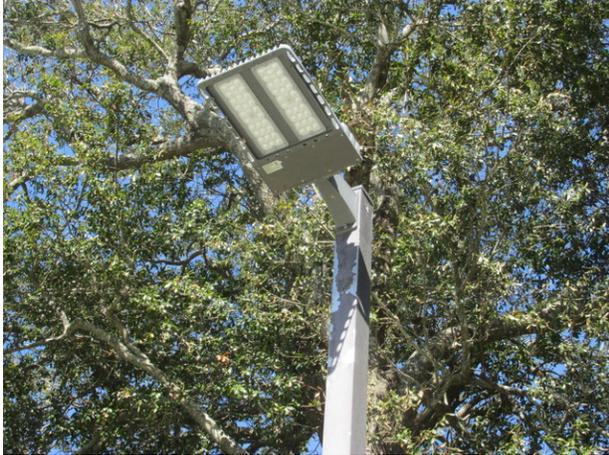
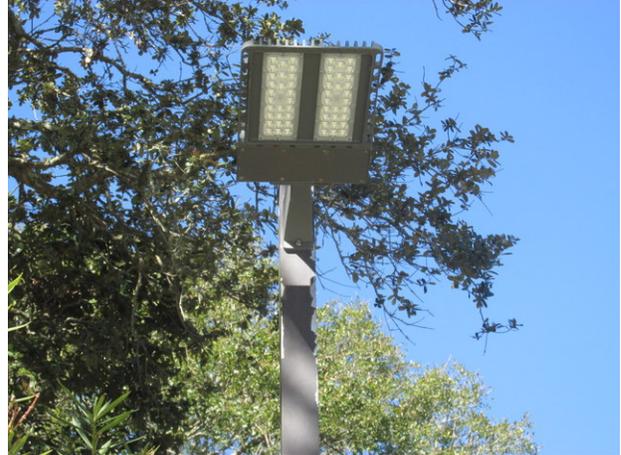
**Condition:** We note finish deterioration at the poles and fixtures.

**Light pole and fixture**

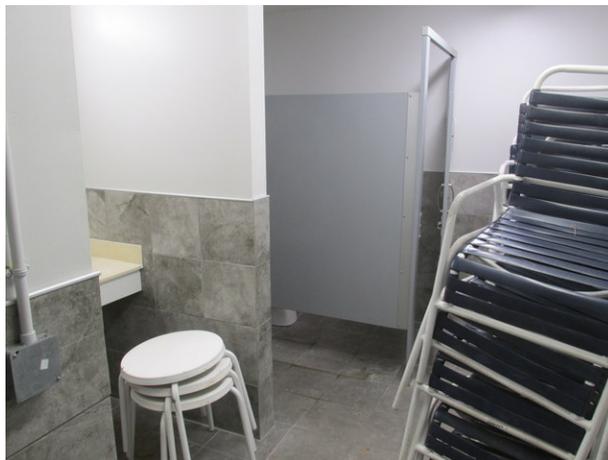
**Condition:** Good overall

**Rest room finishes and fixtures**

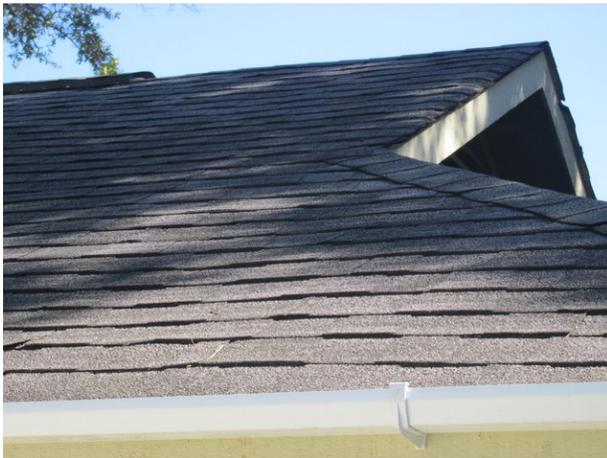
**Condition:** Fair overall condition. Management does not report a history of leaks.

**Asphalt shingle roof at pool house**

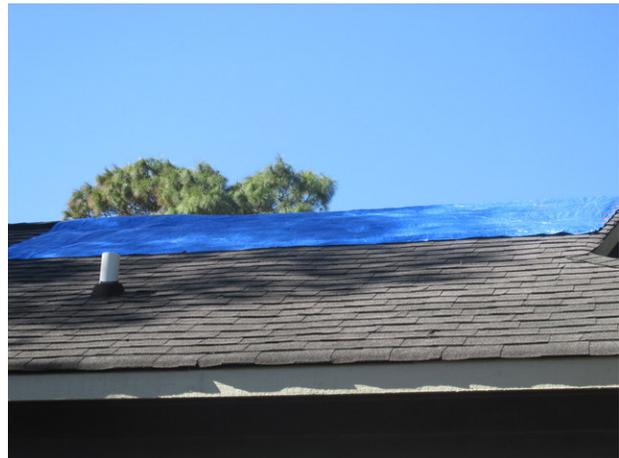
**Tarp at asphalt shingle roof at pool house**

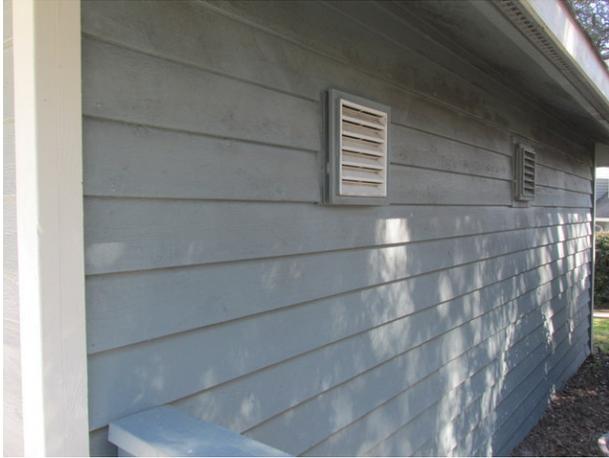
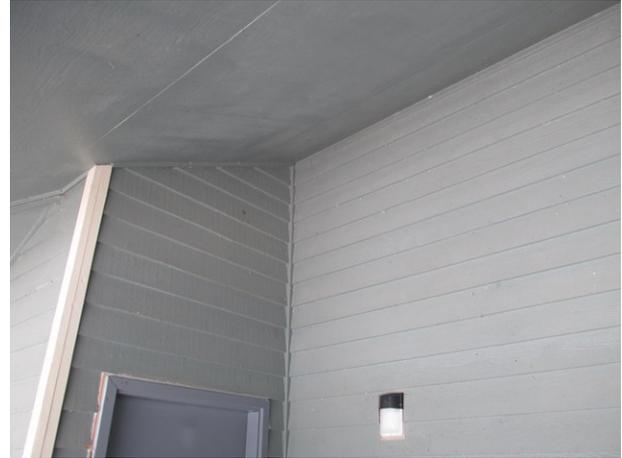
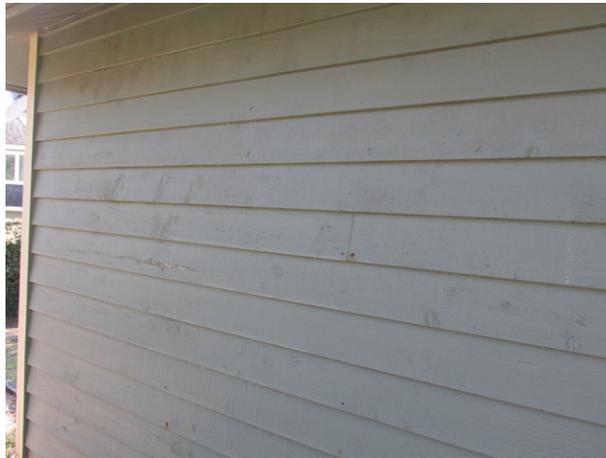
**Condition:** Fair overall condition

**Wood siding at pool house exterior**

**Useful Life:** Up to 40 years. This useful life is dependent upon timely paint applications and partial replacements of deteriorated siding.
